Existing Building

Key Internal Spaces - Committee Rooms and Mayors Office

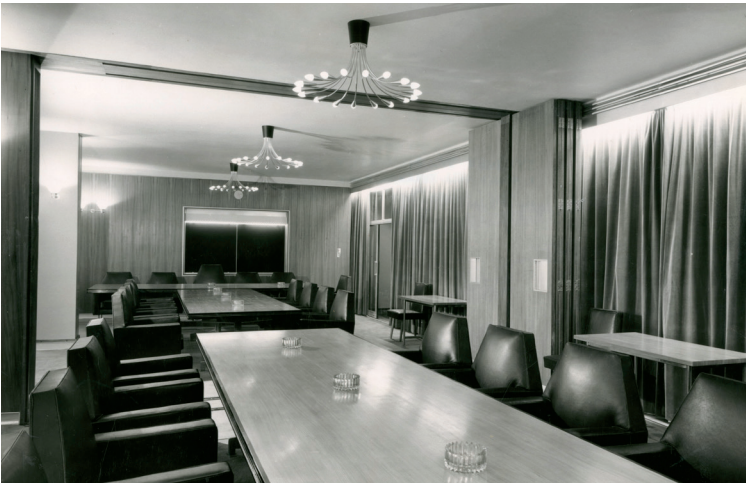
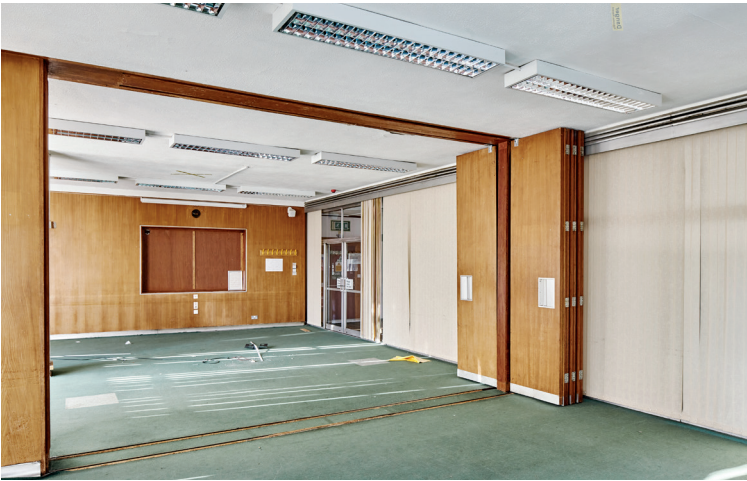
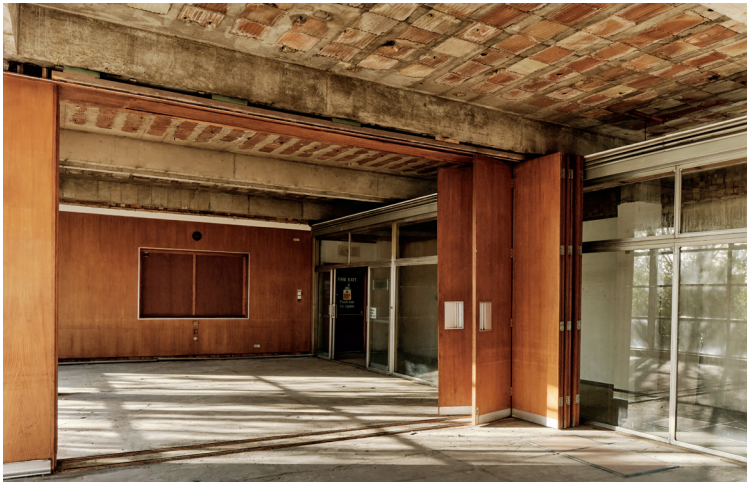
Large Committee Room

Glazing
- Pre-Enabling Works Condition
- Asbestos ceiling

Timber panelling with brass inlays - brass tarnished

Non-Original carpet

Vertical Blinds

Original brass clock removed
- Post-Enabling Works Condition
- Asbestos ceiling removed

Carpet Removed & Blinds Removed (Curtain track retained)

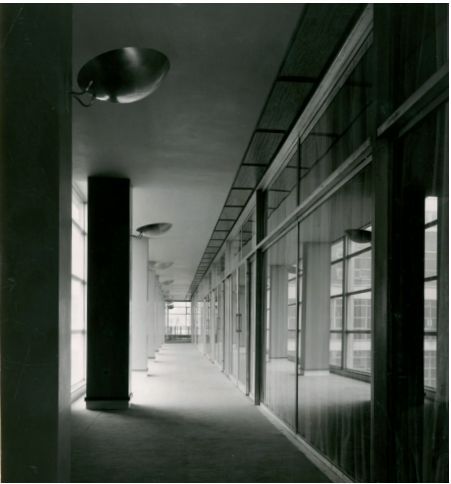
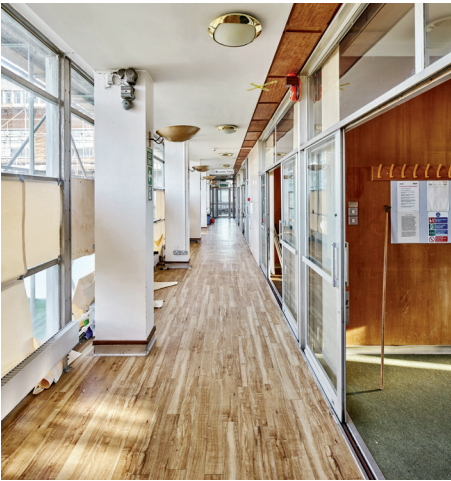
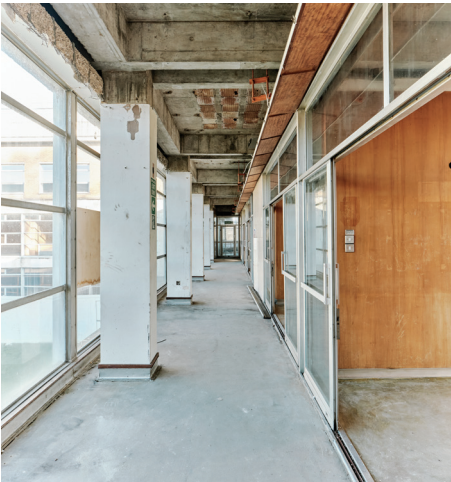
Committee Room Corridor

Top  
Historical Images

Middle  
Pre-Enabling Works

Bottom  
Post-Enabling Works
