# APPENDIX A

# SEWER RECORDS

**Search address supplied** 139  
Cranley Gardens  
London  
N10 3AH

No.139 CRANLEY GARDENS, LONDON, N10 3AG  
SECTION A-A

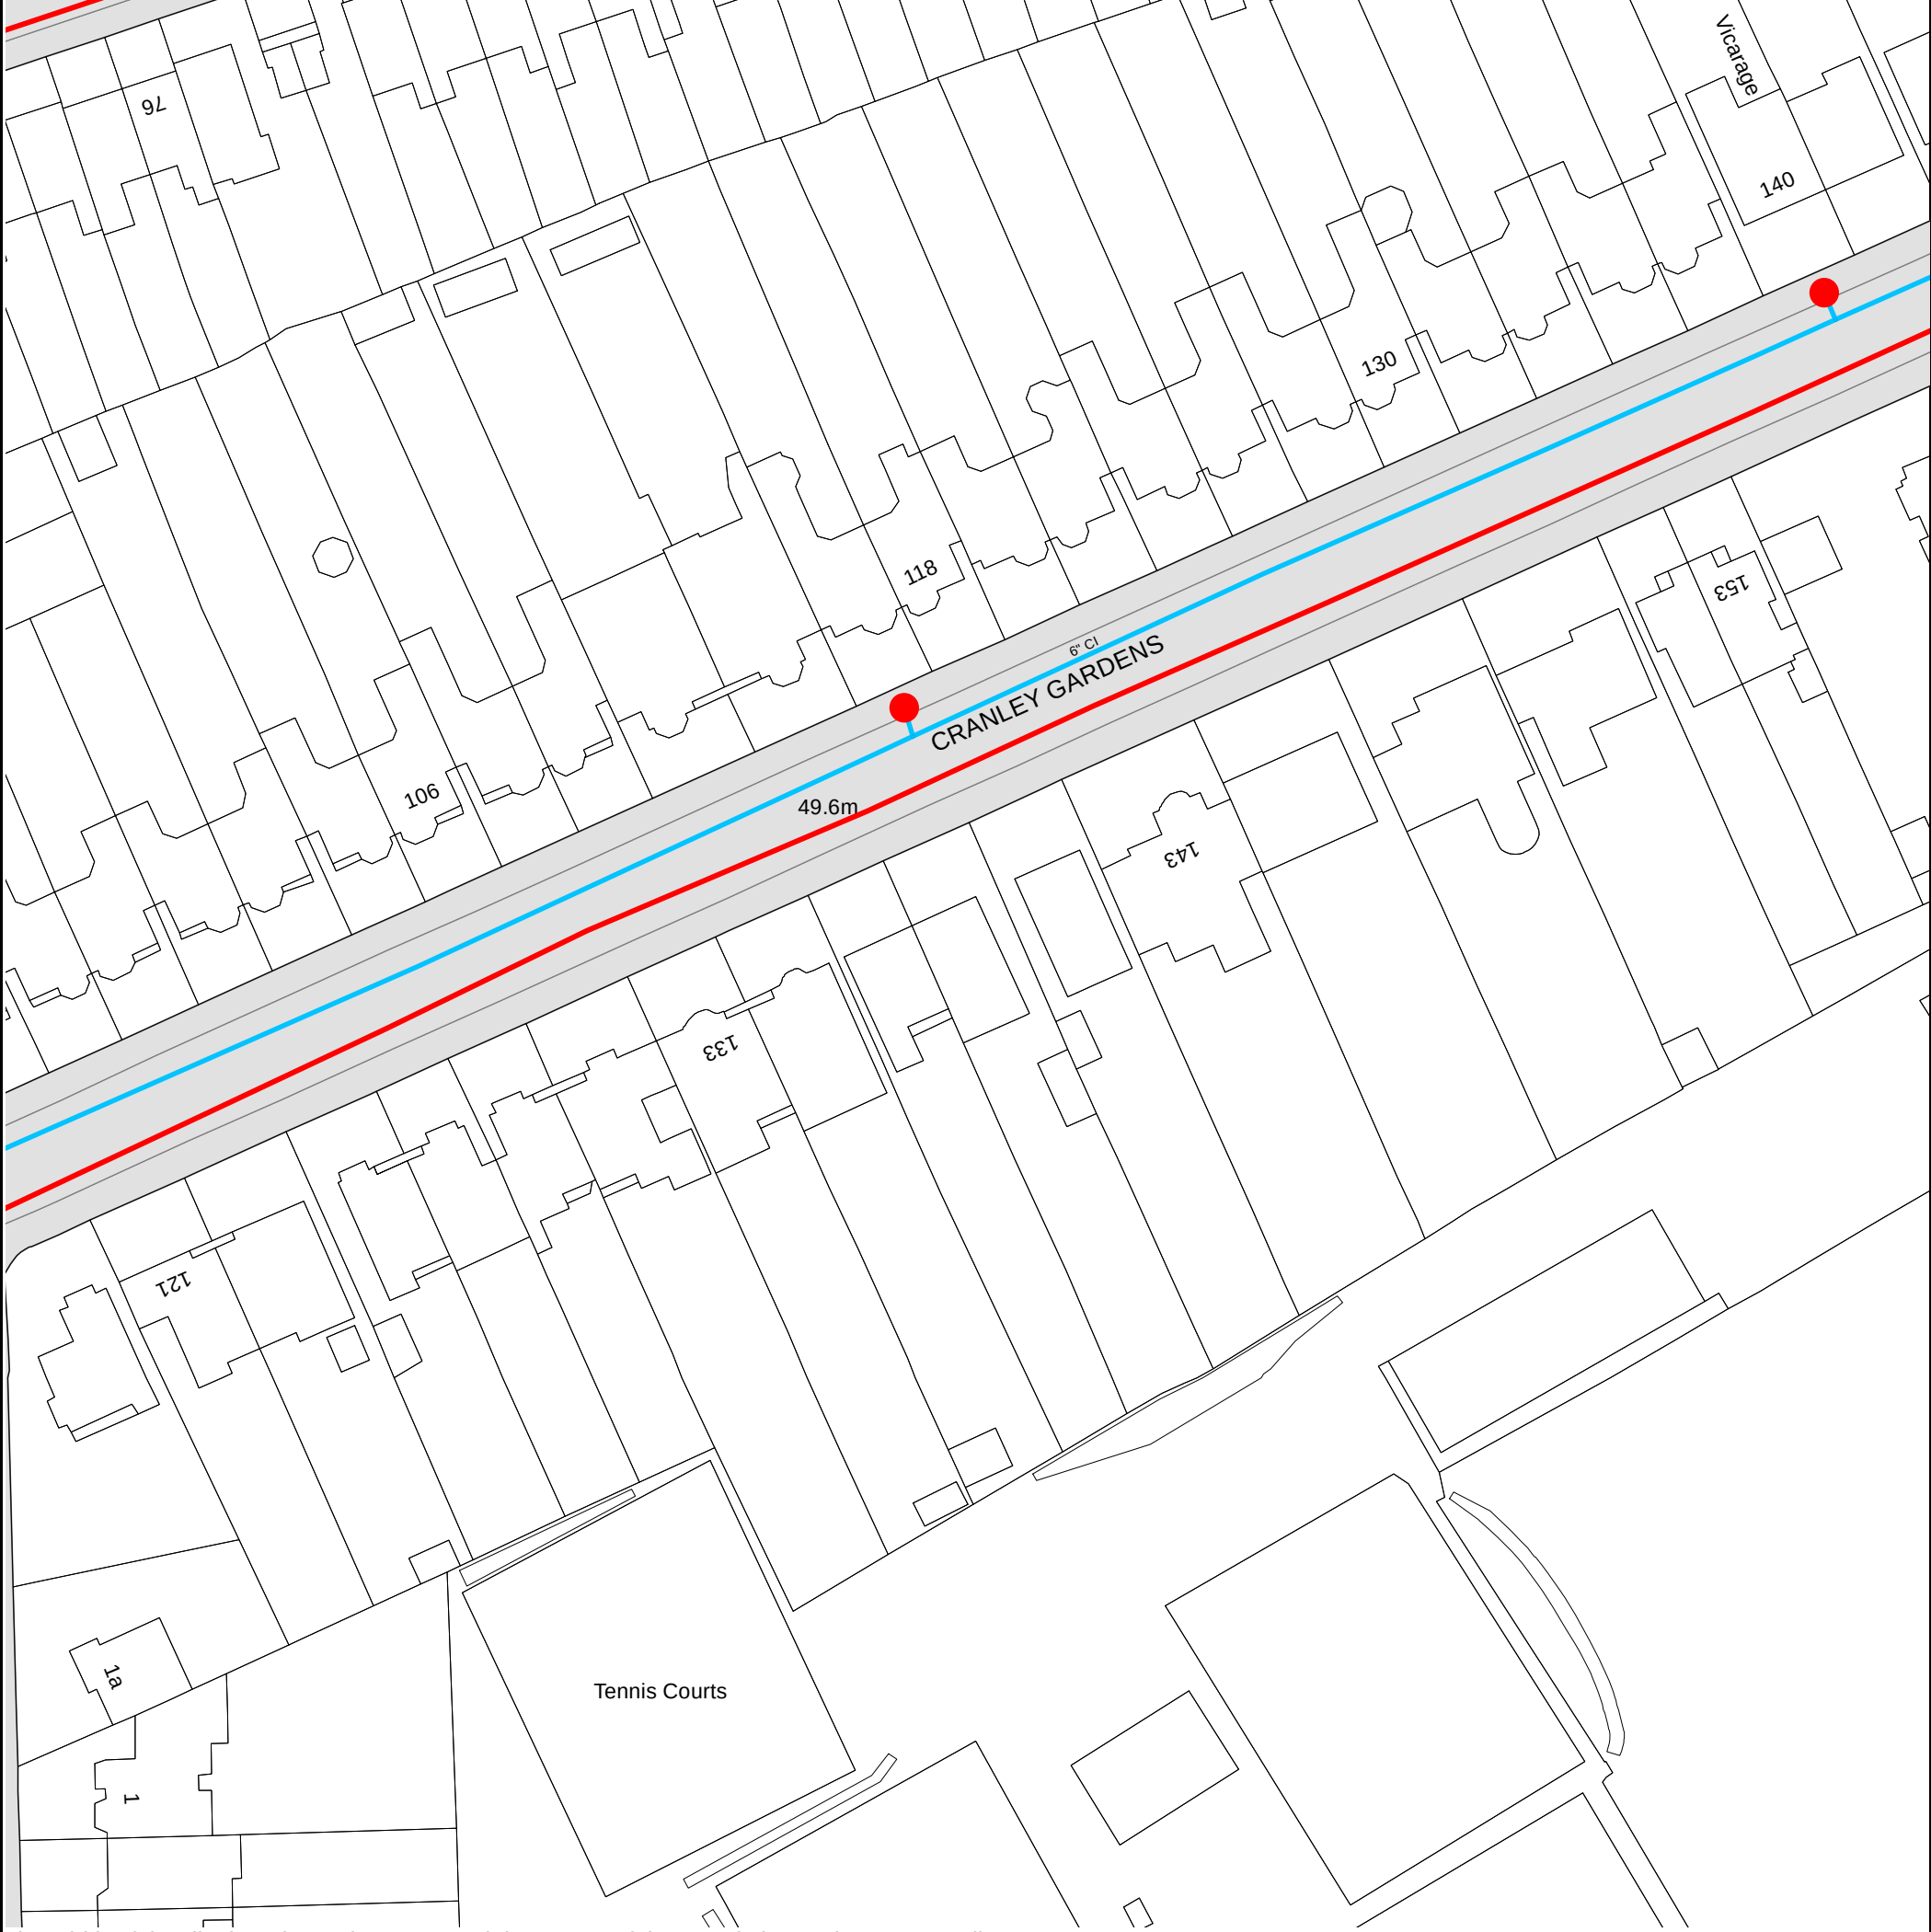
- 6) The text appearing alongside a sewer line indicates the internal diameter of the pipe in millimetres. Text next to a manhole indicates the manhole reference number and should not be taken as a measurement. If you are unsure about any text or symbology present on the plan, please contact a member of Property Searches on 0800 009 4540.

The width of the displayed area is 200 m and the centre of the map is located at OS coordinates 529191, 189043.  
The position of the apparatus shown on this plan is given without obligation and warranty, and the accuracy cannot be guaranteed. Service pipes are not shown but their presence should be anticipated. No liability of any kind whatsoever is accepted by Thames Water for any error or omission. The actual position of mains and services must be verified and established on site before any works are undertaken.

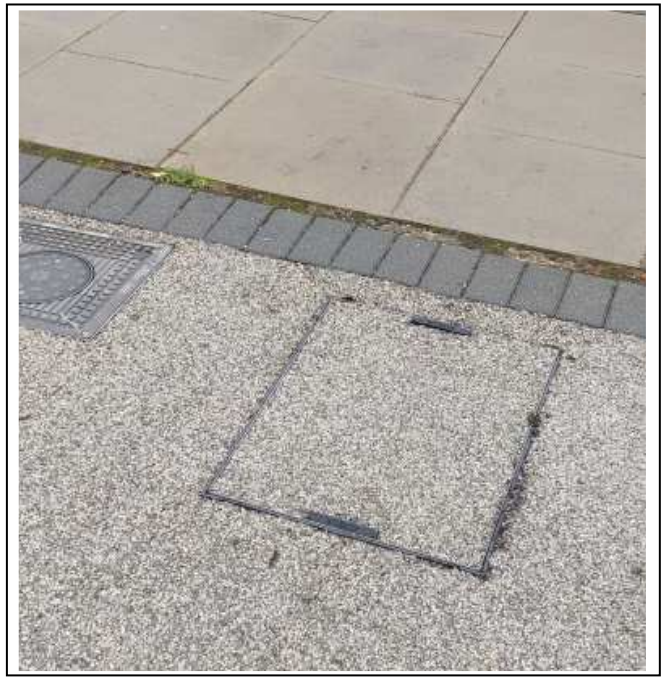
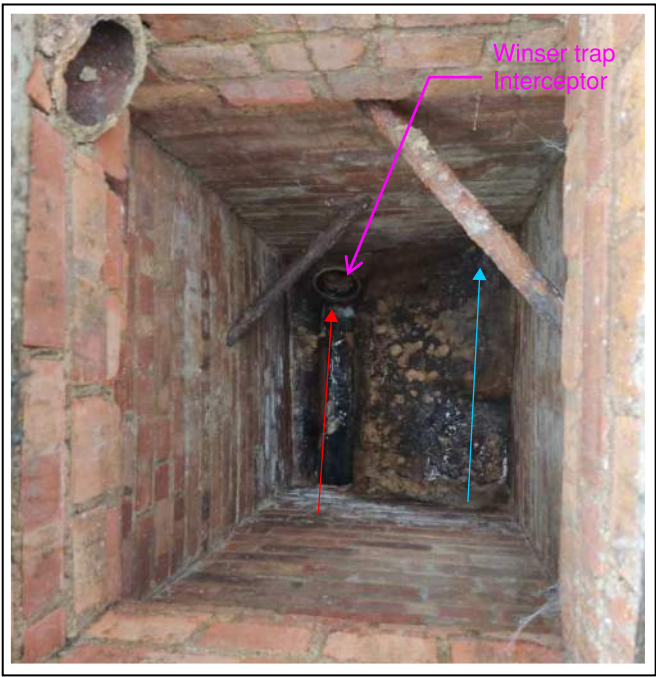
Demarcation chamber  
Has disused vent  
Has winser type interceptor trap  
Has storm water line encased in chamber's benching.

The Winner Type interceptor trap located at MH04 is cracked and requires repair. Originally designed to prevent foul air from entering buildings and rodents from leaving sewers, these traps often caused more problems when installed on combined storm and foul drainage systems. We recommend replacing it with a straight clay piece to ensure proper flow within the system. Additionally, a rat blocker can be installed as a preventive measure.

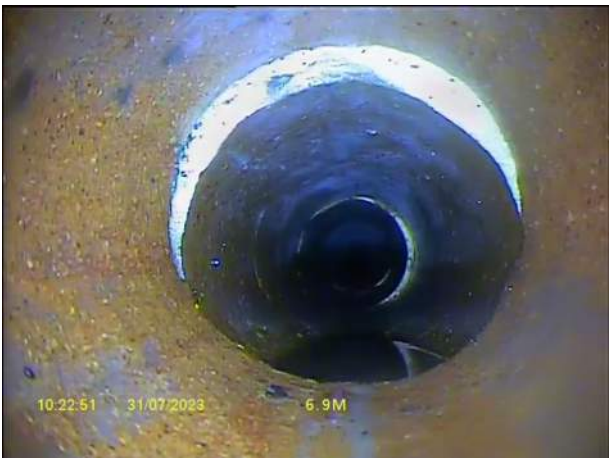
00:00:51, 6.90 m  
Medium displaced joint

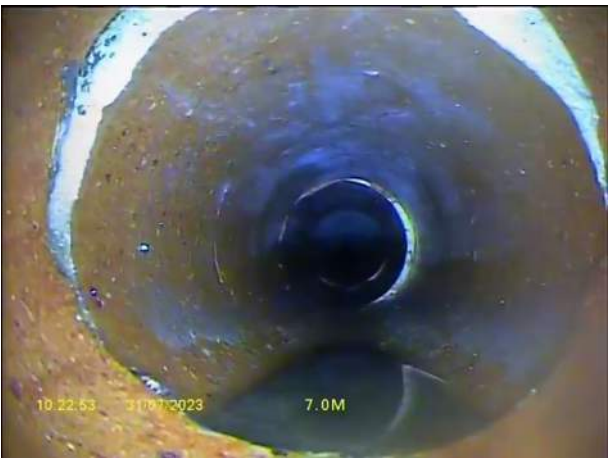
Water level, 5% of the height: Water pooling behind displacement. Can leak.

00:00:53, 7.00 m  
Water level, 5% of the height, Water pooling behind displacement. Can leak.

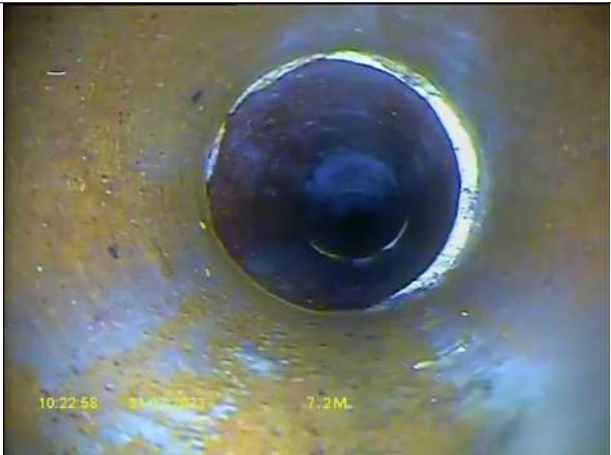
00:00:58, 7.20 m  
Medium displaced joint

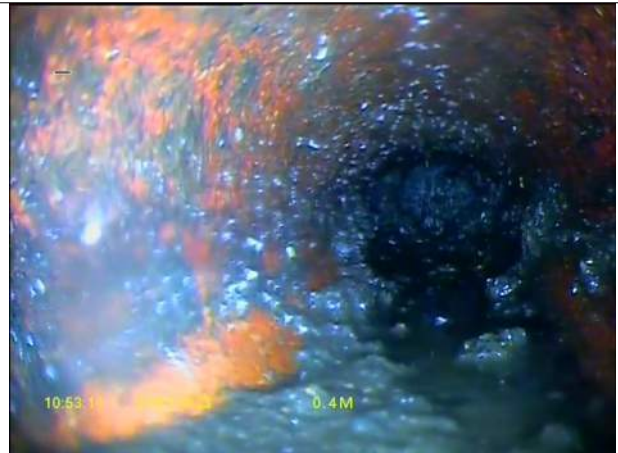
00:00:11, 0.40 m  
Fine settled deposits, 15% area loss

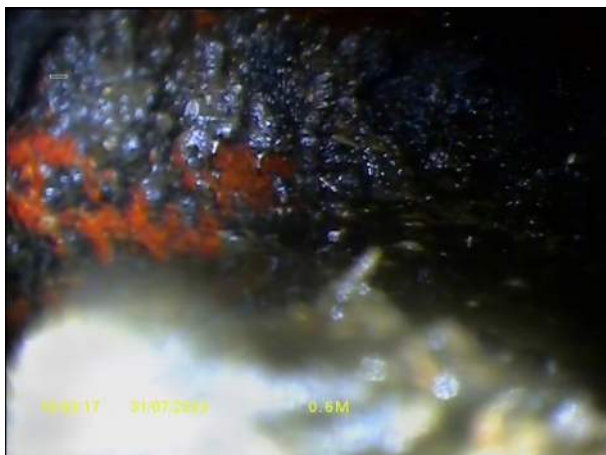
00:00:17, 0.60 m  
Survey abandoned, the pipe is unserviceable, Pipe appears disused and blocked by solid obstruction. Unable to progress.

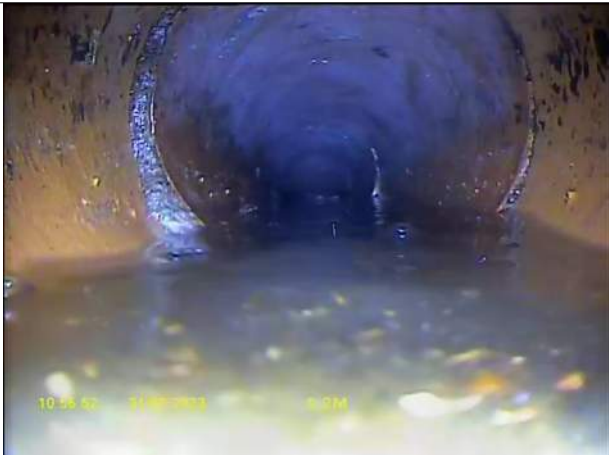
00:00:39, 5.00 m  
Medium displaced joint

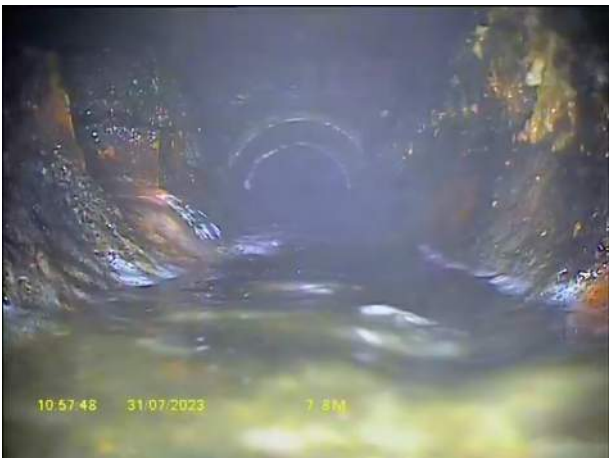
| <b>PLR:</b> | | MH02X | <b>Upstream Node:</b> | MH02 |
|---|---|---|---|---|
| 4 | 7.50 | MHF | Finish manhole, MH03, the pipe is failing to discharge, Responsibility of LWA/Build-over agreement required. Public asset. | |

00:01:17, 7.50 m  
Finish manhole, MH03, the pipe is failing to discharge,  
Responsibility of LWA/Build-over agreement required. Public  
asset.

The responsibility to repair and maintain shared adopted assets belongs to Thames Water. The client should provide a copy of this report to Thames Water who can confirm that these pipes are indeed shared and adopted.

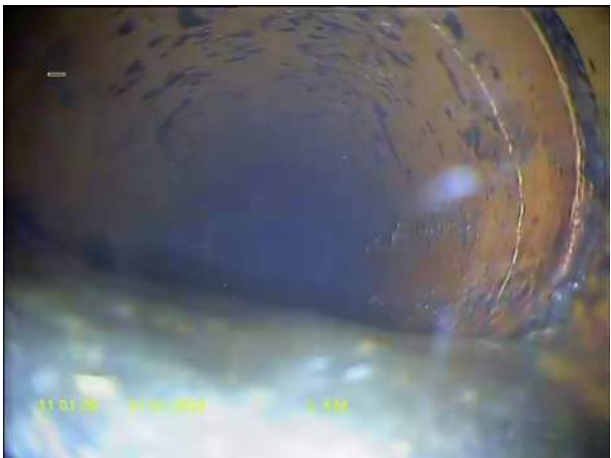
| <b>PLR:</b> | | MH02X | <b>Upstream Node:</b> | MH02 |
|---|---|---|---|---|
| 4 | 2.40 | CC | Circumferential crack from 1 o'clock to 5 o'clock | |

00:02:47, 2.40 m  
Circumferential crack from 1 o'clock to 5 o'clock

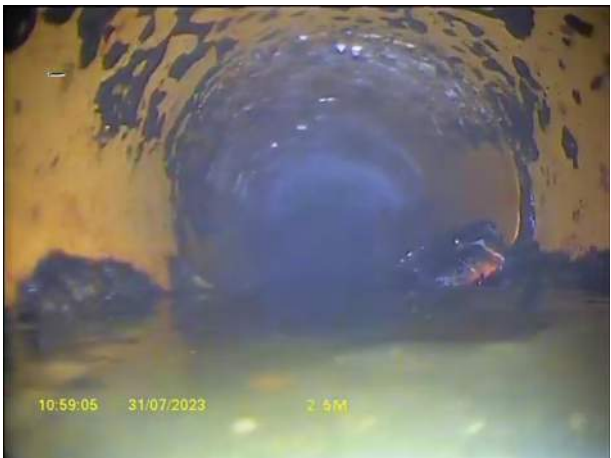
00:00:45, 2.50 m  
Medium displaced joint

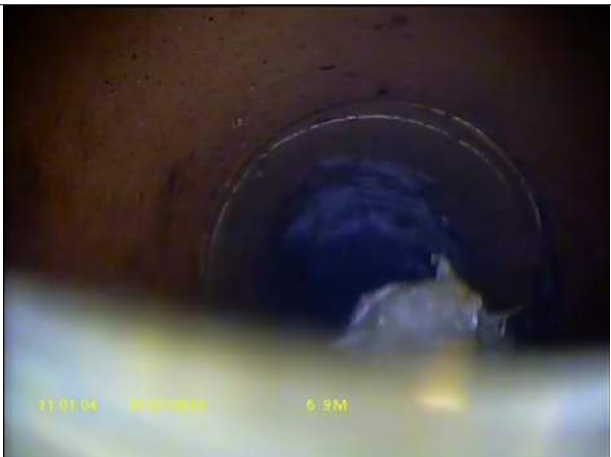
| <b>PLR:</b> | | MH02X | <b>Upstream Node:</b> | MH02 |
|---|---|---|---|---|
| 6 | 7.00 | CC | Circumferential crack from 8 o'clock to 4 o'clock | |

00:02:26, 7.00 m  
Circumferential crack from 8 o'clock to 4 o'clock

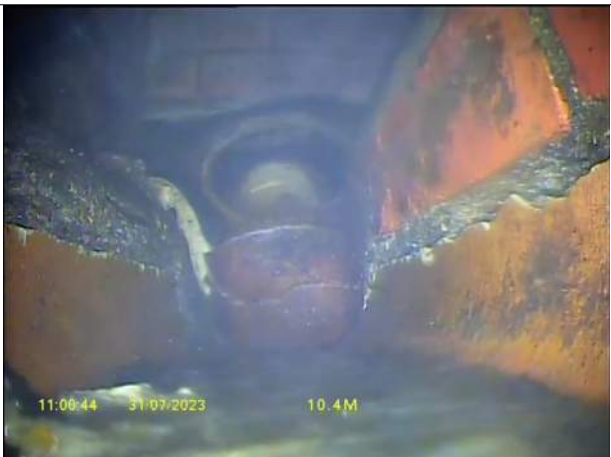
| <b>PLR:</b> | | MH02X | <b>Upstream Node:</b> | MH02 |
|---|---|---|---|---|
| 7 | 10.40 | REM | General remark, Winser Trap missing lid suggesting a history of blockages. | |

00:02:05, 10.40 m  
General remark, Winser Trap missing lid suggesting a history of blockages.

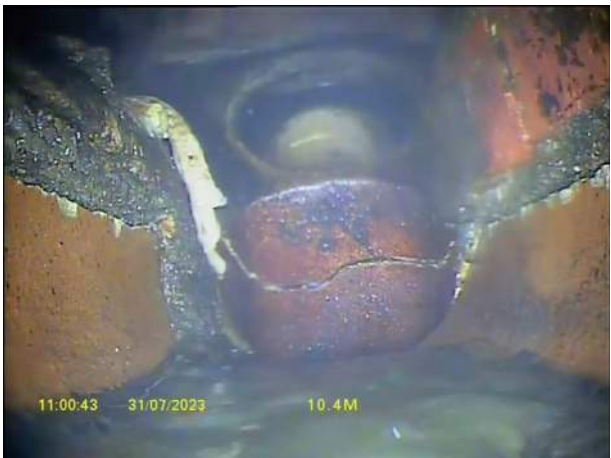
| <b>PLR:</b> | | MH02X | <b>Upstream Node:</b> | MH02 |
|---|---|---|---|---|
| 8 | 10.50 | WRF | Finish winser trap, MH04, the pipe is failing to discharge | |

00:02:05, 10.50 m  
Finish winser trap, MH04, the pipe is failing to discharge
