| PROJECT | S-2310 | HARINGEY CIVIC CENTRE |

| ELEVATION | EAST |
| FLOOR | 1ST FLOOR |

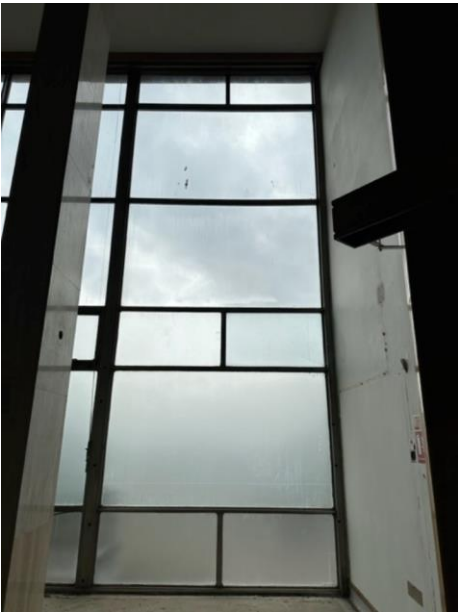
| WIN NO | W1-01 |

| POOR | <input checked="" type="checkbox"/> |

| All surfaces showing signs of deterioration |
| Sections separating |

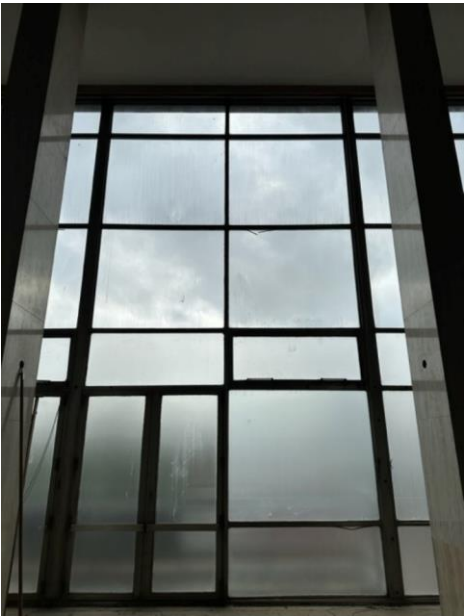
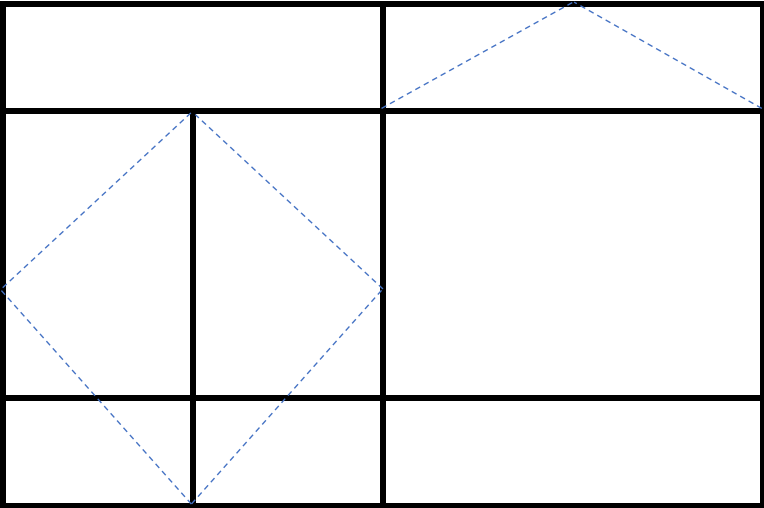
| WIN NO | W1-02 |

| POOR | <input checked="" type="checkbox"/> |

| All surfaces showing signs of deterioration |
| Sections separating |

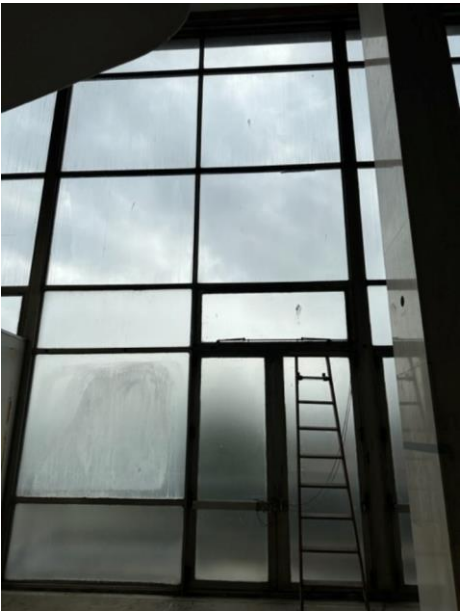
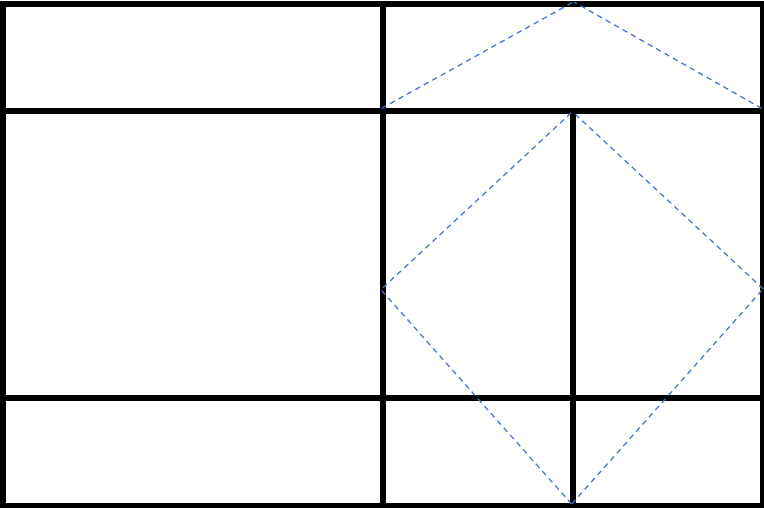
| WIN NO | W1-03 |

| POOR | <input checked="" type="checkbox"/> |

| All surfaces showing signs of deterioration |
| Sections separating |

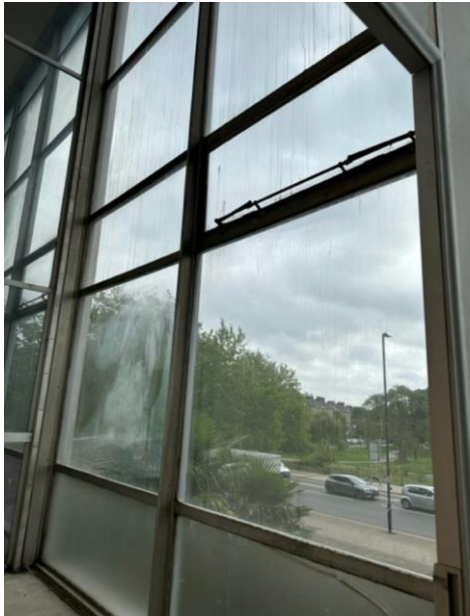
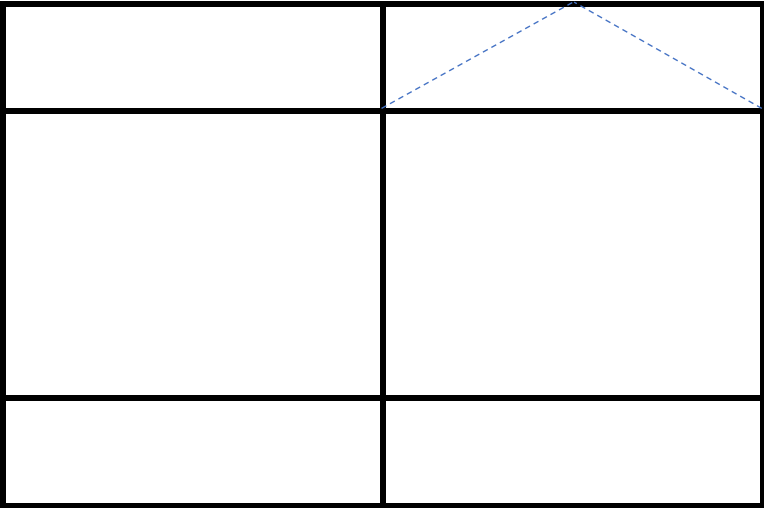
| WIN NO | W1-04 |

| POOR | <input checked="" type="checkbox"/> |

| All surfaces showing signs of deterioration |
| Sections separating |

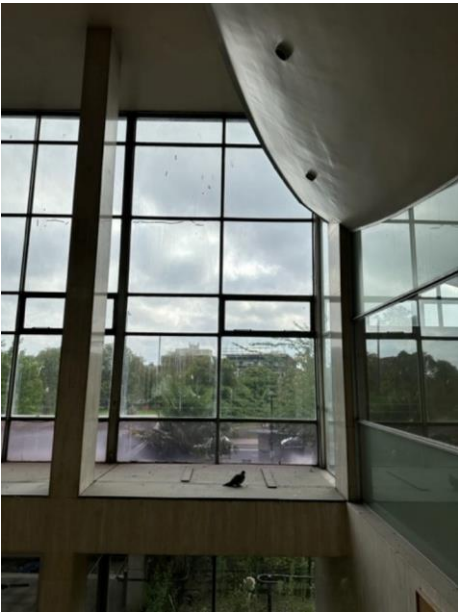
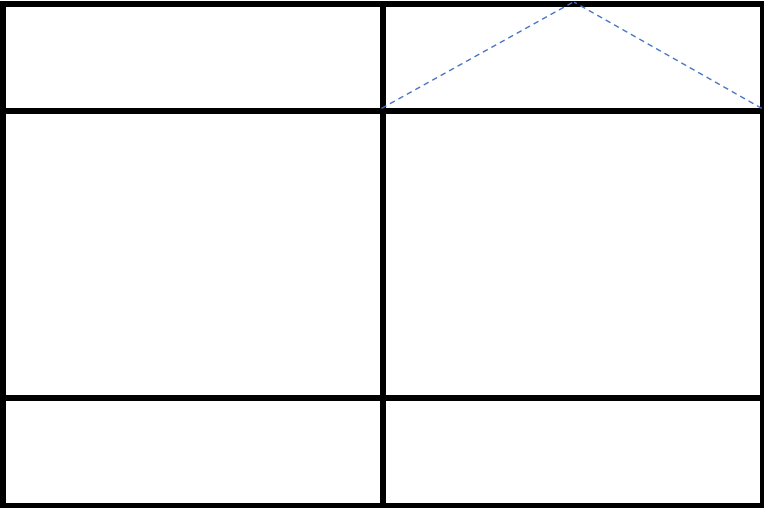
| WIN NO | W1-05 |

| POOR | <input checked="" type="checkbox"/> |

| All surfaces showing signs of deterioration |
| Sections separating |

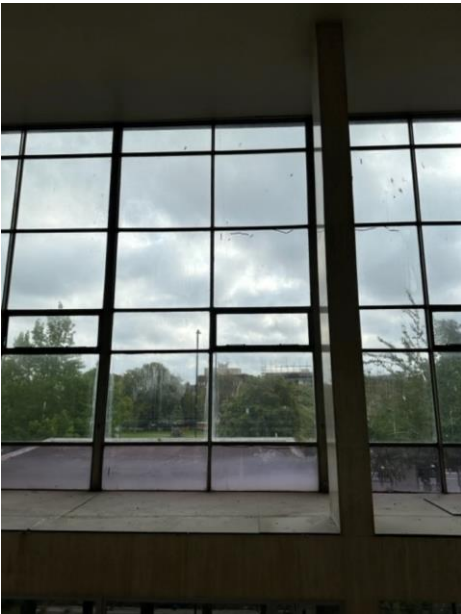
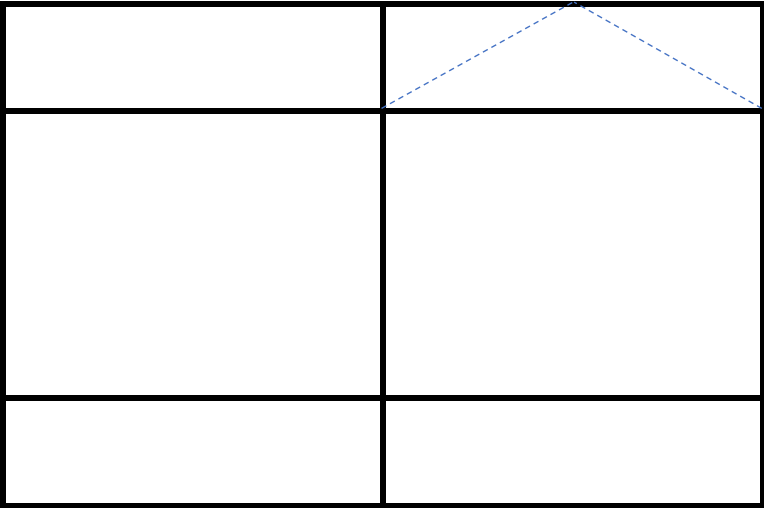
| WIN NO | W1-06 |

| POOR | <input checked="" type="checkbox"/> |

| All surfaces showing signs of deterioration |
| Sections separating |

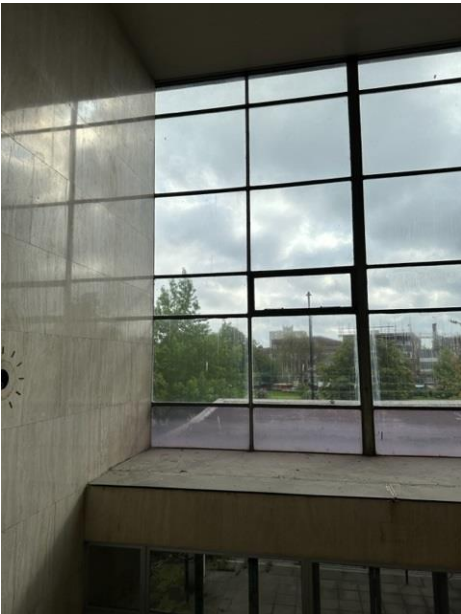
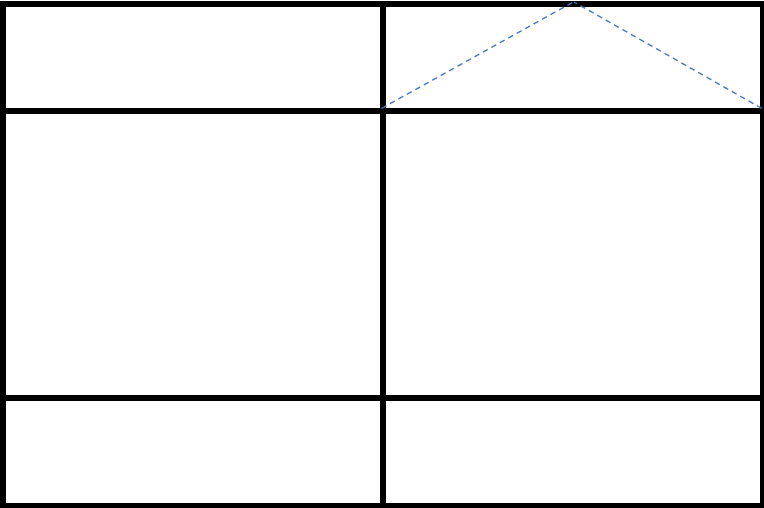
| WIN NO | W1-07 |

| POOR | <input checked="" type="checkbox"/> |

| All surfaces showing signs of deterioration |
