# Site Investigation Report

152369.1.USI

Auger were commissioned by Allianz to undertake a site investigation and CCTV inspection of the underground drainage within the area of concern (AOC) at the property.

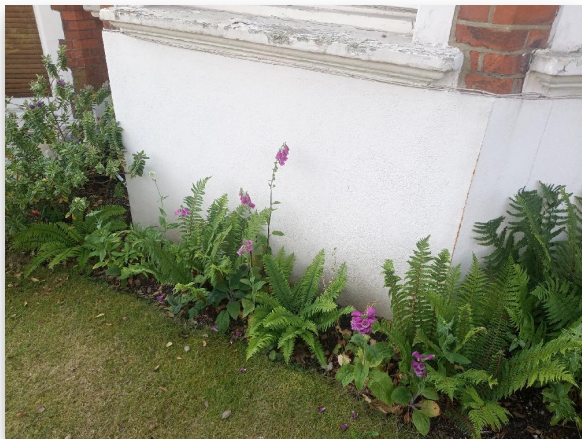
Fig 1.1: Trial Hole 1 Location

**Trial Hole 1**  
TH1 was completed in the proposed location and revealed the footing, soil and root samples were taken.

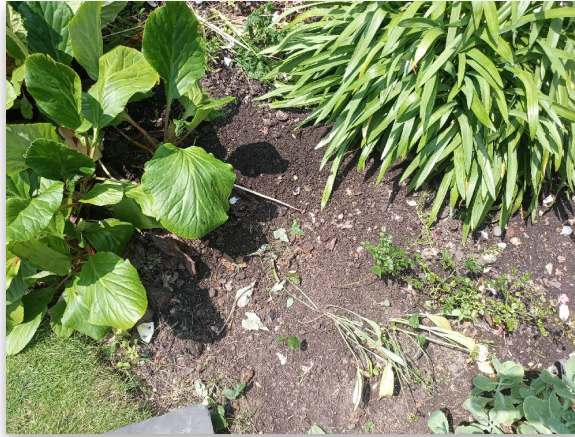
Fig 2.1: Trial Hole 2 Location

**Trial Hole 2**  
We were unable to collect root samples from TH2 because no roots were present during the trial hole, hence no samples were retrieved. Soil samples were taken.
