## PILE INTEGRITY TEST REPORT

Report No: **RP8675** Visit **01**

4 The Chine  
London  
N10 3QA.

Pile Type: Continuous Flight Auger (CFA)

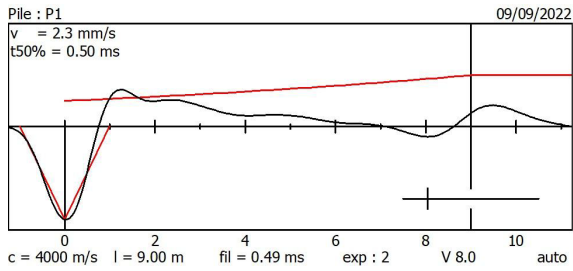
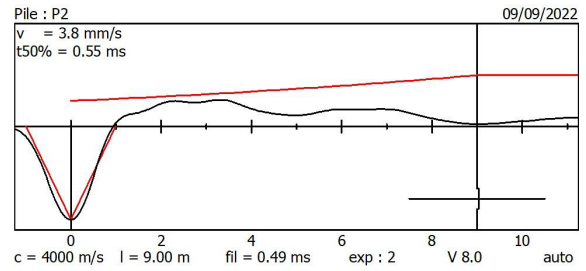
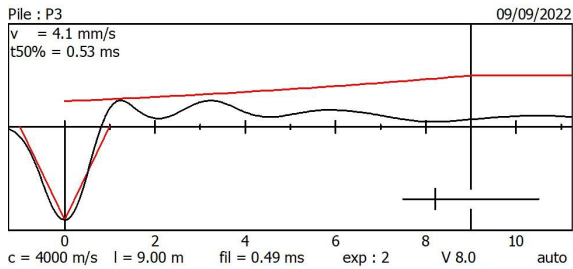
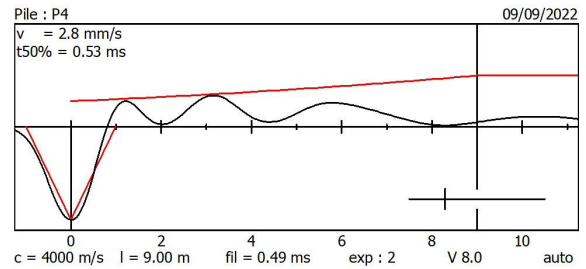
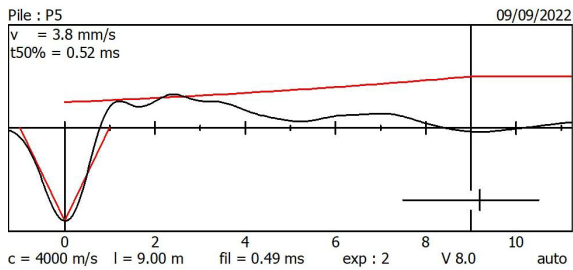
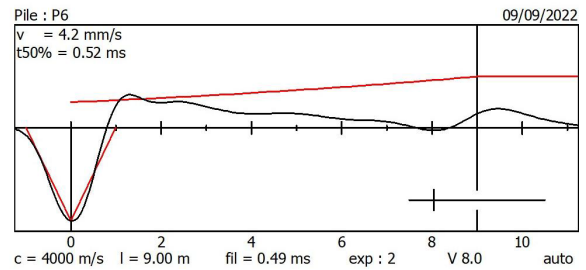
### RESULTANT TRACES

Based on the analysis and interpretation of the resultant traces obtained, it has been concluded that the 6 piles tested are a category 1 in the above table.

Note: the graphs displayed in this appendix are an average of 3 test locations taken across the pile heads.
