# Fountain Bowl

As the full method statement ALT-730 denotes, the main bowl of the fountain it to be refurbished in-situ, a brief overview of the work is denoted as a positive addition to the method statement but is not to be read as the full scope of works for the restoration

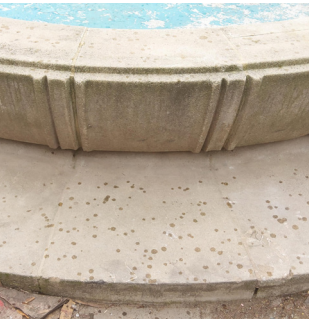
Generally border is in good condition with one bay showing a large section of stone damage which is to be replaced with matching stone. The remainder is to be light repairs and cleaning only.

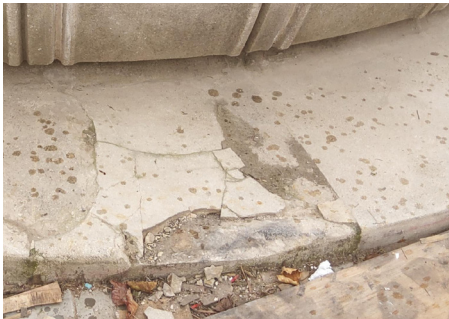
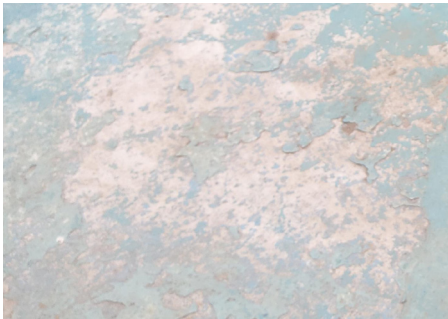
Existing paint shown to be cracking and peeling. To be cleared and removed back to stone for new paint.

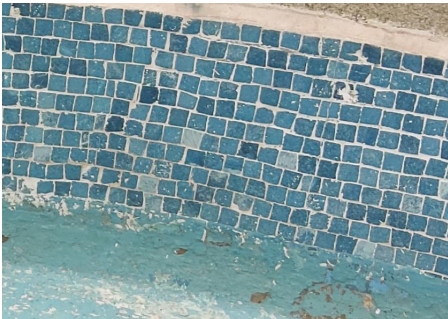
Tiles shown in general good condition. Any loose or unbedded tiles to be reset, any missing tiles to be replaced with replica matching tile.

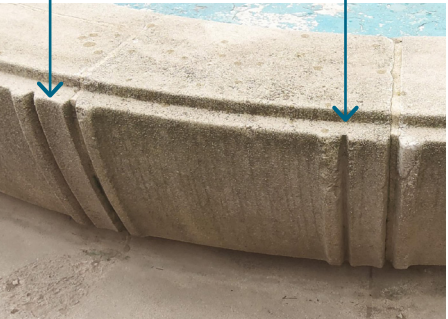
Stone border in general good condition with some detailing missing to be reinstated and cracks infilled. Majority of stone requires cleaning only.

Typical condition of stone fins - shape still distinguishable with some signs of age - no works.

Some fins show missing sections of larger cracks while still distinguishable, cracks are to be filled and fins repaired
