**CCTV REPORT FOR: 22 METHUEN PARK  
LONDON  
N10 2JS**

**CONTENTS:** SITE LAYOUT  
FOUNDATION RECORD  
PHOTOGRAPHS  
LABORATORY TESTING RESULTS  
ROOT IDENTIFICATION

**Insured:** Mrs Josephine Wick  
**Reference:** 084814508

**Site Visit:** 08-May-23  
**Report Date:** 22-Jun-23

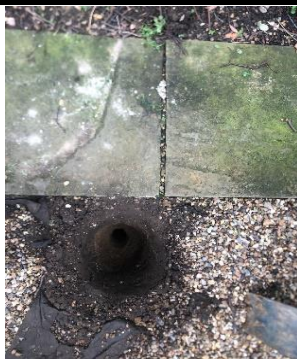
| Depth<br>(m) | Soil Descriptions<br><br>(NB: Field crew description only) | Test<br>Type | Depth (m) | |
|---|---|---|---|---|
| | Photograph | | | |

| Depth<br>(m) | Soil Descriptions<br><br>(NB: Field crew description only) | Test<br>Type | Depth (m) | |
|---|---|---|---|---|
| 1.00 | Soft brown slightly gravelly very sandy CLAY | P.P. 1.5 | 1.000 | |
| 1.50 | Firm brown slightly gravelly sandy CLAY | P.P. 2.0 | 1.500 | |
| 2.80 | Stiff brown mottled grey slightly gravelly slightly sandy CLAY | P.P. 2.0 | 2.000 | |
| 4.00 | End of borehole | P.P. 2.5 | 2.500 | |
