## Monitoring Details:

Job Reference: 9646135

## Monitored Address:

Address: Flat 10, 38 Colney Hatch Lane, LONDON, N10 1DU

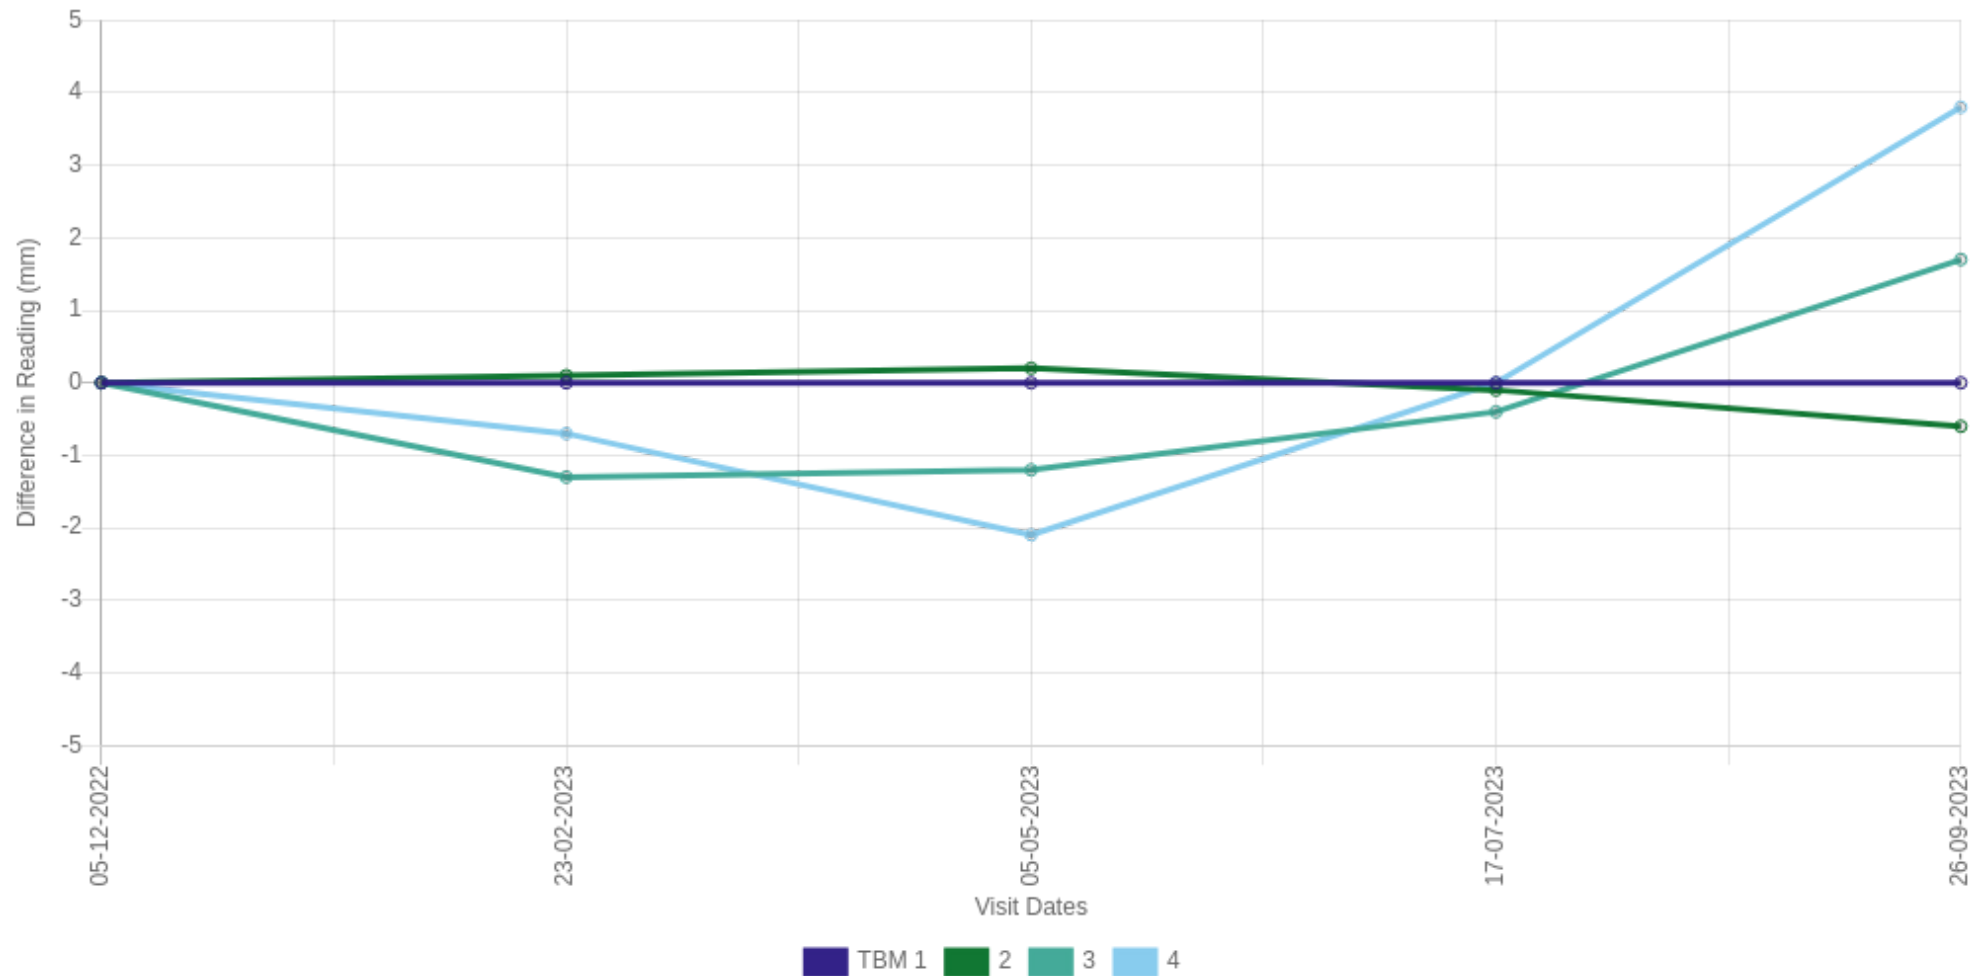
# Level Readings Chart (Points TBM 1 - 4)

| | Visit 1 | Visit 2 | Visit 3 | Visit 4 | Visit 5 | Visit 6 | Visit 7 | Visit 8 | Visit 9 | Visit 10 |
|---|---|---|---|---|---|---|---|---|---|---|
| 2 | 0 | +0.1 | +0.2 | -0.1 | -0.6 | | | | | |
| 3 | 0 | -1.3 | -1.2 | -0.4 | +1.7 | | | | | |
| 4 | 0 | -0.7 | -2.1 | 0 | +3.8 | | | | | |

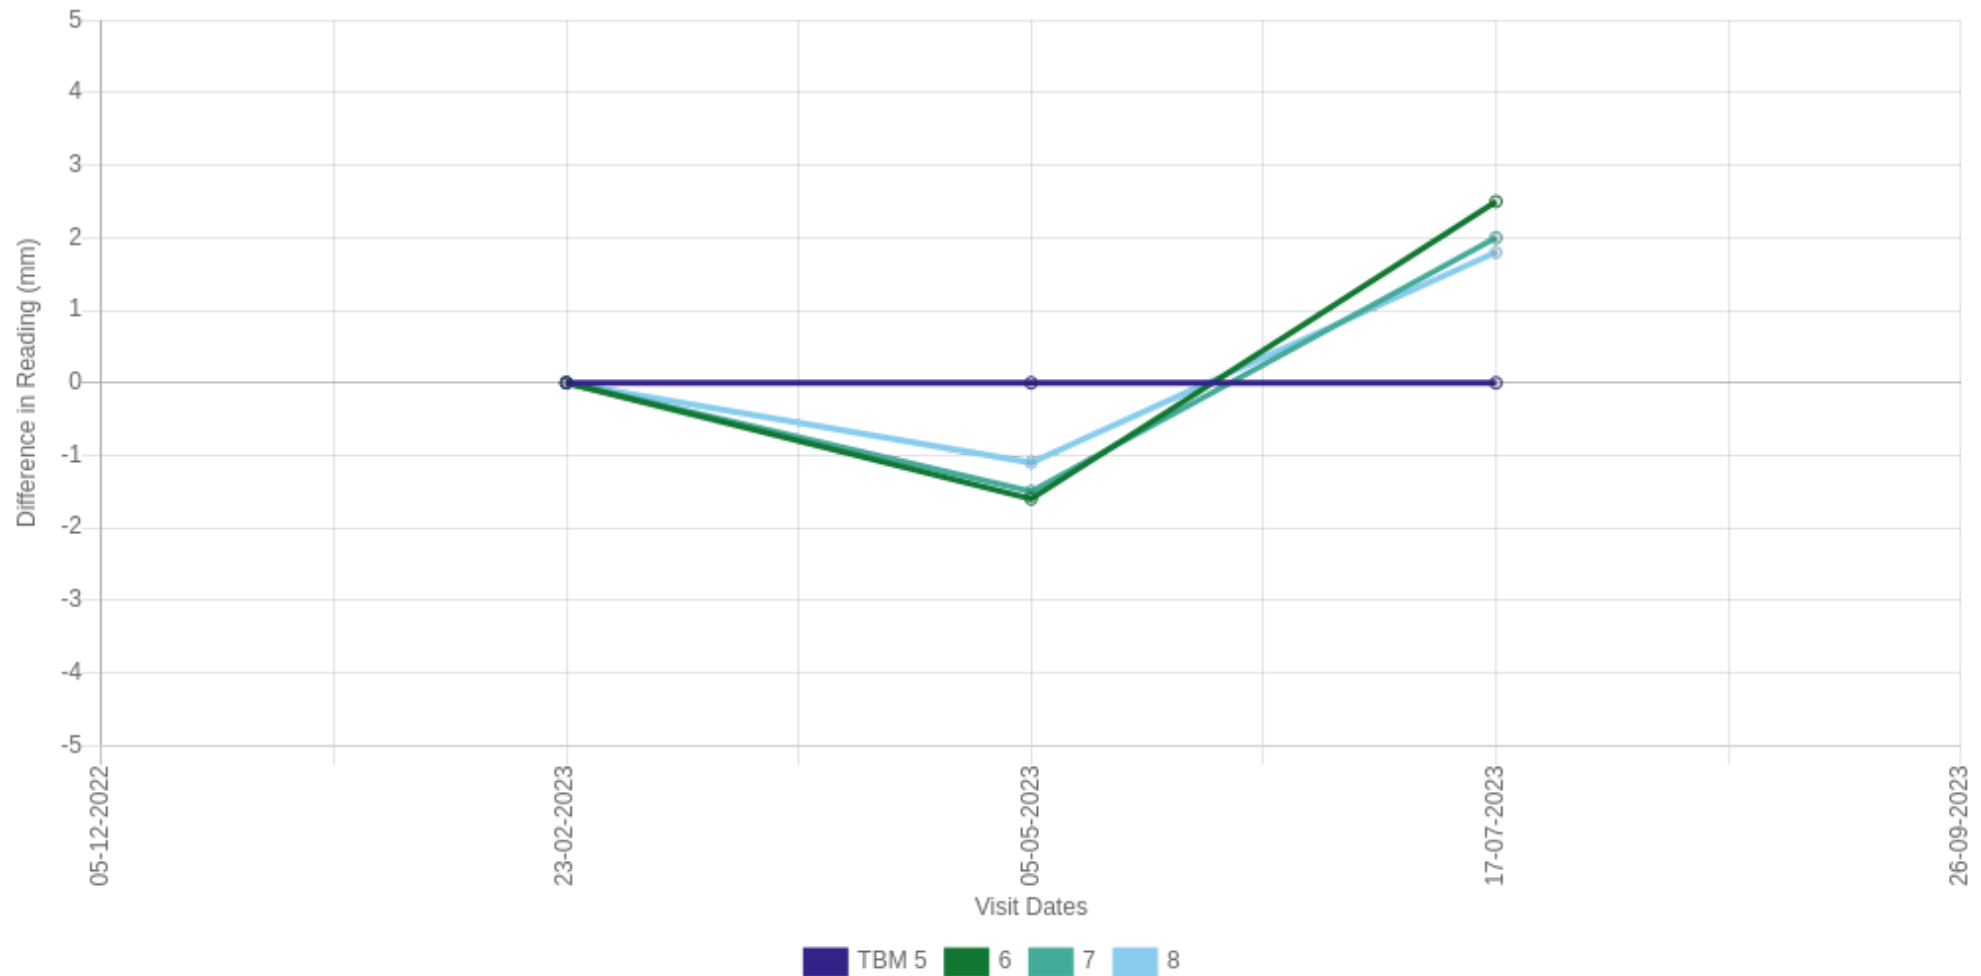
## Level Readings Chart (Points TBM 5 - 8)

| | Visit 1 | Visit 2 | Visit 3 | Visit 4 | Visit 5 | Visit 6 | Visit 7 | Visit 8 | Visit 9 | Visit 10 |
|---|---|---|---|---|---|---|---|---|---|---|
| 6 | | 0 | -1.6 | +2.5 | | | | | | |
| 7 | | 0 | -1.5 | +2 | | | | | | |
| 8 | | 0 | -1.1 | +1.8 | | | | | | |

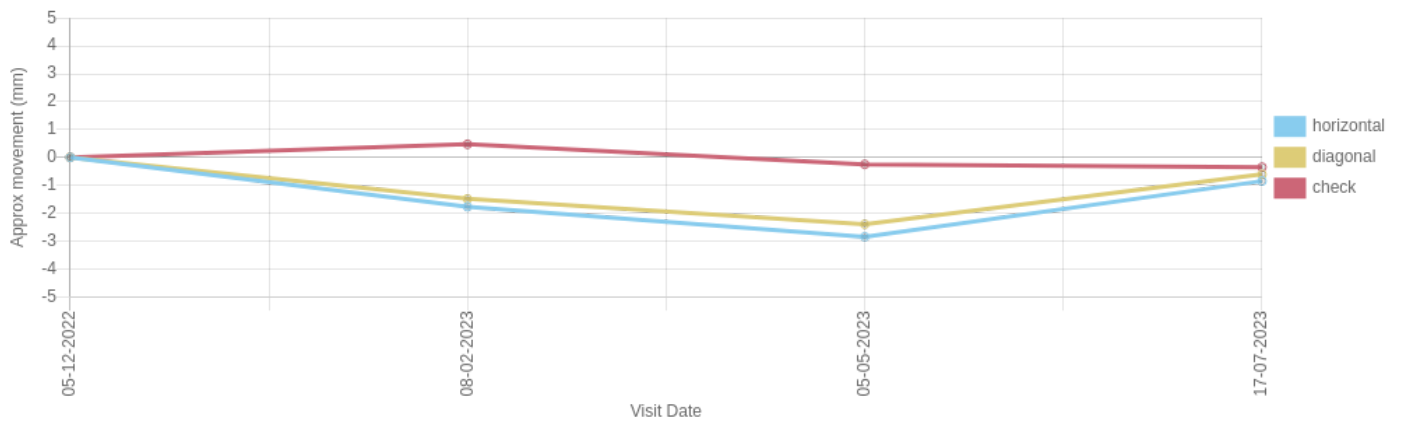
Flat 2 int next to toilet door - Crack Readings Differences (Displayed in Millimetres)

| | Visit 1 | Visit 2 | Visit 3 | Visit 4 | Visit 5 | Visit 6 | Visit 7 | Visit 8 | Visit 9 | Visit 10 |
|---|---|---|---|---|---|---|---|---|---|---|
| H | 0 | -1.77 | -2.85 | -0.85 | | | | | | |
| D | 0 | -1.49 | -2.4 | -0.61 | | | | | | |
| C | 0 | 0.47 | -0.25 | -0.35 | | | | | | |

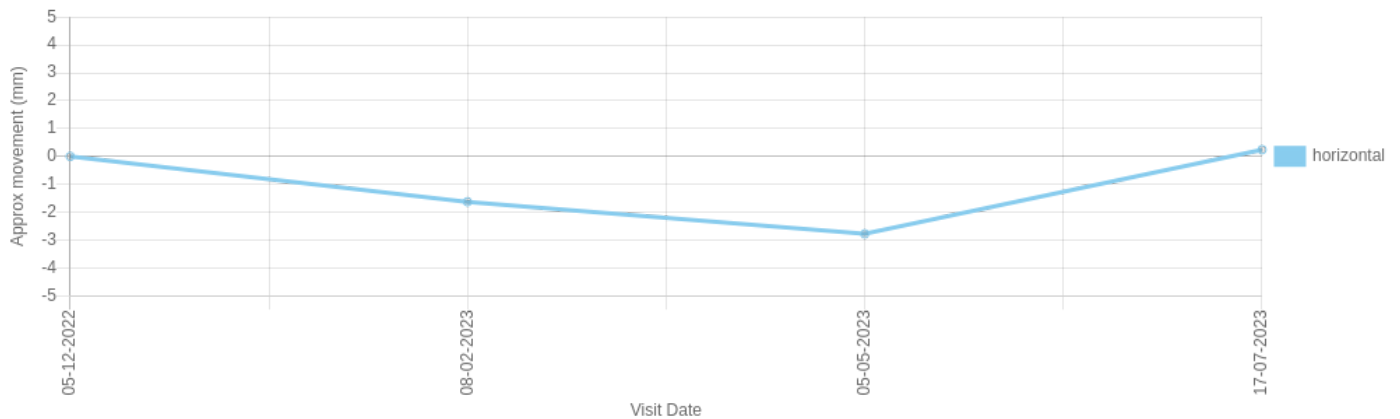
Int flat 2 inside toilet. - Crack Readings Differences (Displayed in Millimetres)

| | Visit 1 | Visit 2 | Visit 3 | Visit 4 | Visit 5 | Visit 6 | Visit 7 | Visit 8 | Visit 9 | Visit 10 |
|---|---|---|---|---|---|---|---|---|---|---|
| H | 0 | -1.63 | -2.78 | 0.24 | | | | | | |

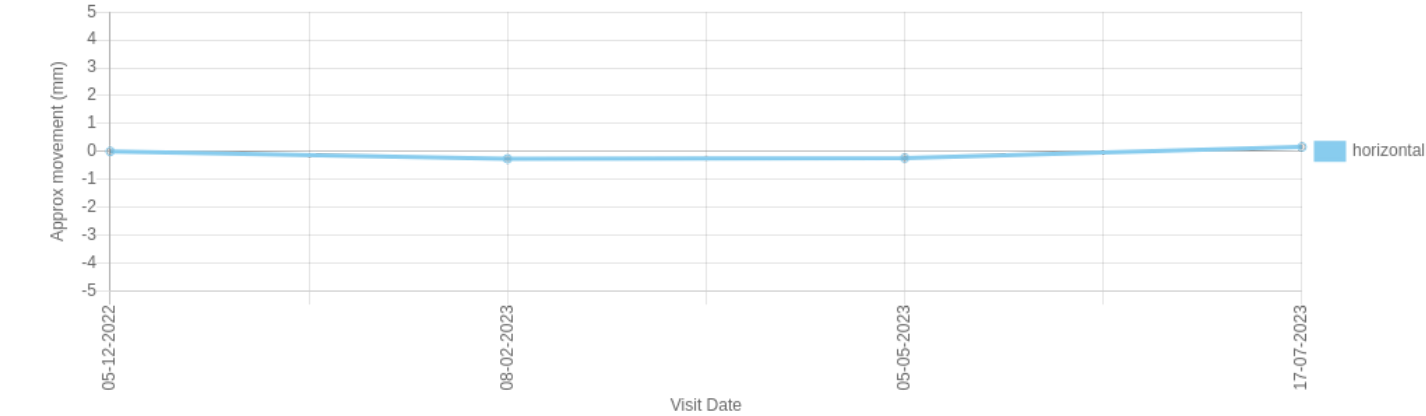
Int flat 2 RHS next to steps.. - Crack Readings Differences (Displayed in Millimetres)

| | Visit 1 | Visit 2 | Visit 3 | Visit 4 | Visit 5 | Visit 6 | Visit 7 | Visit 8 | Visit 9 | Visit 10 |
|---|---|---|---|---|---|---|---|---|---|---|
| H | 0 | -0.27 | -0.24 | 0.16 | | | | | | |
