Alexander Smirnov

**'Guildens', Courtenay  
Avenue, Highgate, London**  
*Basement Impact Assessment*

Revision 2

March, 2023

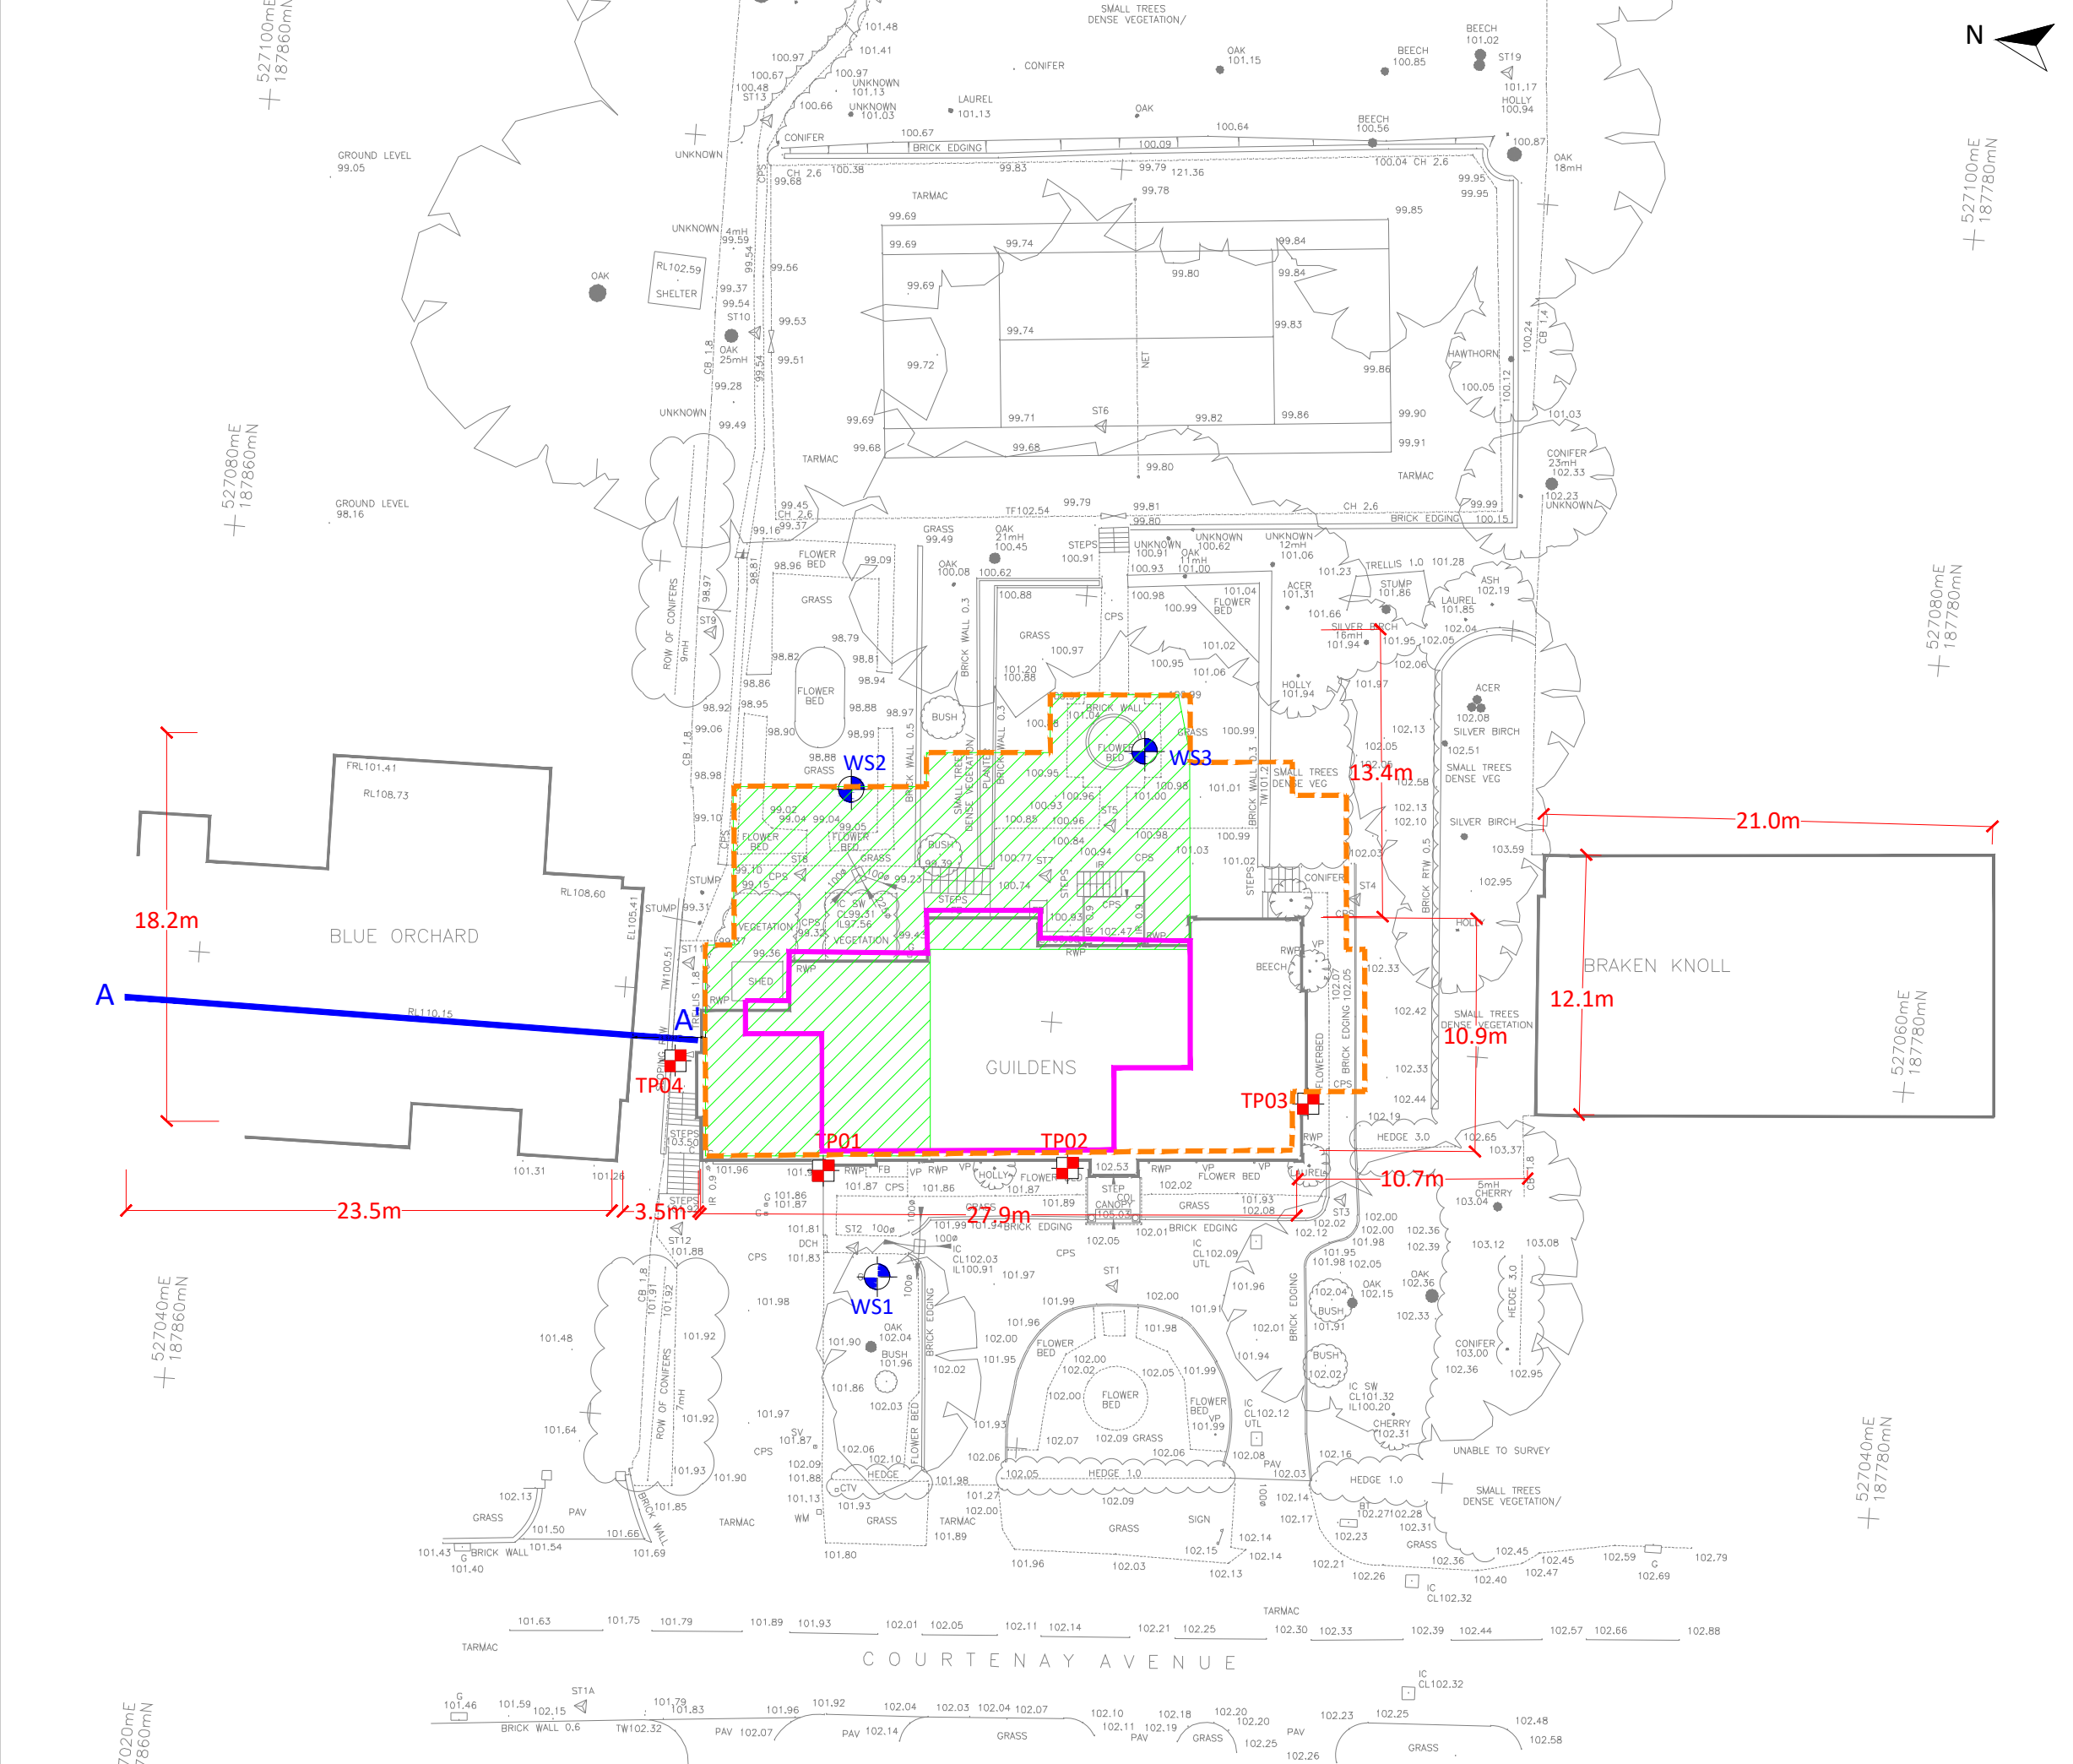
Drawings showing the existing layout of the property can be found in Appendix A and the site layout plan in Figure 2.

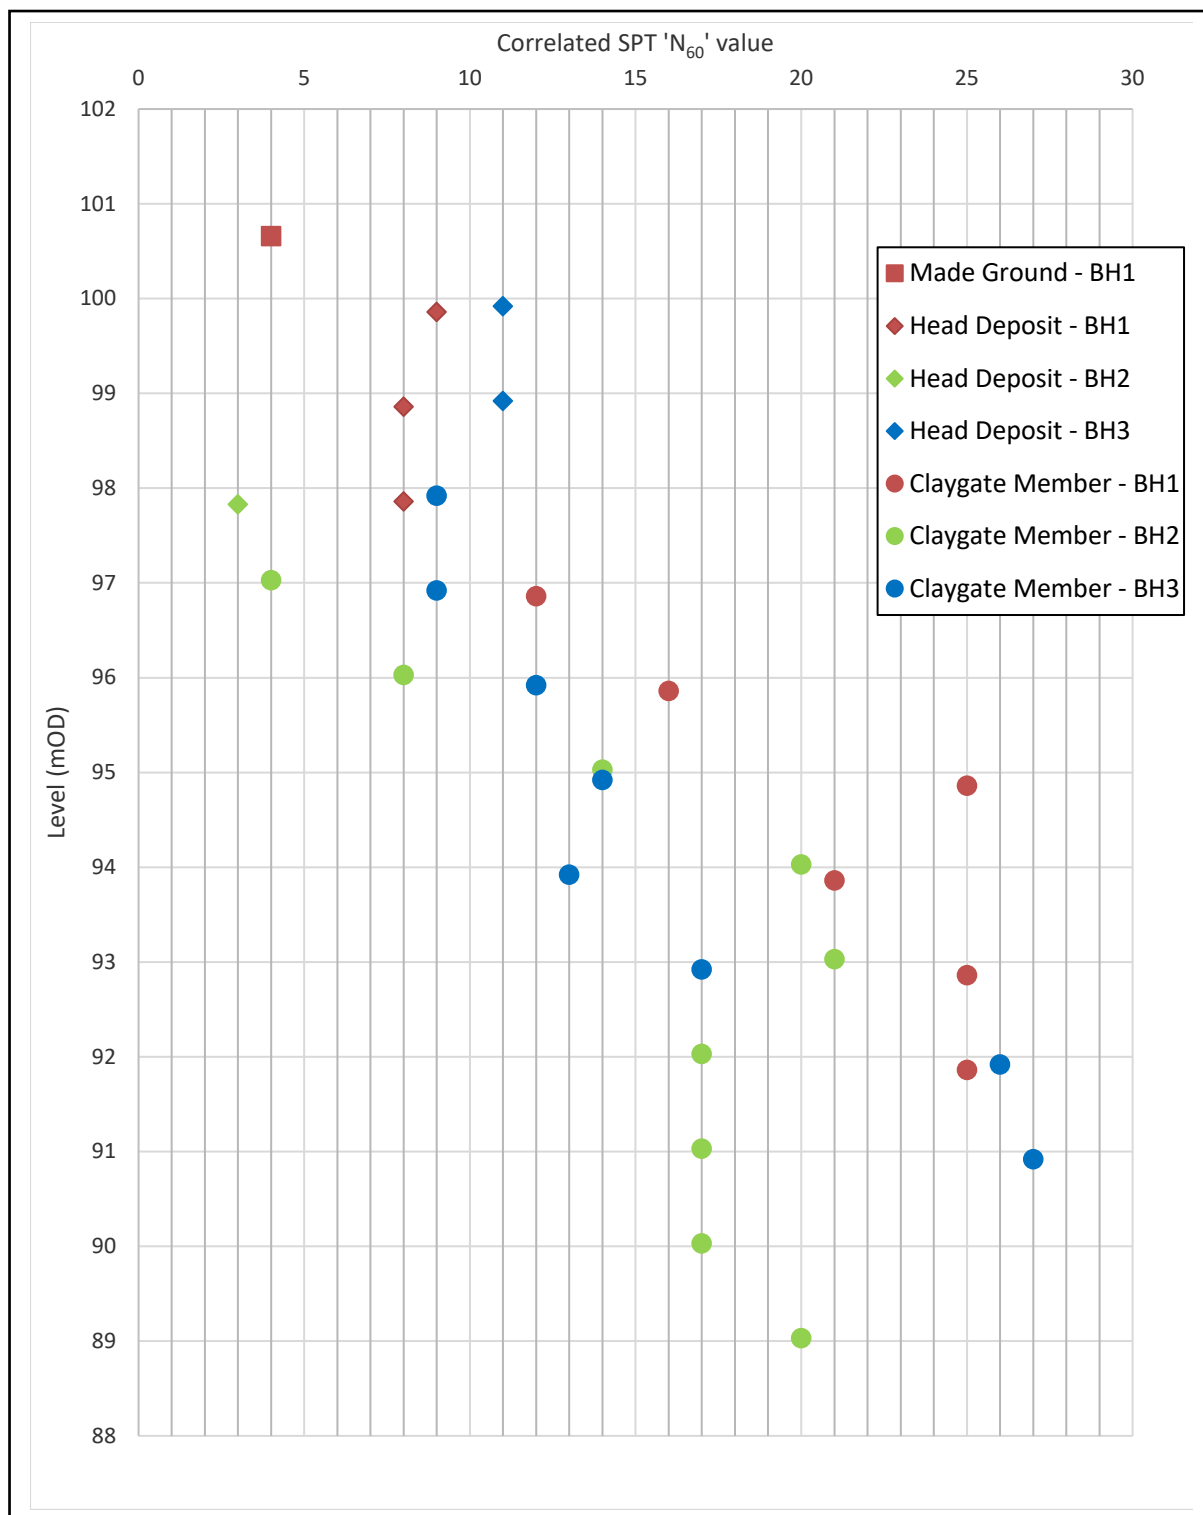
| | Title<br><b>Standard Penetration Test (SPT)<br/>'N<sub>60</sub>' values vs Level</b> | <b>Figure 4</b> |

The observed strata are discussed separately in the following sections together with the results of the geotechnical testing. A plot of the SPT 'N' versus depth (mbgl) is presented in Figure 4. The recorded SPT 'N' values have been normalised to take into account the high energy efficiency of the drilling equipment used during the site investigation.

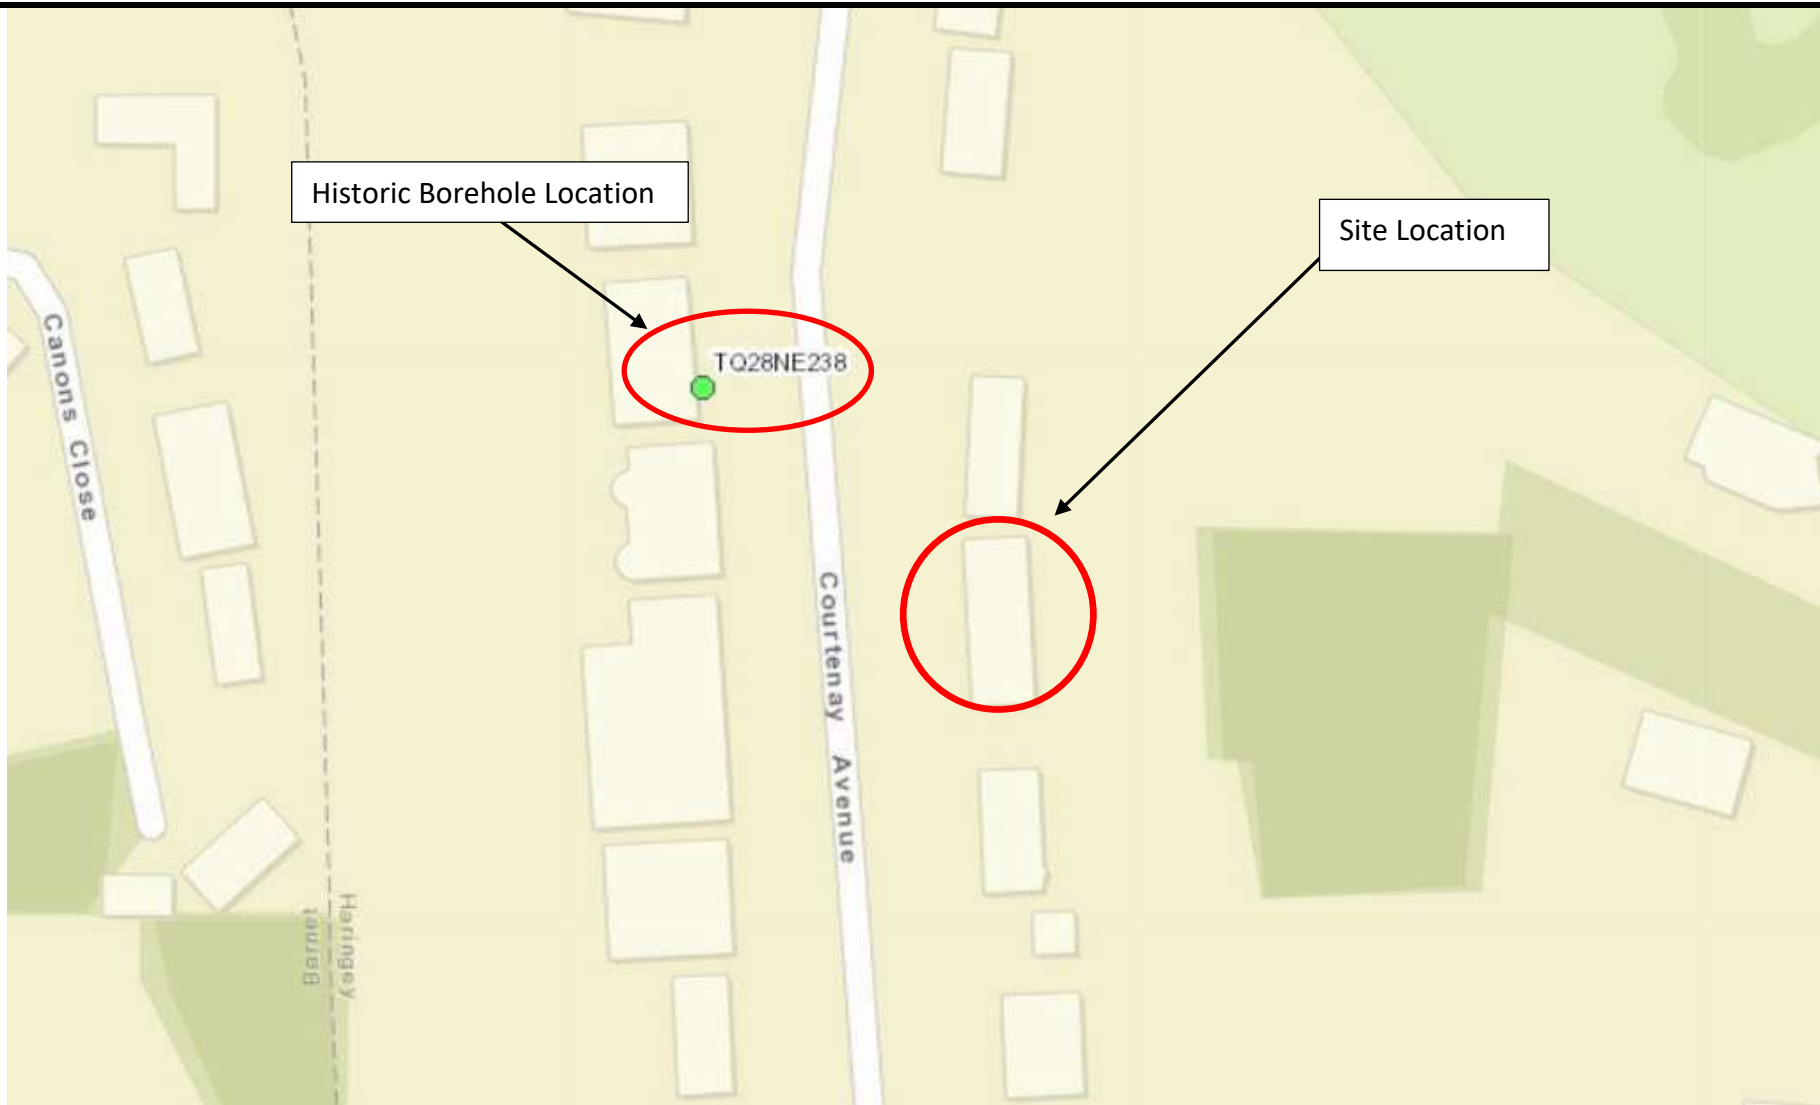
| | Title<br><b>Historic Borehole Location</b> | <b>Appendix C</b> |

The historical borehole record in Appendix C shows that groundwater was struck during drilling at 3.95mbgl. Given the close proximity and the likelihood of similar ground conditions, it is possible that groundwater will be encountered on site at ‘Guildens’ house.
