**CRANWOOD HOUSE, 100 WOODSIDE AVENUE, MUSWELL HILL. N10 3JA**  
**SUPPLEMENTARY CONTAMINATION INVESTIGATION AND REMEDIATION METHIOD STATEMENT.**  
Planning Application Reference No. HGY/2021/2727

The Brownfield Consultancy was instructed by Formation Design and Build Ltd (the client) to undertake a Phase 2 supplementary soil contamination investigation at the above site.

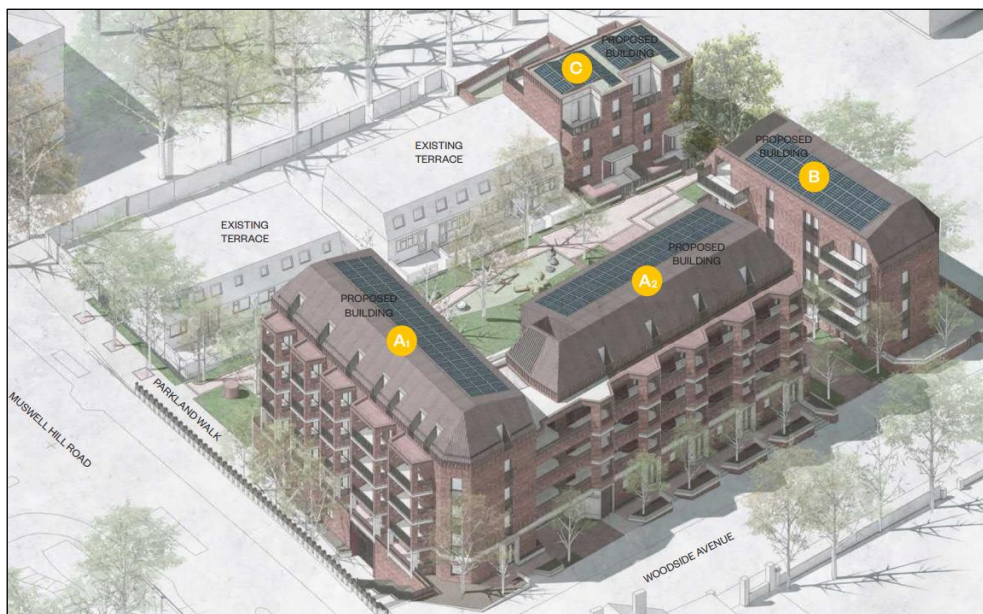
Planning permission has been granted to replace the existing care home with 41 new homes for council rent and market sale in a mixture of apartments, maisonettes and houses in three buildings of three, four and six storeys. Building A will comprise a basement level and five stories. Building B comprises four stories and Building C comprises a pair of conventional semidetached two storey residential houses. In a similar configuration to the previous structure, there will be a lower (basement) area of landscaping within the central area and an area of landscaping at a similar level to Woodside Road. The difference in level will be approximately 1.00-1.50m. Landscaping proposals are included in Appendix A.

The layout is presented below:-

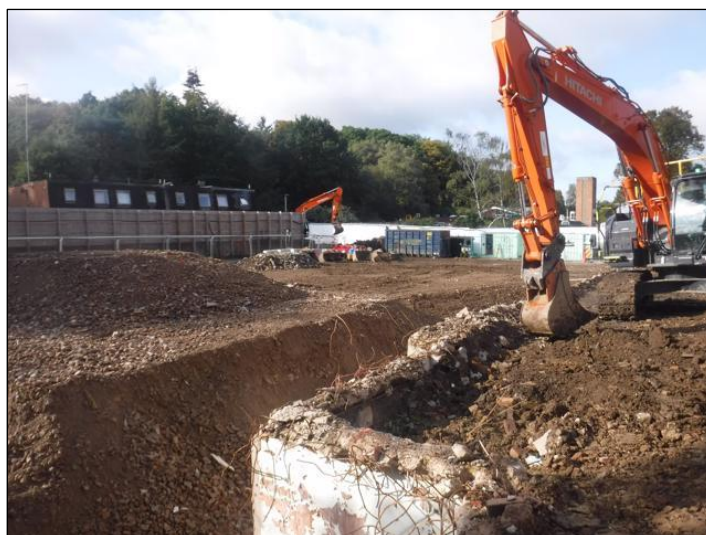
Looking southerly from the northeast corner.

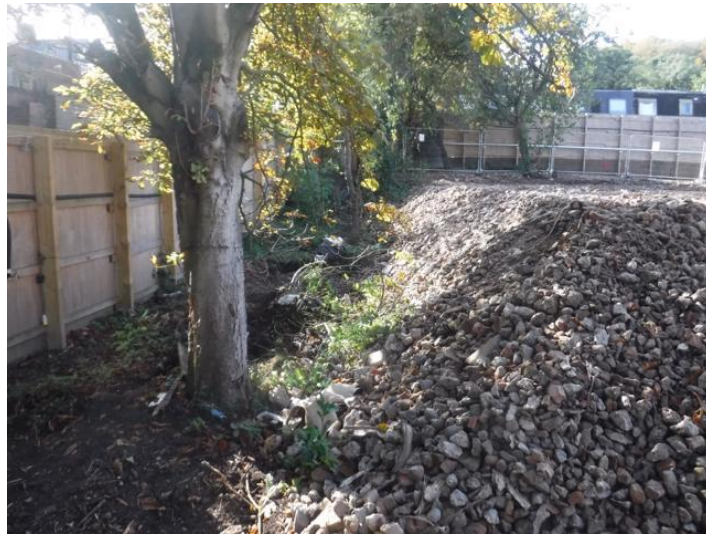
Eastern boundary.

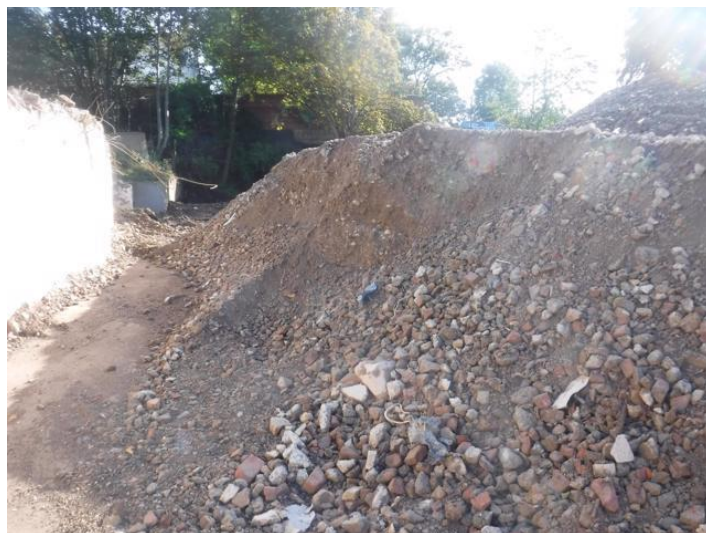
Northern boundary. Retaining wall on left.

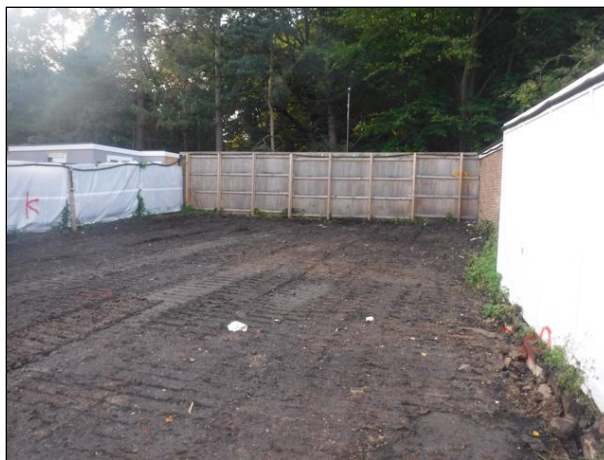
In the southwest projection, formerly a Car Park, four trial pits (TP101-TP104) were driven and Made Ground was encountered to depths of 0.40-0.70m. A photograph of the area is presented below:-

Made Ground in TP101, TP102 and TP103 comprised humic gravelly SAND and sandy GRAVEL & COBBLE with variable quantities of clay. Gravel comprised flint, brick, concrete and, in TP102, clinker. Coarse gravel sized pockets of ash were recorded in TP103 and a larger pocket in TP101 (0.45-0.60m) in the west of the pit. In TP104, Topsoil to 0.05m overlies orange brown SAND to 0.30m which in turn overlies flint GRAVEL to 0.40m.

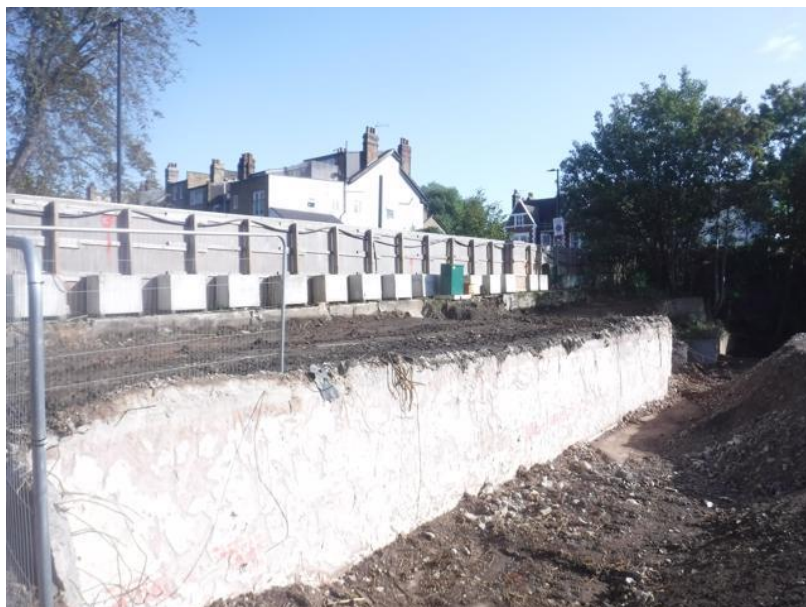
TP107 and TP110 were excavated immediately south of Woodside Road along a strip of ground that was being retained. A photograph is presented below:-

Made Ground in TP107 was encountered to 0.80m and comprised brown and grey SAND with gravel and cobble of brick, concrete and flint. Fragments of hard plastic and pockets of topsoil and grass were also recorded. In TP110, brown and grey sandy GRAVEL and COBBLE of brick, concrete and flint was encountered to 0.65m which in turn was underlain by reworked London Clay to 0.80m.

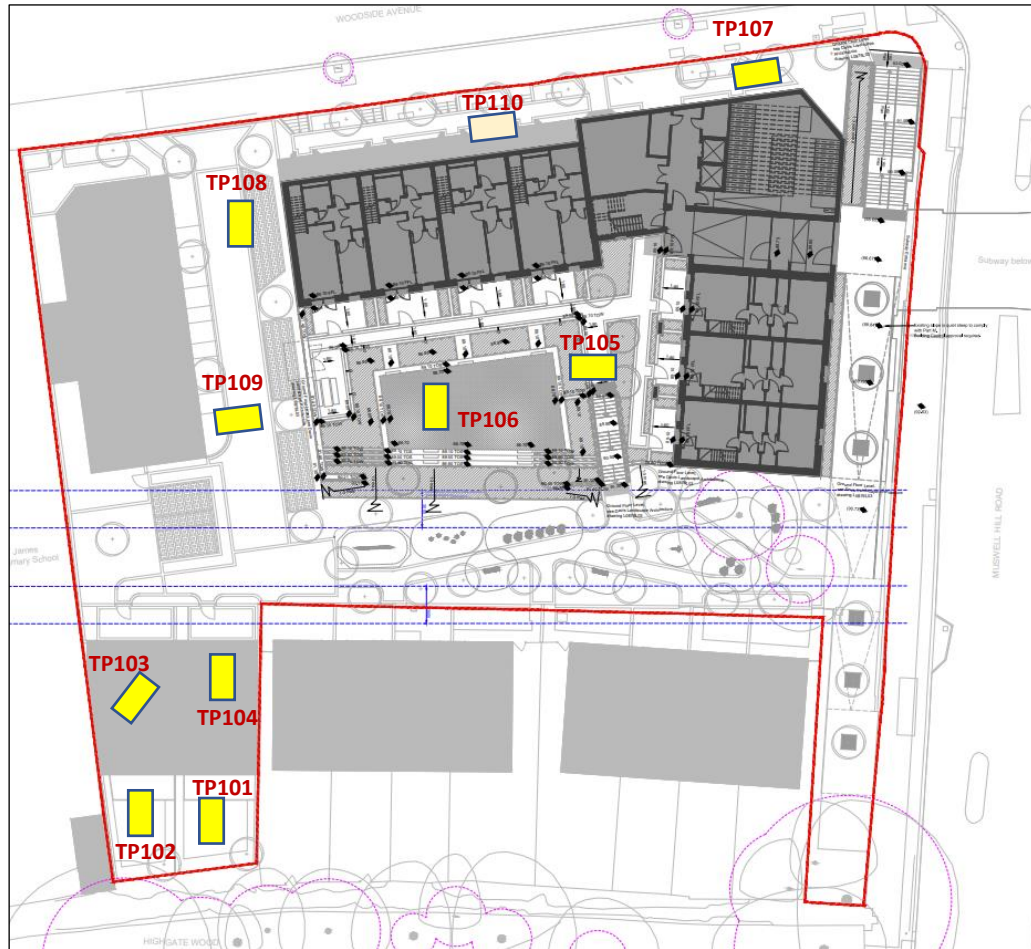
## EXPLORATORY HOLE LOCATION PLAN

With the exception of the southwest projection, soil investigation was not possible along the southern boundary of the site due to a buried culvert. This feature, together with the locations of the trial pits, are denoted on the Exploratory Hole Location Plan in Appendix A.
