Proposed bathroom

**CONSTANTINE ARCHITECTS**

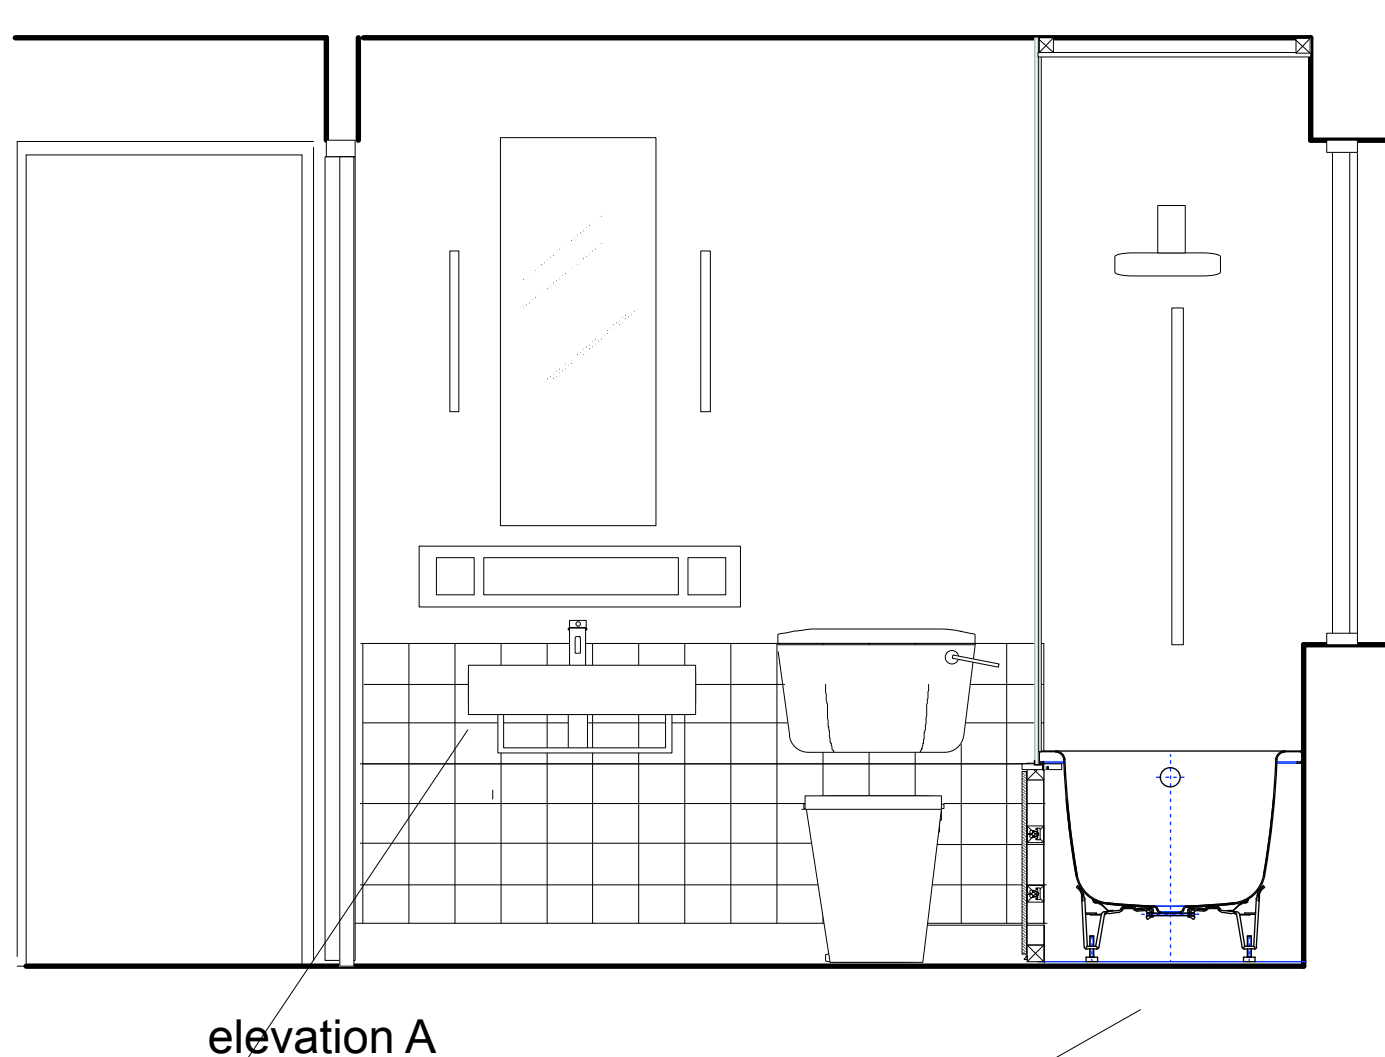
enamel bath placed back in the original position  
 where the shower is currently  
 -All breaches in the riser to be made good with blocks to  
 60 minutes fire integrity with a new isolation valve under  
 the bath

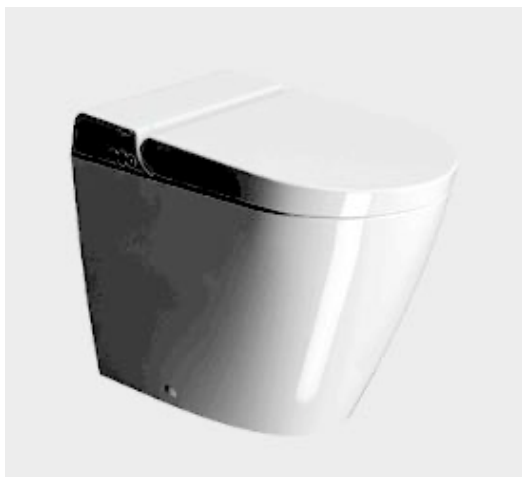
replacement WC ( existing is 1 year old)

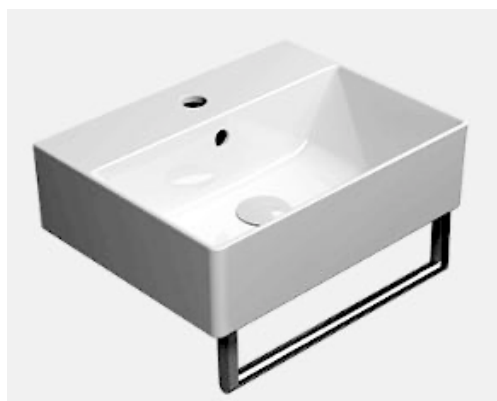
replacement wallhung basin

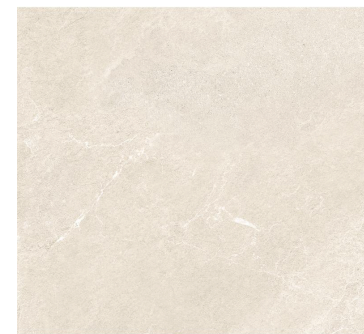
Terratinta porcelain stoneware series LESS

To replace damaged  
 and chipped existing  
 tiles

100x100mm
