# Preliminary Ecological Appraisal and Roost Assessment

105 Raleigh Road, London, N8 0JD

The demolition of the existing two buildings, and the erection of a new, four storey, residential building

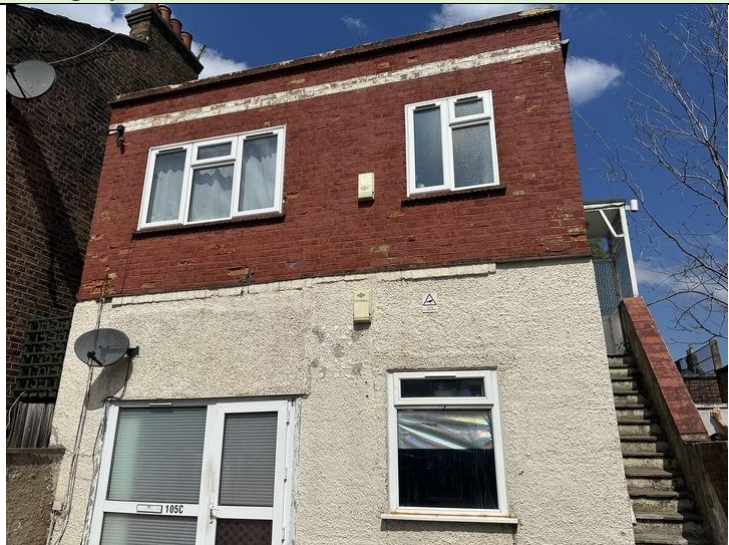
| | EPSL reference | Bat species affected | Distance from site | Impacts allowed by licence |
|---|---|---|---|---|
| <p><i>Summary</i><br/>B1 is a two-storey detached residential building. B1 has a flat-roof that appears to be clad in bitumen felt from both aerial imagery, and small sections that could be seen on site. B1 also has a single storey flat roof extension on the northern aspect of the building, also clad in bitumen felt. There is a small gap underneath the bargeboard on the eastern elevation of B1, and there is also no internal loft void present in B1. B1 is due to be demolished according to the proposed plans.<br/>B1 was assessed to have <b>negligible habitat value</b>.</p> | | | | |

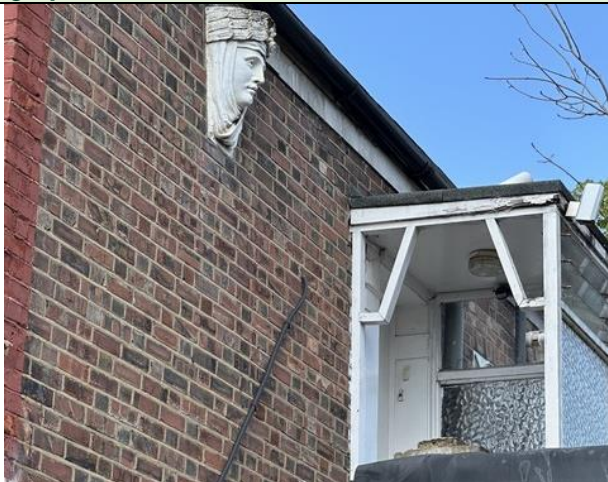
| Feature | Materials | Condition/description/suitability | Photograph(s) |
|---|---|---|---|
| Walls | Brick and render | <b>Condition/description</b><br>Good condition with no visible gaps or cracks.<br><b>Suitability/access/evidence of bats</b><br>N/A | |

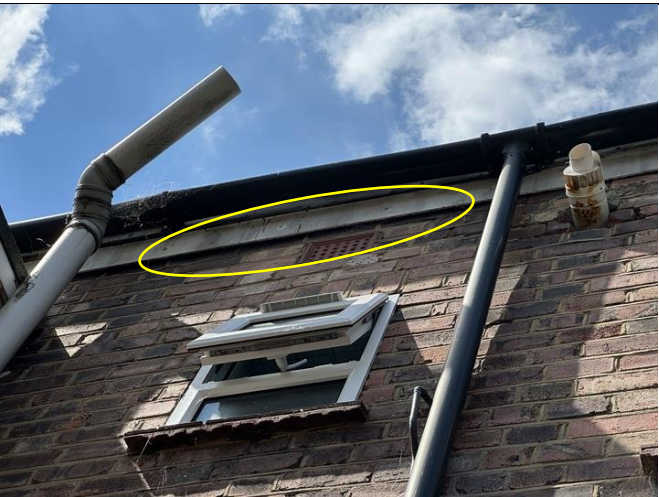
| Feature | Materials | Condition/description/suitability | Photograph(s) |
|---|---|---|---|
| Barge boards/fascia boards | Wood and PVC | <b>Condition/description</b><br>Mostly good condition, small gap underneath the bargeboard on the eastern elevation.<br><b>Suitability/access/evidence of bats</b><br>A gap underneath the bargeboard could provide potential roosting habitat for crevice dwelling species such as pipistrelles, with the size of the feature, The approximate length of the gap was 3m with the approximate depth being 20cm, this is likely to be able to fit low to medium numbers of crevice dwelling bats. | |

| <p><i>Recommendations</i></p> | <p><b>Roosting habitat [Buildings/trees]</b><br/> Owing to the nature of the proposed development and the very low potential for impacts to bat roosts, further bat surveys are considered to be disproportionate. It is anticipated that any risk to bats can be reduced to an acceptably low level through the implementation of a non-licenced mitigation plan and precautionary working method during pre- and post-development. This will include the following measures:</p> <ul style="list-style-type: none"> <li>• A non-licenced mitigation plan for the proposed works will be required, with an inspection of roosting features such as the gap in the bargeboard on the eastern elevation of B1, and any parts of the buildings that were obscured at the time of survey (timber cladding on B2) before works can commence. An appropriately licensed ecologist with an endoscope should adequately assess these features, using a ladder if necessary.</li> <li>• A toolbox talk will be undertaken with all contractors on site, about the importance of carefully removing tiles and wooden cladding and what to do in the case of a bat being found. In the unlikely event that bats are unexpectedly found during any stage of the development, work should stop immediately, and a suitably qualified ecologist should be contacted to seek further advice.</li> <li>• The use of night-time lighting will be avoided, or sensitive lighting design will be implemented to avoid light spill on to the retained trees.</li> <li>• Works will be scheduled during the winter months (November to March) when bats are least likely to be present, insofar as is possible.</li> </ul> <p><b>Foraging and commuting habitat</b><br/> No further surveys are required</p> <p><b>Artificial lighting</b><br/> A low impact lighting strategy will be adopted for the site during post-development which outlines the areas of the site that will be retained as dark corridors. Parameters can be found on the Bat Conservation Trust website:<br/> <a href="https://www.bats.org.uk/our-work/buildings-planning-and-development/lighting-2">https://www.bats.org.uk/our-work/buildings-planning-and-development/lighting-2</a></p> <p><b>Suggested biodiversity enhancements</b><br/> The installation of two bat boxes at the site will provide additional roosting habitat for bats.<br/> The bat boxes will be incorporated into the fabric of the new dwelling. They will be suitable for pipistrelles (which have been identified locally through EPSL data). Suitable bat boxes include Habibat Bat Box, Ibstock Enclosed Bat Box or similar alternative brand.<br/> Bat boxes should be positioned 3-5m above ground level facing in a south or south-westerly direction with a clear flight path to and from the entrance, away from artificial light.</p> |

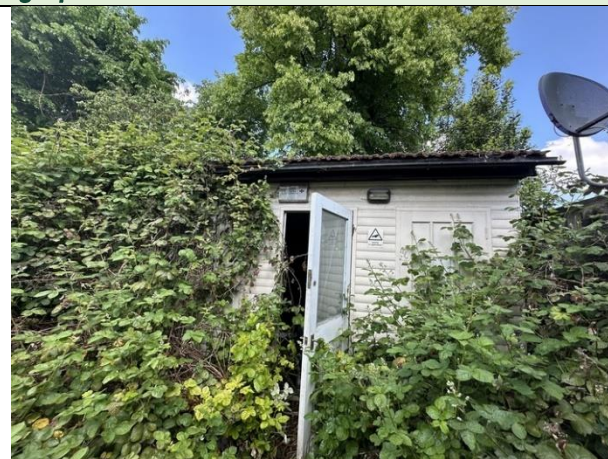
| <b>B2 Building description</b> | | | <b>Photographs</b> |
|---|---|---|---|
| <p><b>Summary</b><br/> B2 is a single-storey detached, disused, residential building. B2 has a pitched and gabled roof clad in concrete tiles, with no visible slipped or broken tiles. B2 has wooden clad walls which are tight and do not appear to have any gaps underneath the boards, the eaves on B2 are also well sealed with no visible gaps. There is a loft void present in B2, due to the ceiling being rotten and fallen away, this is open to the rest of the building, there is no ridge beam present and there are thick floor-to-ceiling cobwebs throughout. B2 is due to be demolished according to the proposed plans. B2 was assessed to have <b>negligible habitat value</b>.</p> | | | |

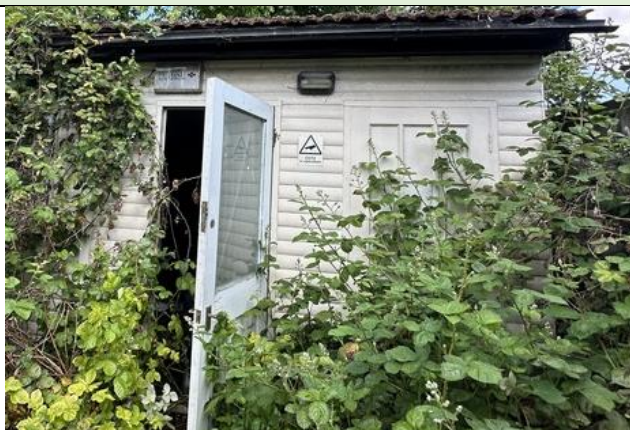
| <b>B2 Building description</b> | | | <b>Photographs</b> |
|---|---|---|---|
| Walls | Timber cladding on brick walls | <p><b>Condition/description</b><br/> Good condition with no visible gaps, bramble scrub obscured the view of a lot of the walls, and only the front wall could be seen as the others couldn't be reached.</p> <p><b>Suitability/access/evidence of bats</b><br/> From the area of wall that was able to be seen, the wooden cladding was sitting flush to the side of the wall and has been painted over, sealing any gaps that may or may not be present between the wooden boards.</p> | |

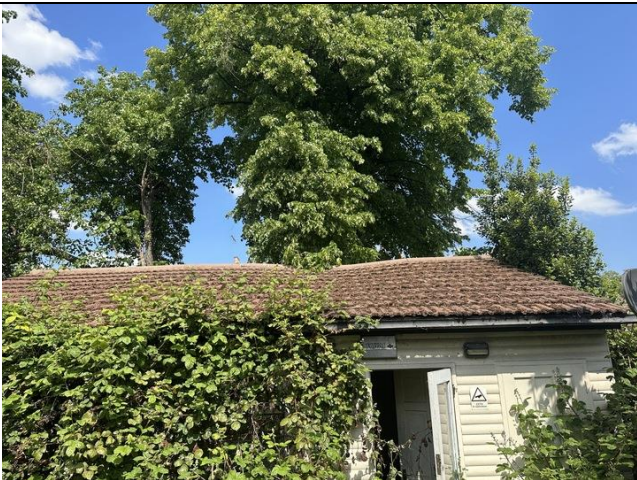
| Roof | Concrete tiles | <b>Condition/description</b><br>The roof was slightly sunk in the middle, however, the tiles were tightly interlocked, and no visible gaps could be seen.<br><b>Suitability/access/evidence of bats</b><br>N/A | |

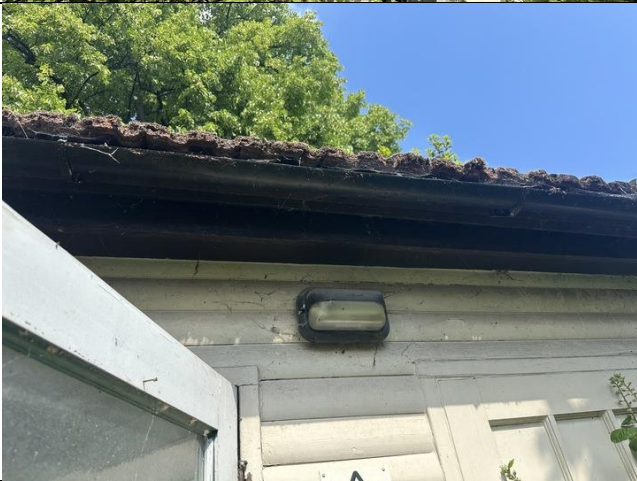
| Eaves | Wood | <b>Condition/description</b><br>Good condition, tightly sealed.<br><b>Suitability/access/evidence of bats</b><br>N/A | |

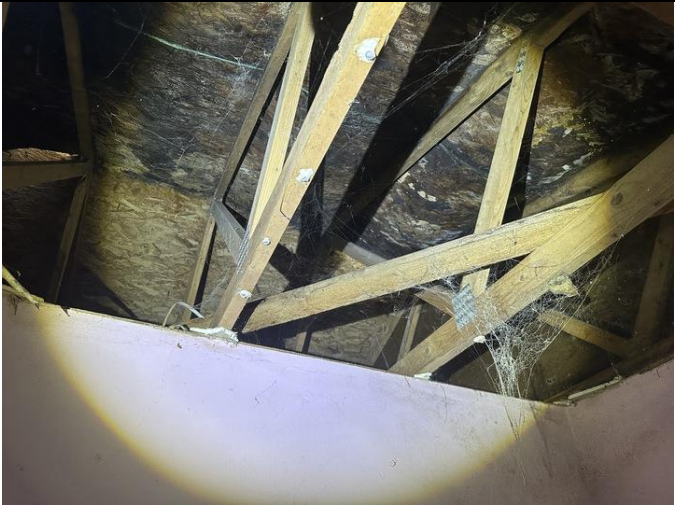
| Internal voids | Timber rafters and ridge beam.<br>No roof lining. | <p><b>Condition/description</b><br/>Internal space measures approx. 7.5m long, 6m wide, floor to ridge height approx. 0.5m. Bitumen felt lining present, however, this was only present on small amounts of the roof, all other areas were lined with chipboard. Timber rafters present with thick floor to ceiling cobwebs attached and extending down to the floor below, small cracks in the ridge of the roof let daylight in, however, not large enough for bats to access. Internal temperature was 26°C, and relative humidity was 44%.</p> <p><b>Suitability/access/evidence of bats</b><br/>No bat droppings present, no other evidence of bats present either.</p> | |

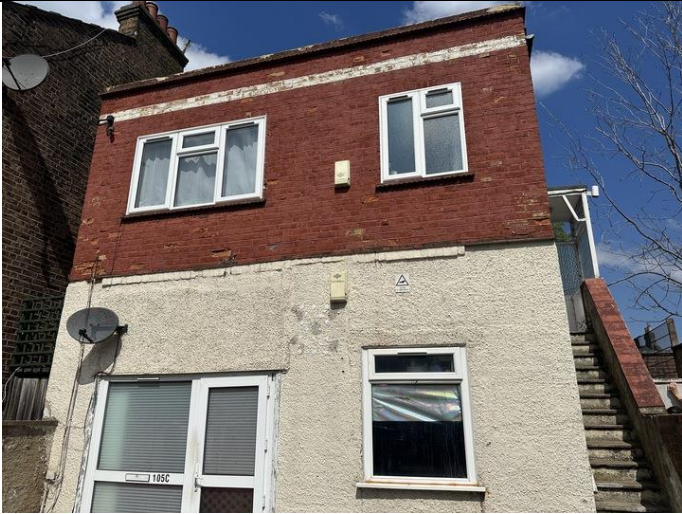
| Buildings | |
|---|---|
| | Figure 1: Main dwelling (B1) on site. |

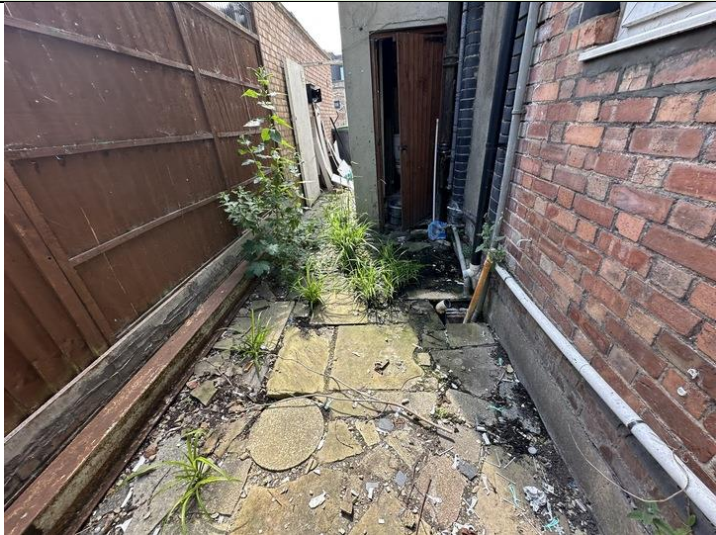
| Developed land; sealed surface | |
|---|---|
| | Figure 3: hard standing walkway present on site (to the east of B1). |

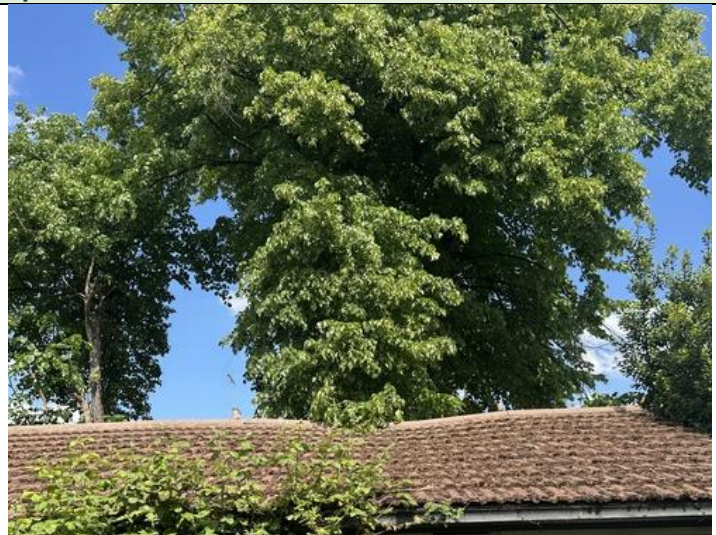
| Developed land; sealed surface | |
|---|---|
| | Figure 4: Scattered trees present on site (to the rear of B2). |
