## Appendix A – Photo Schedule

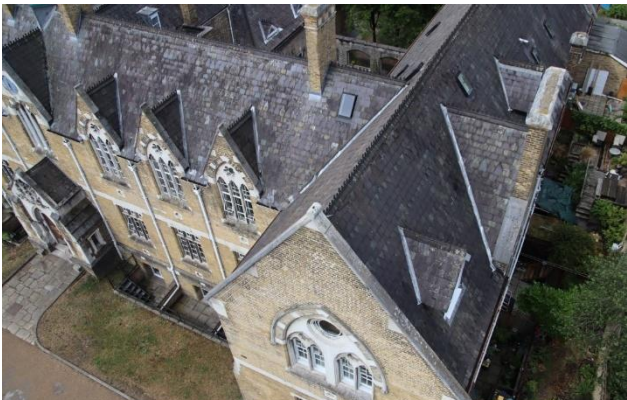
| Number | Description | Photograph |
|---|---|---|
| 1. | <b>Old School Court</b><br><br>Aerial view of front of property looking south-west, with left-hand transept in the foreground. | |

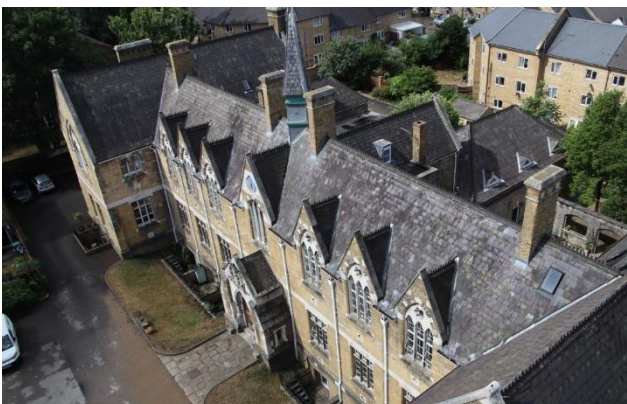
| Number | Description | Photograph |
|---|---|---|
| 2. | <b>Old School Court</b><br><br>Aerial view of front of property looking south-west. | |

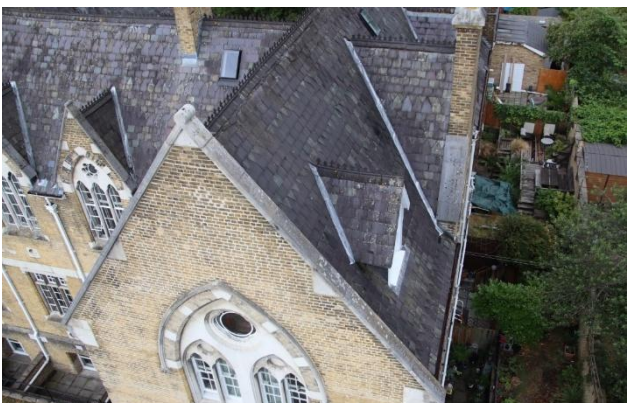
| Number | Description | Photograph |
|---|---|---|
| 3. | <b>Old School Court</b><br><br>Aerial view of front of property looking west across the right-hand transept. | |

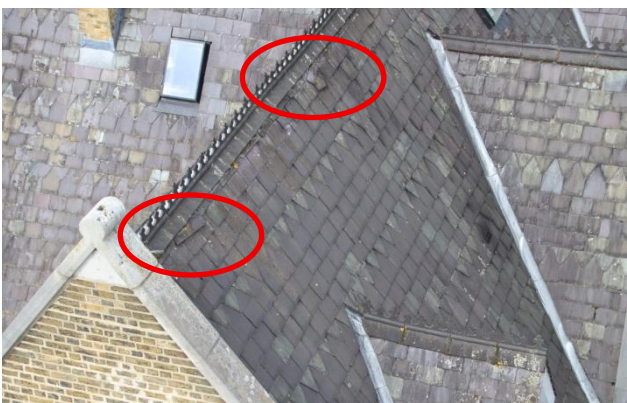
| Number | Description | Photograph |
|---|---|---|
| 4. | <b>Old School Court</b><br><br>Aerial view of front of property looking west.<br><br>Note slipped slates, as indicated. | |

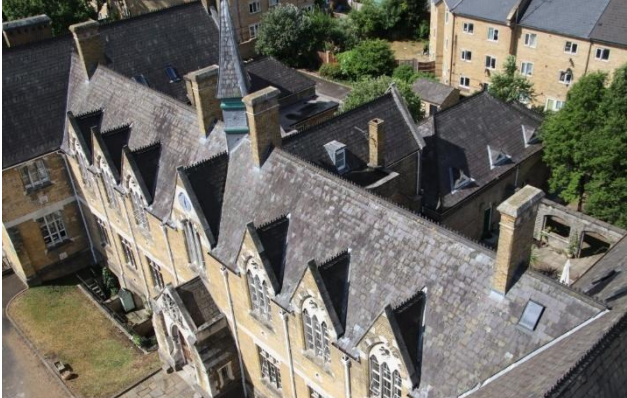
| Number | Description | Photograph |
|---|---|---|
| 5. | <p><b>Old School Court</b></p> <p>Aerial view of front of property looking south-west.</p> | |

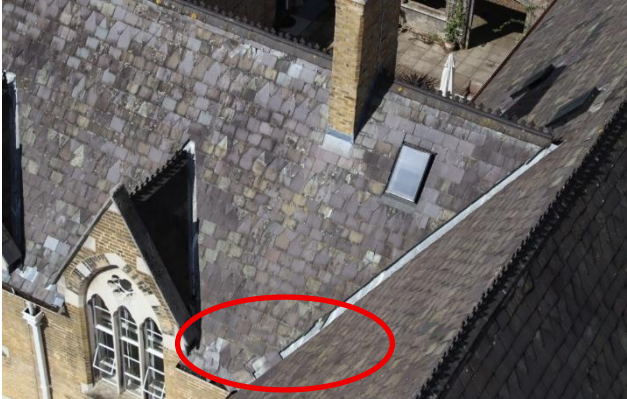
| Number | Description | Photograph |
|---|---|---|
| 6. | <p><b>Old School Court</b></p> <p>Aerial view of front of property looking west.</p> <p>Note slipped slates obstructing the valley gutter.</p> | |

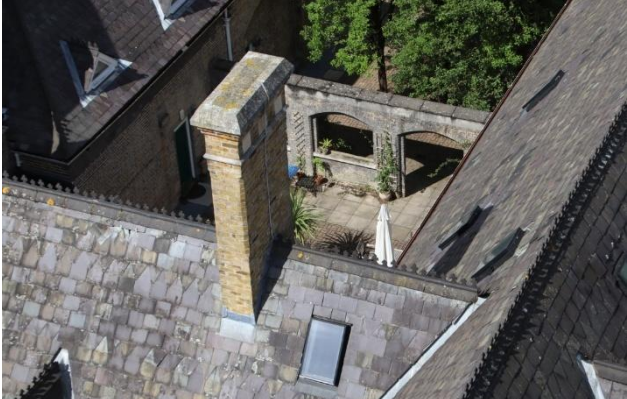
| Number | Description | Photograph |
|---|---|---|
| 7. | <p><b>Old School Court</b></p> <p>Aerial view of chimney to front of property.</p> | |

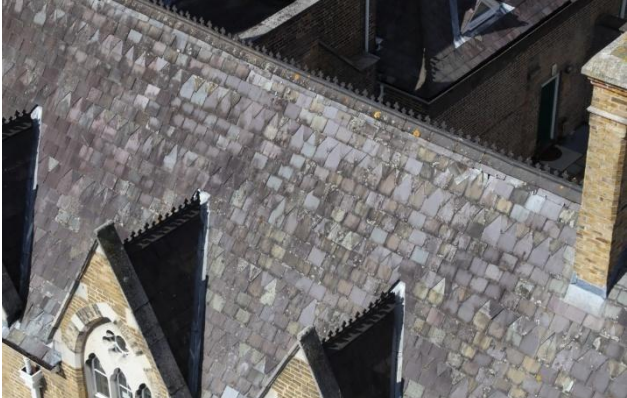
| Number | Description | Photograph |
|---|---|---|
| 8. | <p><b>Old School Court</b></p> <p>Aerial view of front of property looking west across front roof slope.</p> | |

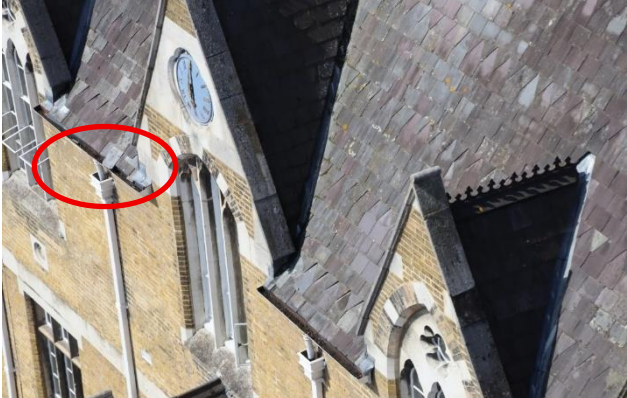
| Number | Description | Photograph |
|---|---|---|
| 9. | <p><b>Old School Court</b></p> <p>Aerial view of front roof slope and associated rainwater goods.</p> <p>Note slipped slate obstructing gutter.</p> | |

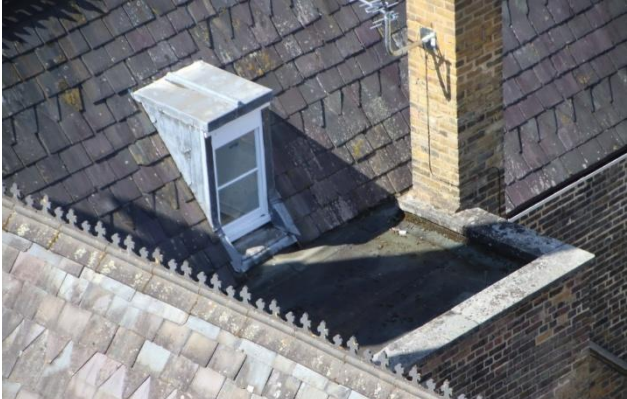
| Number | Description | Photograph |
|---|---|---|
| 10. | <p><b>Old School Court</b></p> <p>Aerial view of flat roof and adjacent dormer to central rear section of main structure.</p> | |

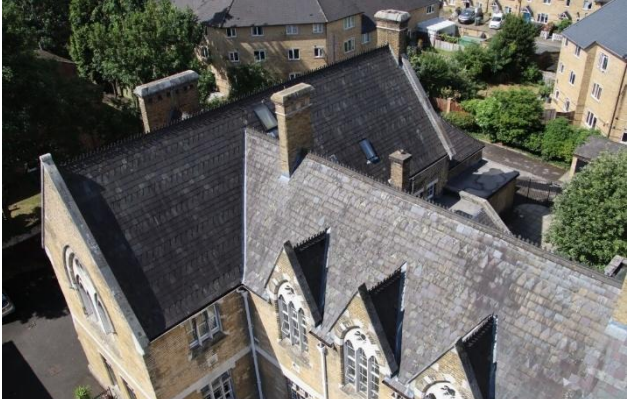
| Number | Description | Photograph |
|---|---|---|
| 11. | <p><b>Old School Court</b></p> <p>Aerial view of front of property looking south-west across front elevation to the left-hand transept.</p> | |

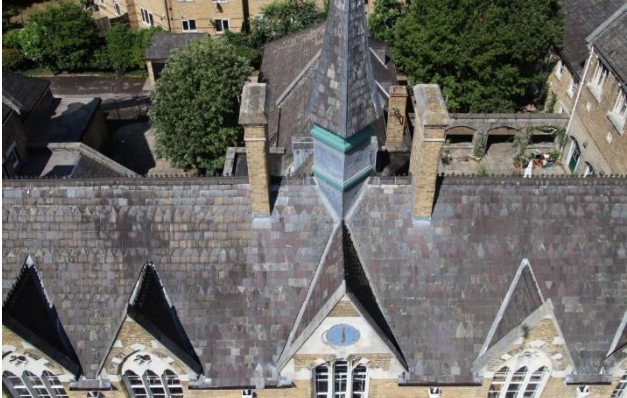
| Number | Description | Photograph |
|---|---|---|
| 12. | <p><b>Old School Court</b></p> <p>Aerial view of front of property and spire looking west across front elevation</p> | |

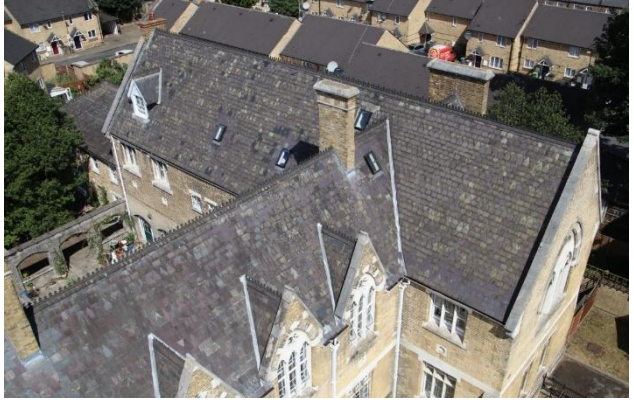
| Number | Description | Photograph |
|---|---|---|
| 13. | <p><b>Old School Court</b></p> <p>Aerial view of front of property looking north-west across front elevation towards the right-hand transept.</p> | |

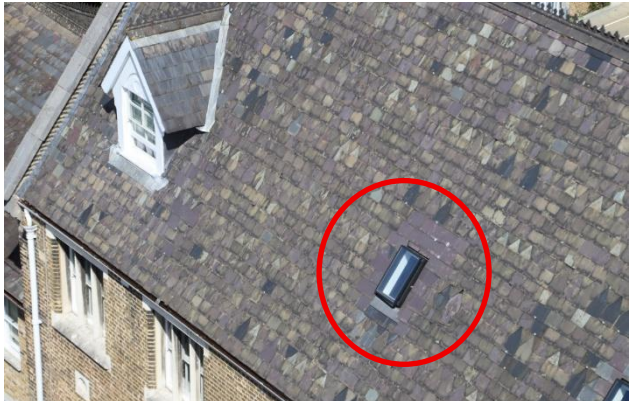
| Number | Description | Photograph |
|---|---|---|
| 14. | <p><b>Old School Court</b></p> <p>Aerial view from front of property looking north-west to south slope of right-hand transept.</p> <p>Note evidence of localised slate replacement surrounding existing rooflight.</p> | |

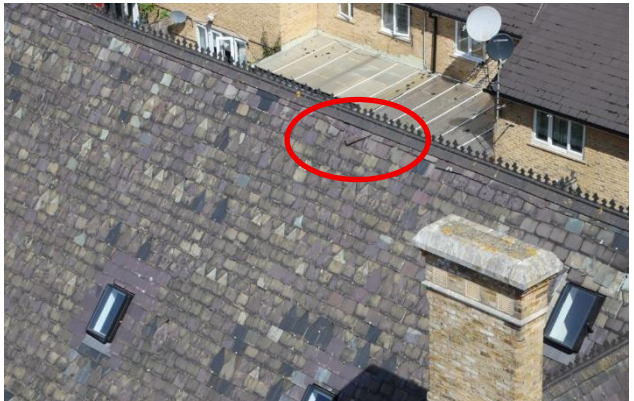
| Number | Description | Photograph |
|---|---|---|
| 15. | <p><b>Old School Court</b></p> <p>Aerial view from front of property looking north-west to south slope of right-hand transept.</p> <p>Note slipped slate at ridge line.</p> | |

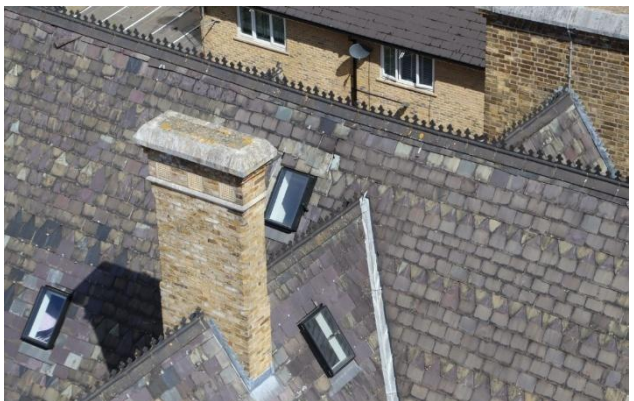
| Number | Description | Photograph |
|---|---|---|
| 16. | <p><b>Old School Court</b></p> <p>Aerial view from front of property looking north-west to south slope of right-hand transept.</p> | |

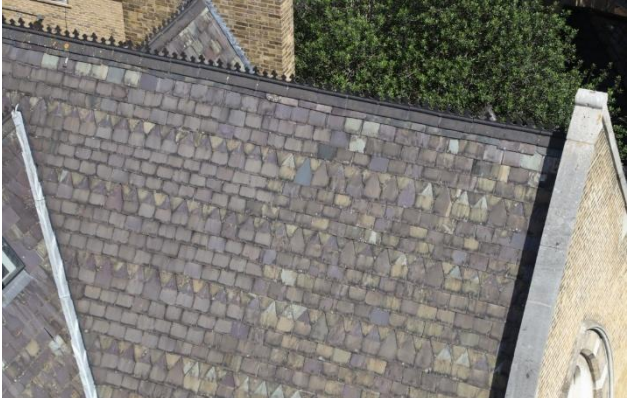
| Number | Description | Photograph |
|---|---|---|
| 17. | <p><b>Old School Court</b></p> <p>Aerial view from front of property looking north-west to south slope of right-hand transept.</p> <p>Note faded and discoloured roof covering.</p> | |

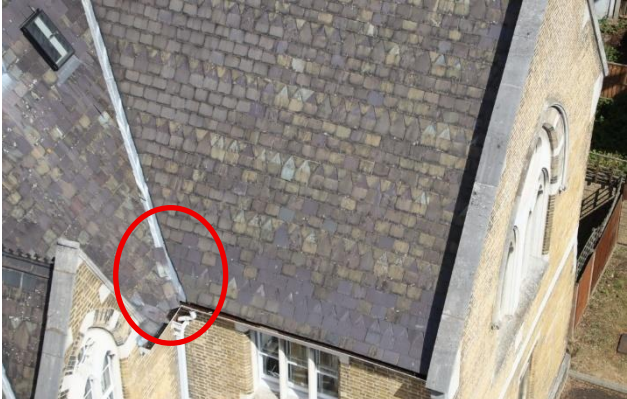
| Number | Description | Photograph |
|---|---|---|
| 18. | <p><b>Old School Court</b></p> <p>Aerial view from front of property looking north-west to south slope of right-hand transept.</p> <p>Note slipped slates obstructing valley gutter.</p> | |

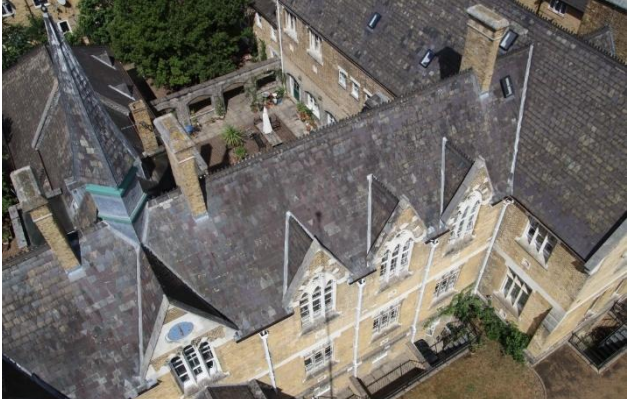
| Number | Description | Photograph |
|---|---|---|
| 19. | <p><b>Old School Court</b></p> <p>Aerial view of front of property looking north-west across front elevation towards the right-hand transept.</p> | |

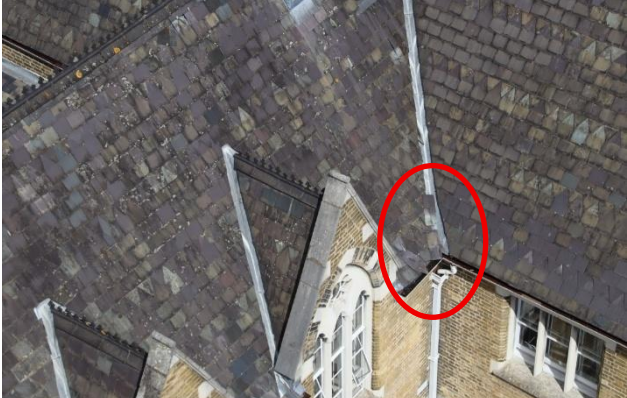
| Number | Description | Photograph |
|---|---|---|
| 20. | <p><b>Old School Court</b></p> <p>Aerial view from front of property showing valley at junction of right-hand transept with main structure.</p> | |

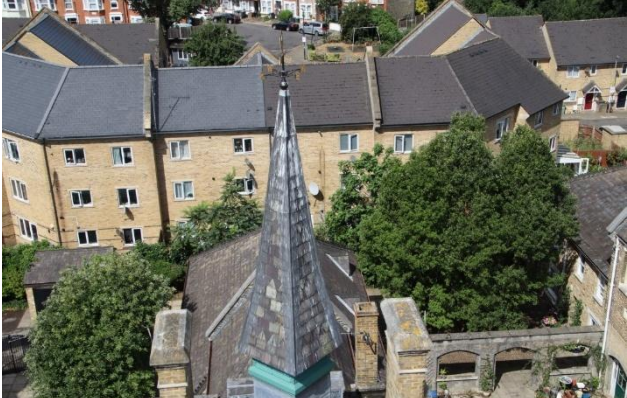
| Number | Description | Photograph |
|---|---|---|
| 21. | <p><b>Old School Court</b></p> <p>Aerial view of spire.</p> | |

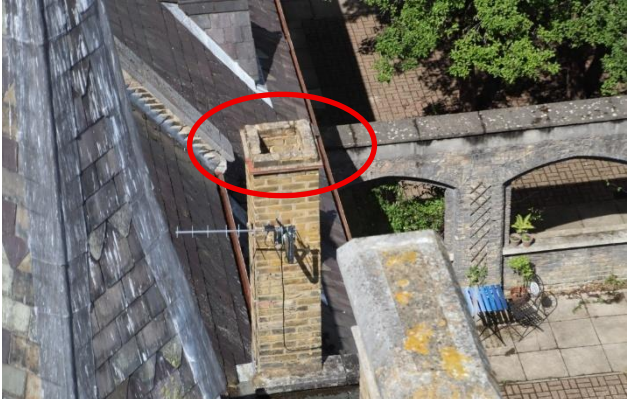
| Number | Description | Photograph |
|---|---|---|
| 22. | <p><b>Old School Court</b></p> <p>Aerial view of chimney associated with central transept.</p> <p>Note open flue.</p> | |

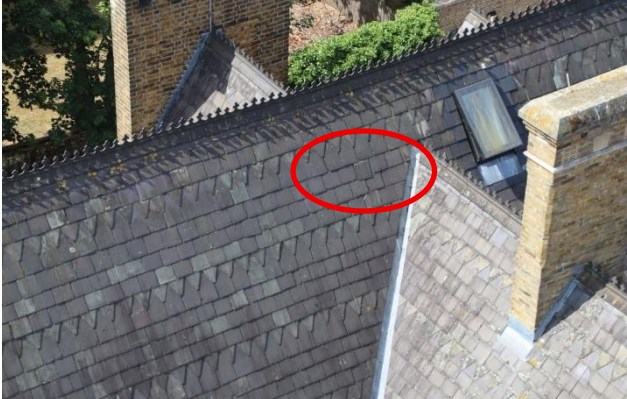
| Number | Description | Photograph |
|---|---|---|
| 23. | <p><b>Old School Court</b></p> <p>Aerial view from front of property showing valley at junction of left-hand transept with main structure.</p> <p>Note slipped slate.</p> | |

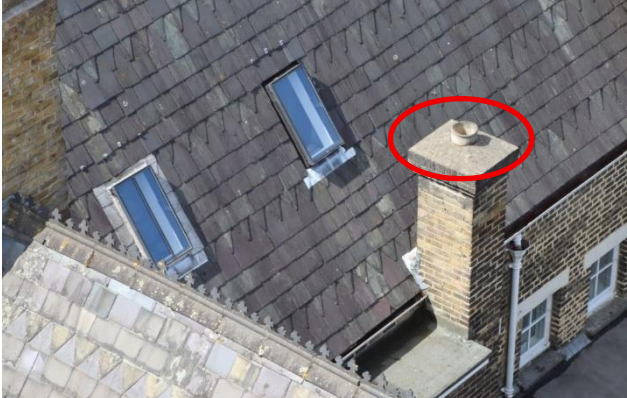
| Number | Description | Photograph |
|---|---|---|
| 24. | <p><b>Old School Court</b></p> <p>Aerial view from front of property showing north facing roof slope of left-hand transept.</p> <p>Note open flue.</p> | |

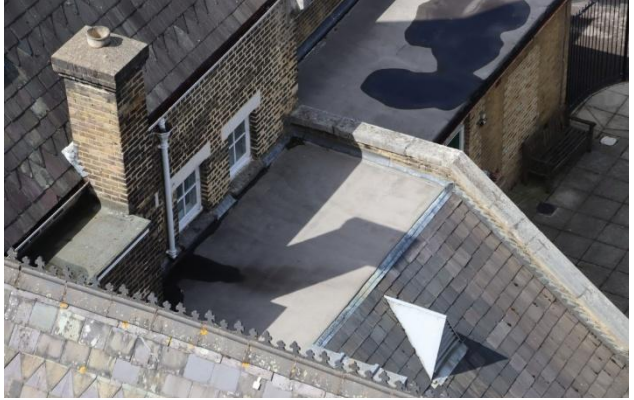
| Number | Description | Photograph |
|---|---|---|
| 25. | <p><b>Old School Court</b></p> <p>Aerial view from front of property showing north facing roof slope of left-hand transept and associated flat roofs.</p> | |

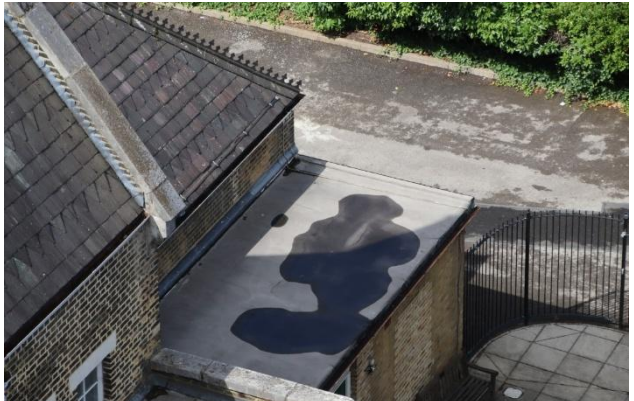
| Number | Description | Photograph |
|---|---|---|
| 26. | <p><b>Old School Court</b></p> <p>Close up view of flat roof to north elevation of left-hand transept.</p> <p>See also Photo 25.</p> | |

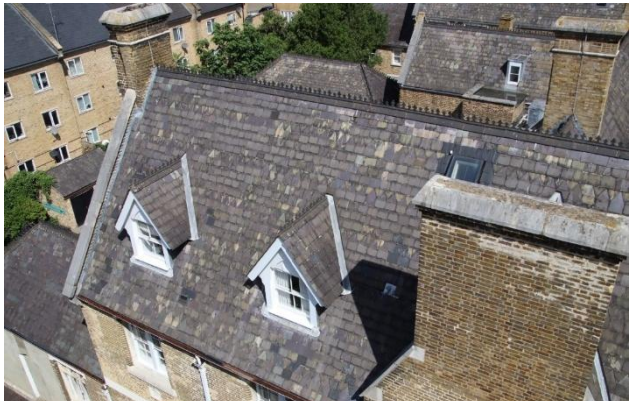
| Number | Description | Photograph |
|---|---|---|
| 27. | <p><b>Old School Court</b></p> <p>Aerial view from south elevation of left-hand transept.</p> | |

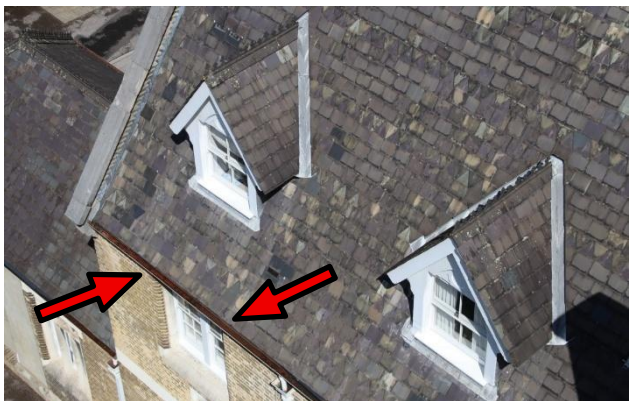
| Number | Description | Photograph |
|---|---|---|
| 28. | <p><b>Old School Court</b></p> <p>Close up view of Photo 27.</p> <p>Note that gutter appears to be holding water.</p> | |

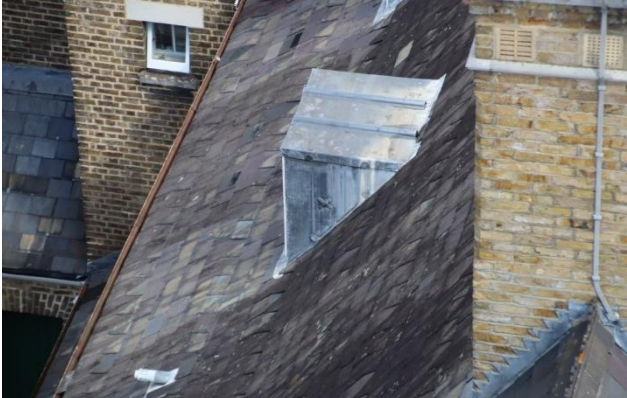
| Number | Description | Photograph |
|---|---|---|
| 29. | <p><b>Old School Court</b></p> <p>Aerial view from south flank elevation to rear (west facing) roof slope of main structure.</p> | |

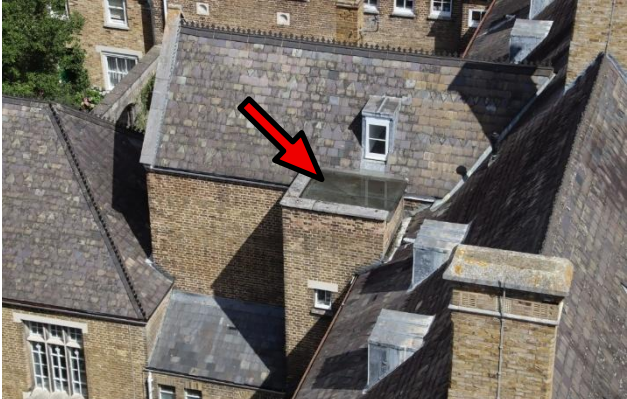
| Number | Description | Photograph |
|---|---|---|
| 30. | <p><b>Old School Court</b></p> <p>Distant view of Photo 29.</p> <p>Note ponding to flat roof.</p> | |

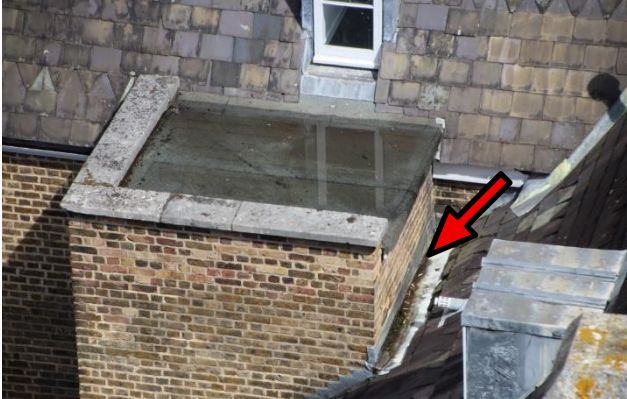
| Number | Description | Photograph |
|---|---|---|
| 31. | <p><b>Old School Court</b></p> <p>Close up view of flat roof referenced in Photo 30.</p> <p>Note sediment build up to back gutter in addition to flooded flat roof.</p> | |

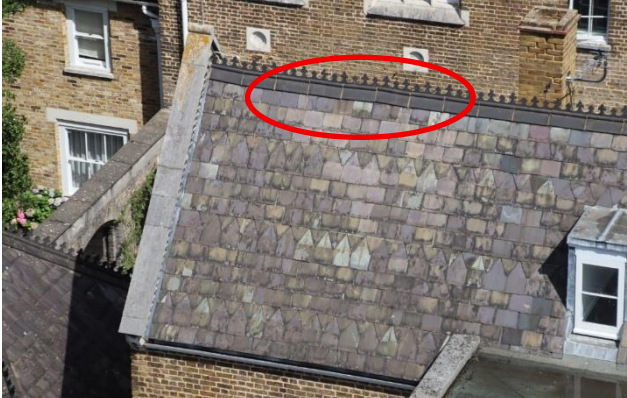
| Number | Description | Photograph |
|---|---|---|
| 32. | <p><b>Old School Court</b></p> <p>View of south roof slope to central transept.</p> <p>Note minor deflection to ridge line.</p> | |

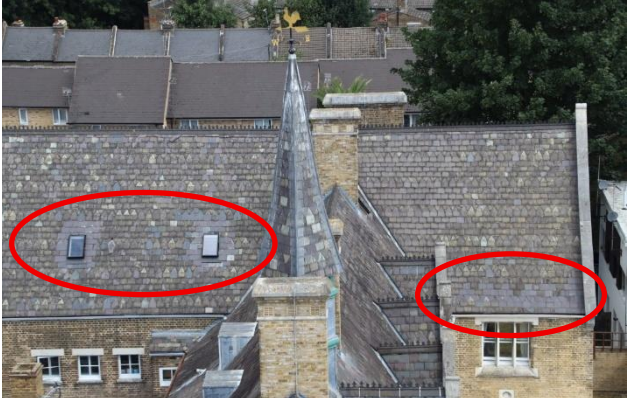
| Number | Description | Photograph |
|---|---|---|
| 33. | <p><b>Old School Court</b></p> <p>View of south face of spire, and south roof slope of right-hand transept.</p> <p>Note evidence of historic localised replacement.</p> | |

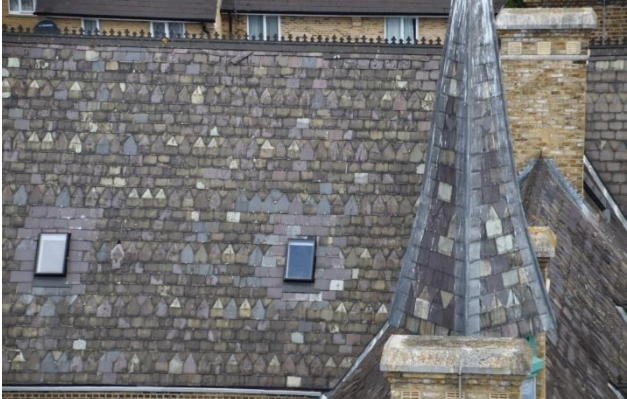
| Number | Description | Photograph |
|---|---|---|
| 34. | <p><b>Old School Court</b></p> <p>Close up view of Photo 33.</p> | |

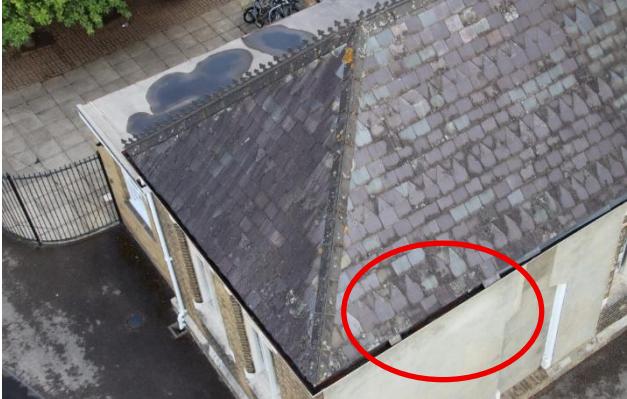
| Number | Description | Photograph |
|---|---|---|
| 35. | <p><b>Old School Court</b></p> <p>View of single storey rear addition to left-hand transept.</p> <p>Note slipped slates obstructing gutter.</p> | |

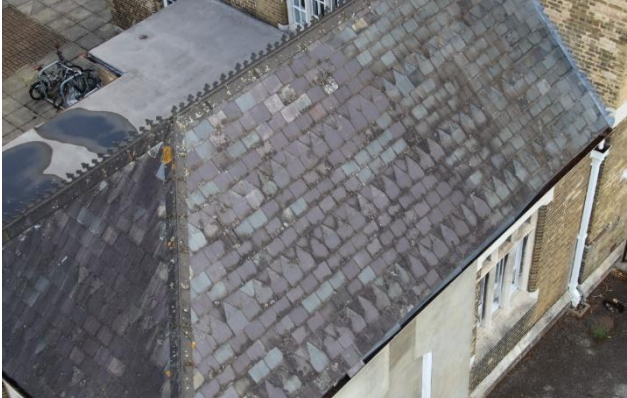
| Number | Description | Photograph |
|---|---|---|
| 36. | <p><b>Old School Court</b></p> <p>Alternate view of Photo 35.</p> | |

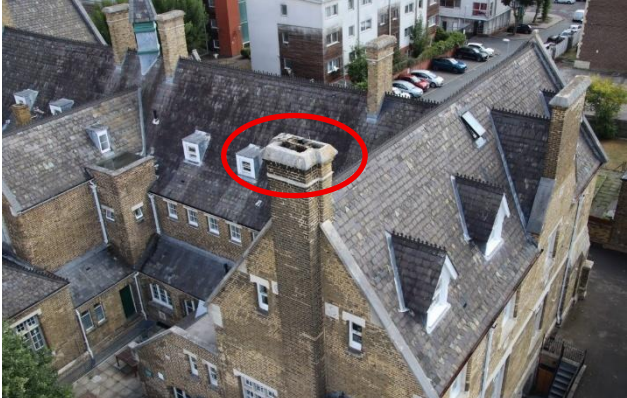
| Number | Description | Photograph |
|---|---|---|
| 37. | <p><b>Old School Court</b></p> <p>Aerial view from south-west corner of block to rear roof slope (west elevation) of main structure.</p> <p>Note open flue.</p> | |

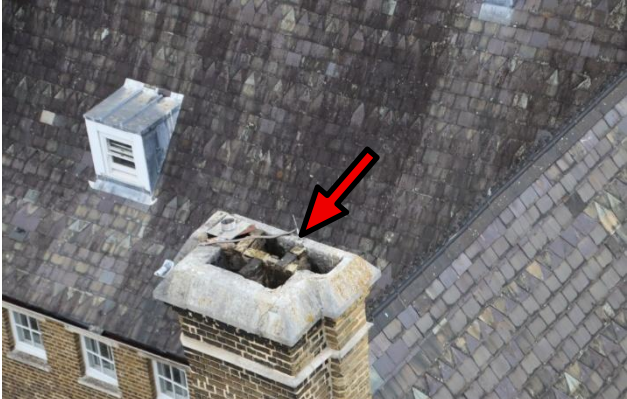
| Number | Description | Photograph |
|---|---|---|
| 38. | <p><b>Old School Court</b></p> <p>Alternate view of Photo 37.</p> <p>Note open chimney flue and obstructed gutter.</p> | |

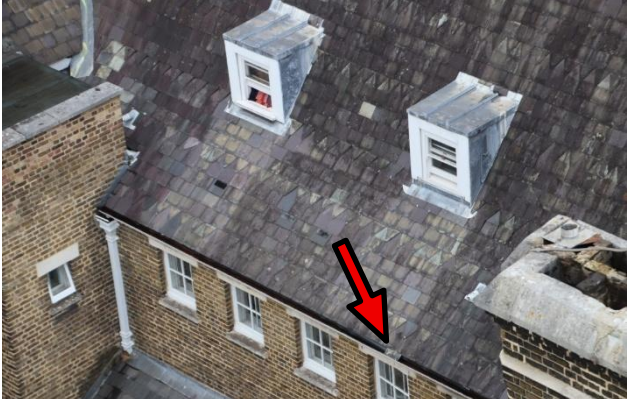
| Number | Description | Photograph |
|---|---|---|
| 39. | <p><b>Old School Court</b></p> <p>Close up view of Photo 37, showing rear roof slope and associated dormers to main structure.</p> <p>Note staining to roof covering and obstructed gutter.</p> | |

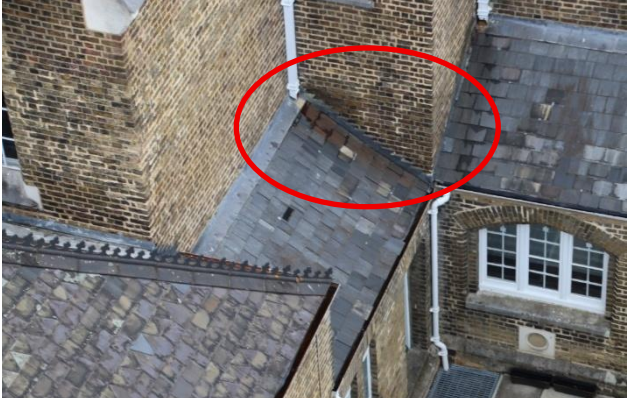
| Number | Description | Photograph |
|---|---|---|
| 40. | <p><b>Old School Court</b></p> <p>View of mono-pitched roof to rear of main structure.</p> <p>Note water staining to slates at base of downpipe and adjacent brickwork.</p> | |

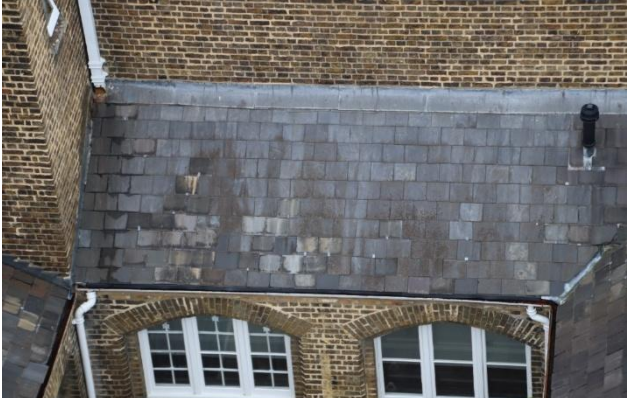
| Number | Description | Photograph |
|---|---|---|
| 41. | <p><b>Old School Court</b></p> <p>View of mono-pitched roof to rear of main structure, adjacent Photo 40.</p> <p>Note heavy staining and discolouration to slates.</p> | |

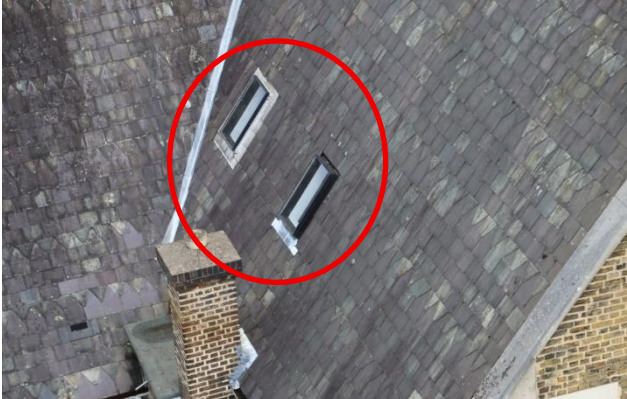
| Number | Description | Photograph |
|---|---|---|
| 42. | <p><b>Old School Court</b></p> <p>View of north roof slope to left-hand transept.</p> <p>Note evidence of historic repairs to existing rooflight surrounds.</p> | |

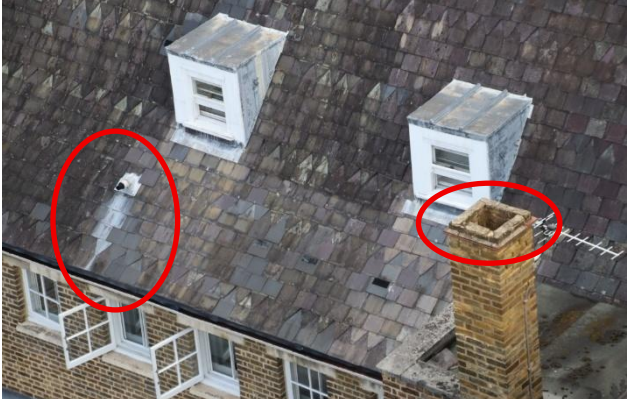
| Number | Description | Photograph |
|---|---|---|
| 43. | <p><b>Old School Court</b></p> <p>View of west (rear) roof slope to main structure.</p> <p>Note staining of slates attributed boiler flue, and open chimney flue.</p> | |

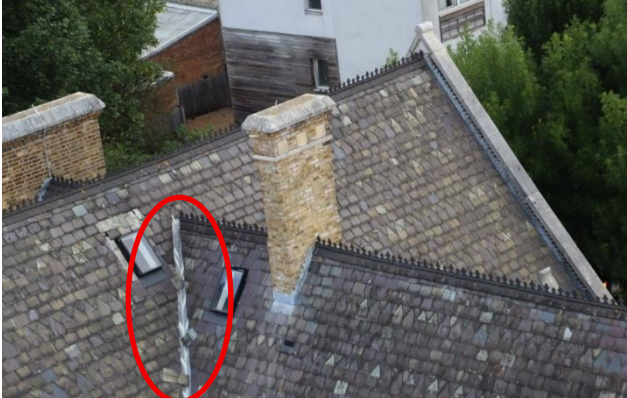
| Number | Description | Photograph |
|---|---|---|
| 44. | <p><b>Old School Court</b></p> <p>View of rear valley at junction of right-hand transept with main structure.</p> <p>Note slipped slates obstructing valley gutter.</p> | |

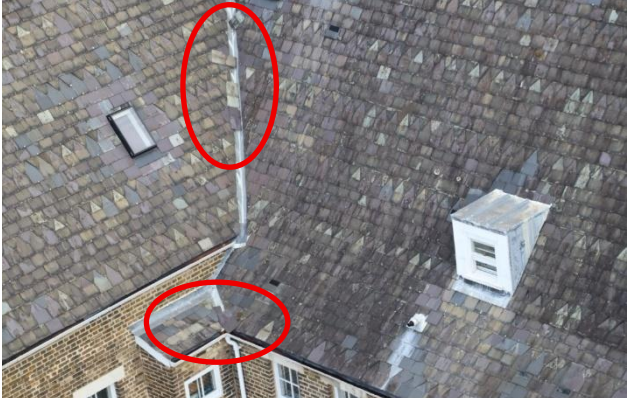
| Number | Description | Photograph |
|---|---|---|
| 45. | <p><b>Old School Court</b></p> <p>View of rear valley at junction of right-hand transept with main structure.</p> <p>See also Photo 44.</p> | |

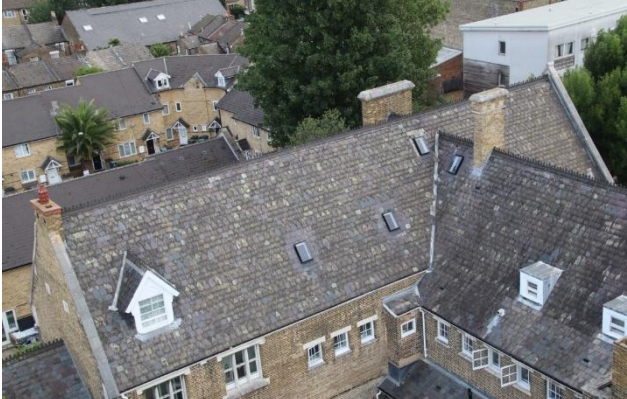
| Number | Description | Photograph |
|---|---|---|
| 46. | <p><b>Old School Court</b></p> <p>View of south roof slope to right-hand transept.</p> | |

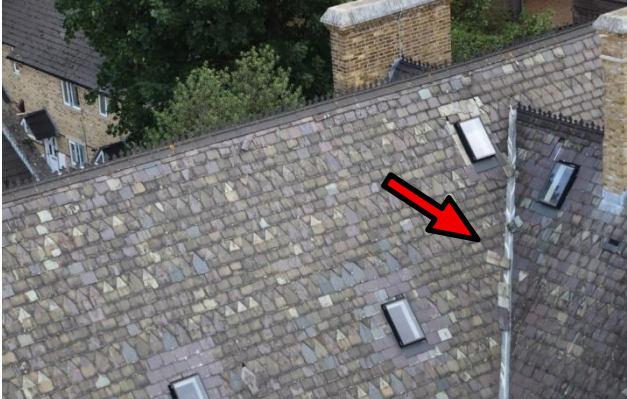
| Number | Description | Photograph |
|---|---|---|
| 47. | <p><b>Old School Court</b></p> <p>Close up view of Photo 46.</p> | |

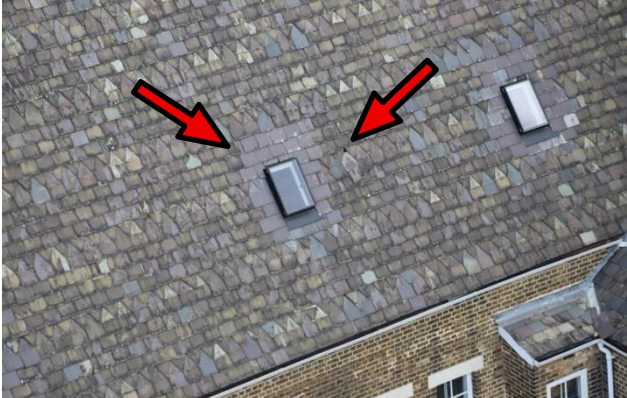
| Number | Description | Photograph |
|---|---|---|
| 48. | <p><b>Old School Court</b></p> <p>Alternate view of Photo 47.</p> <p>Note evidence of localised repair to existing rooflight surround, and hole within roofing covering attributable to slipped slate.</p> | |

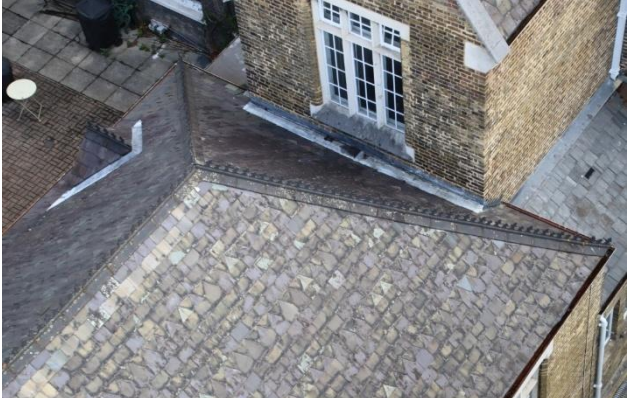
| Number | Description | Photograph |
|---|---|---|
| 49. | <p><b>Old School Court</b></p> <p>View of junction of addition roof slope to rear of main structure.</p> | <p>An aerial photograph showing the junction of a new roof slope (darker, more uniform tiles) and an existing roof slope (lighter, more varied tiles) on a brick building. A window with white frames is visible on the upper right side of the building.</p> |

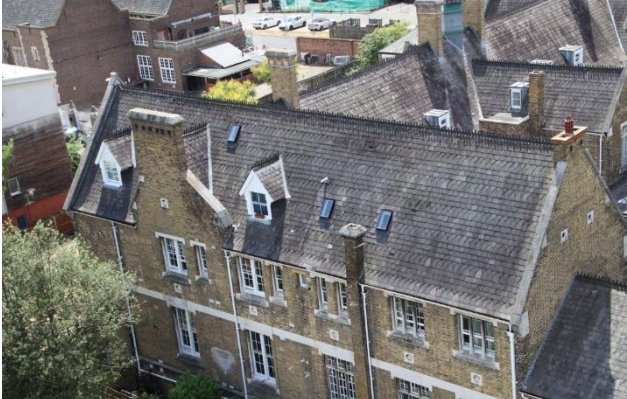
| Number | Description | Photograph |
|---|---|---|
| 50. | <p><b>Old School Court</b></p> <p>View of north elevation and roof slope of right-hand transept.</p> | <p>A wide aerial photograph showing the north elevation and roof slope of a large brick building. The building features multiple chimneys, dormer windows, and a complex roof structure. The surrounding area includes other buildings and greenery.</p> |
