Address: 84 Talbot Road, London, N6 4RA

## Monitoring Review Report

WHC Reference: WHC-20048  
Client: Sedgwick International UK  
Client Reference: 10802411  
Report Date: 3<sup>rd</sup> September 2025

## Establish Movement

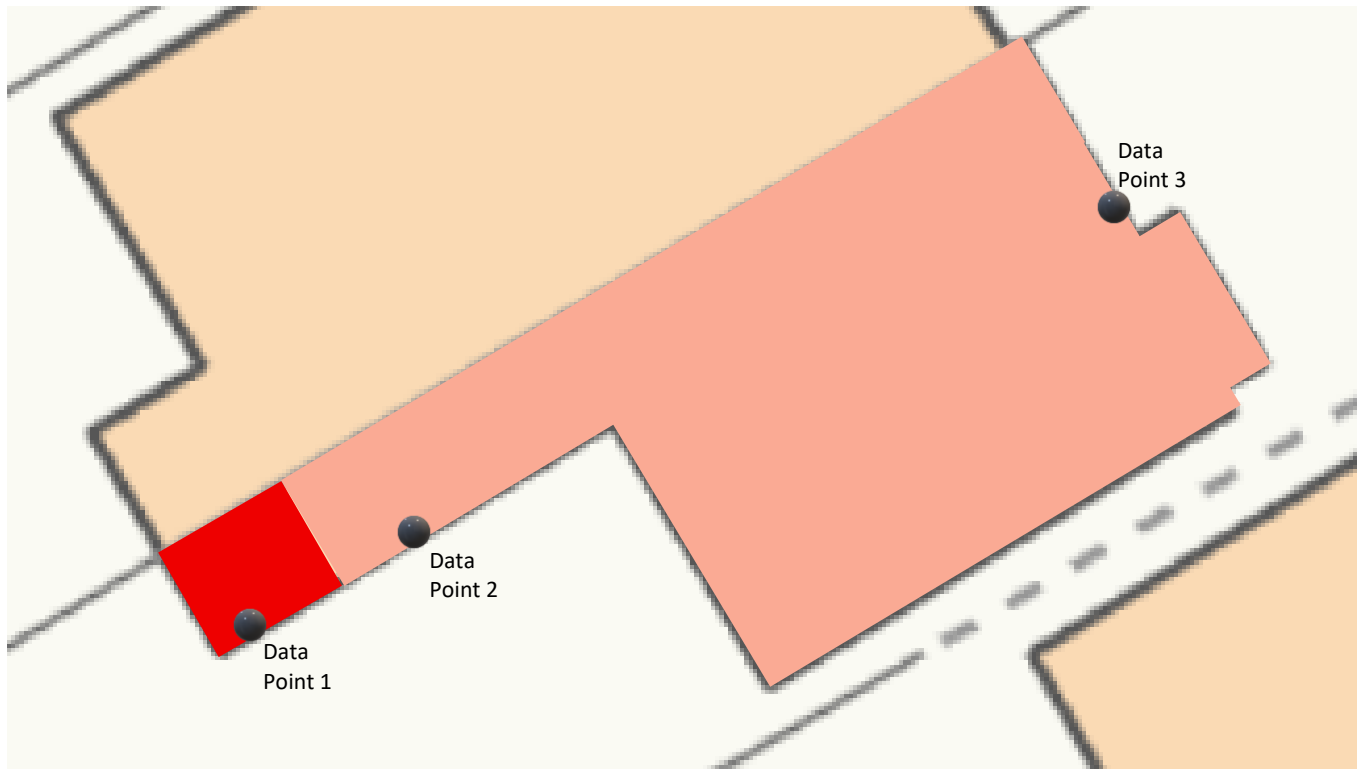
Figure (i) – Site plan denoting areas of varying movement  
(Darker Red denoting increase in movement)

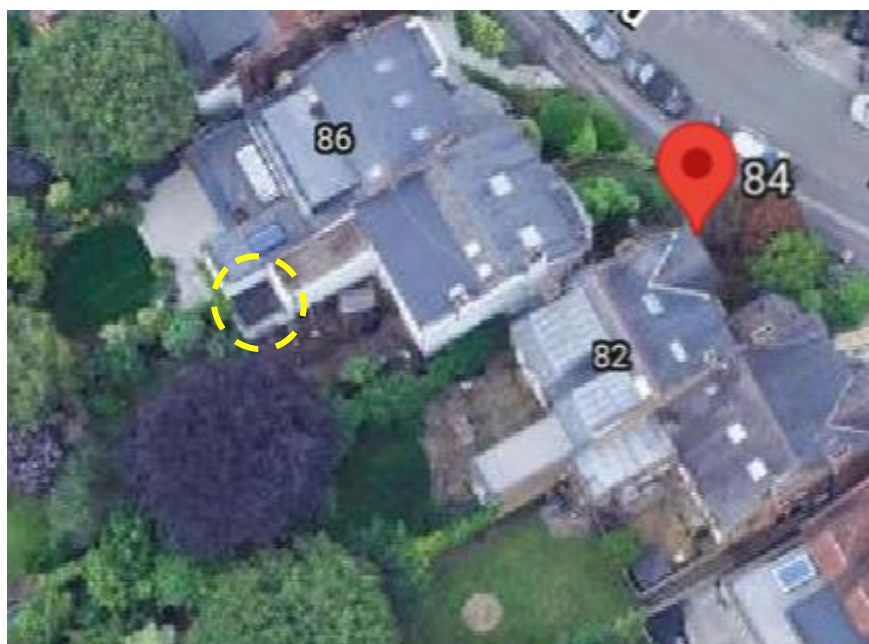
Figure (ii) – Satellite monitoring data, dated from 7<sup>th</sup> June 2021 to 18<sup>th</sup> July 2025

Synthetic Aperture Radar (SAR) systems operate with a side-looking geometry and illuminate the Earth with a series of microwave pulses. As the spacecraft moves, sending pulse transmissions, the SAR detects echoes of previous pulses, scattered from the Earth. The raw data collected by the SAR is then focused to form an image. This is achieved in the direction, perpendicular to the direction of travel, through knowledge of the time delay, and in the flight direction through combinations of echoes from multiple locations to synthesize a large antenna aperture. A complex set of algorithmic calculations are then applied to the raw data to correct atmospheric distortions which provide the results, shown in figures (ii) and (iii).

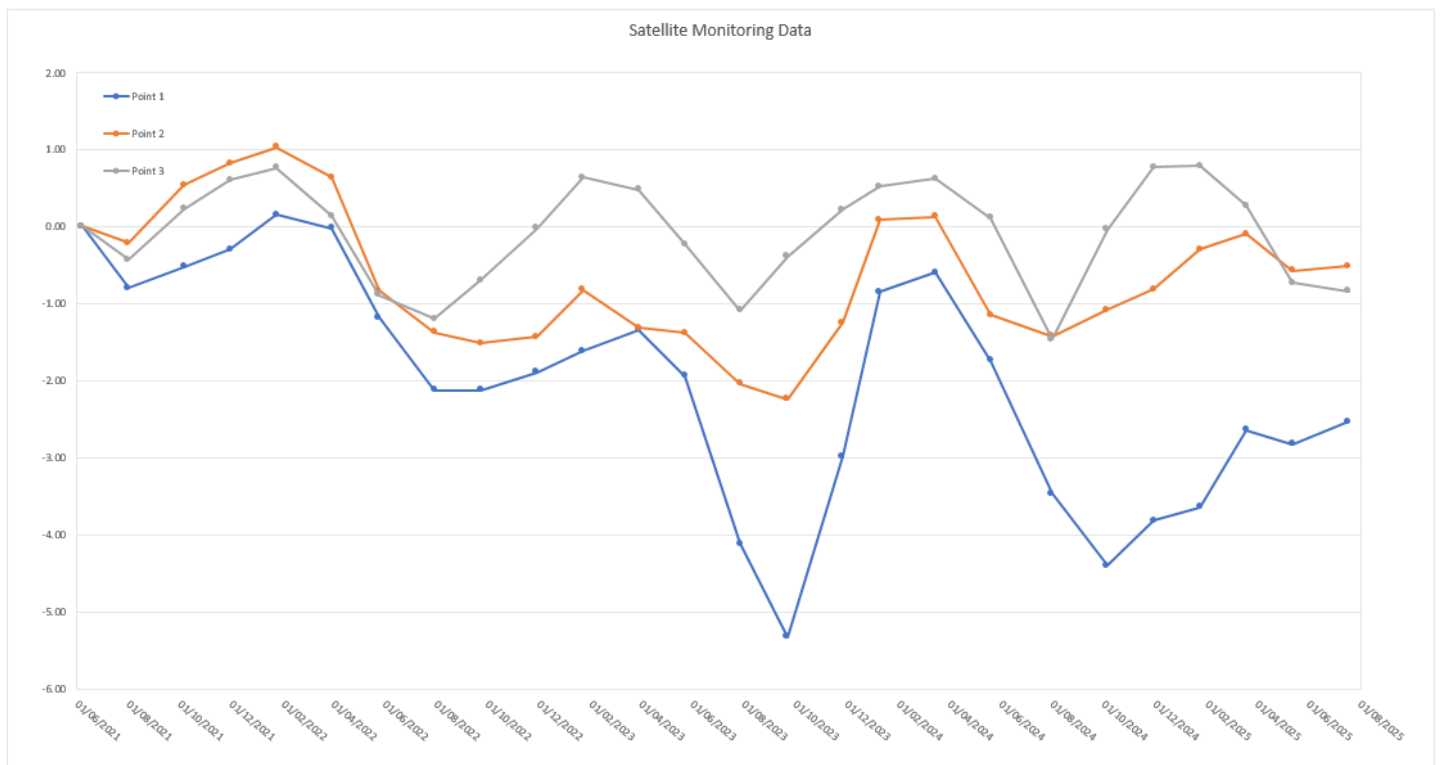
Figure (iii) – Satellite monitoring data in graphical form

The pattern of movement recorded to the single storey rear extension at the property address of 84 Talbot Road, London, N6 4RA, are consistent with a building suffering from the effects of tree root induced clay shrinkage subsidence (TRICCS). Upward movement was recorded commencing September 2021 through to February 2022 which is consistent with the increase in precipitation as shown within Figure (iv) on page 6 of this report in July 2021 where 123.3mm of rainfall was recorded. Further upward movement was recorded commencing October 2022 and 2023, together with September 2024 which is in line with the increase in rainfall highlighted on page 6.

Downward movement of the property was recorded within the satellite monitoring data from February to October 2022, together with March to October 2023 and March to September 2024 due to a reduction in rainfall during both periods.

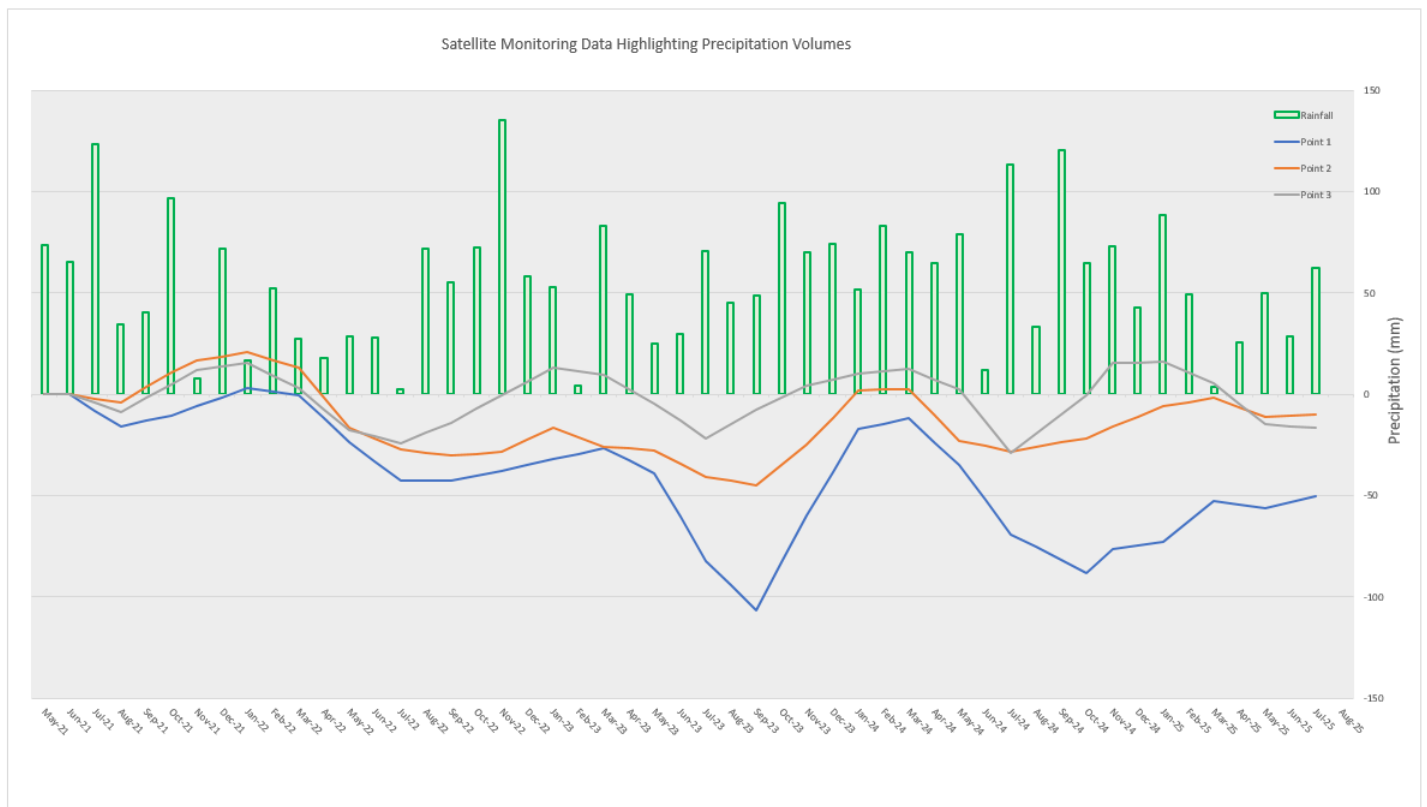
Figure (v) – Precipitation Plotted Against Satellite Monitoring Readings

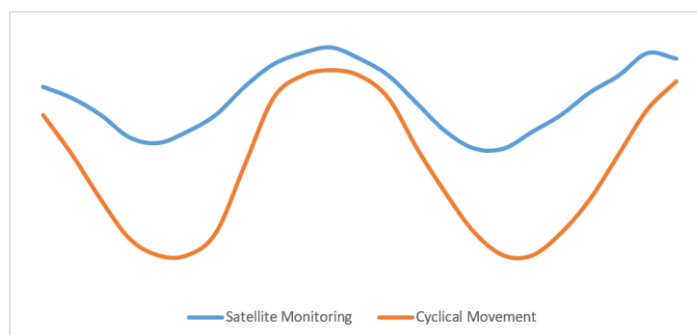
The results provided by satellite monitoring data are, by design, broadly correlated to provide evidential proof of the influence of surrounding vegetation on the stability of a reflection point. Accepting that the magnitude of movement is unlikely to match exactly, that at foundation, by virtue of the buffering and latency effects of the building cracking, corbelling and finally yielding at the roof line, the pattern of timing of movement is broadly the same.

Figures provided within the graph are to be read as accumulative readings and not as a direct comparison with level monitoring data, as indicated on Figure (vi) below.

Figure (vi) – Relationship between satellite and level monitoring data
