ARBORICULTURAL IMPACT ASSESSMENT AND TREE PLANTING REPORT

10 Coolhurst Road, London N8 8EL and garage block adjacent to 2 Coleridge

Road N8 8EJ

**OUR REF: SHA 1934**

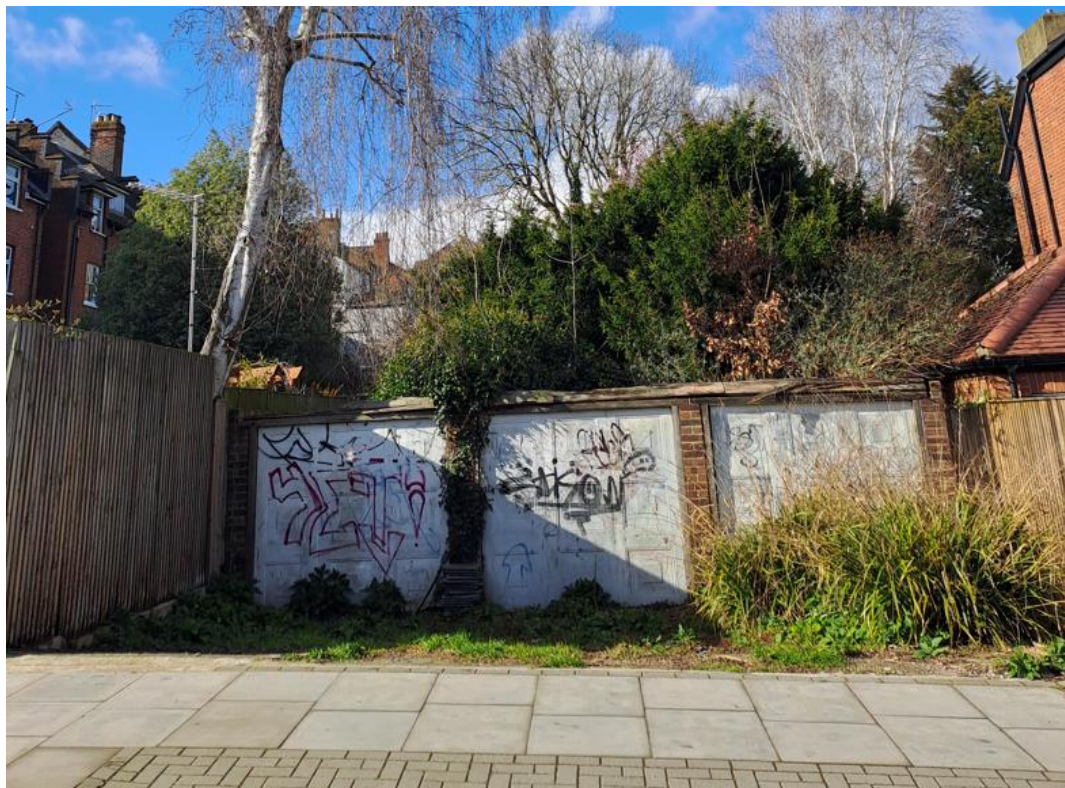
*Photo 1 – looking north at the garage. Note the silver birch on the left hand side has consent to be removed.*

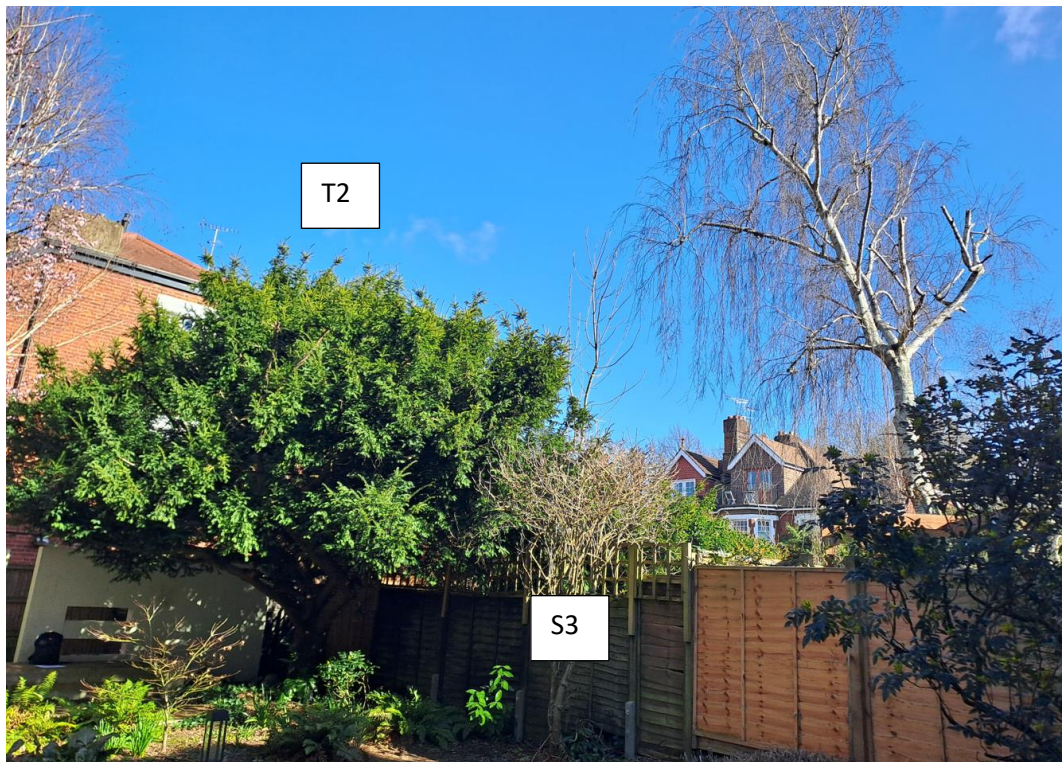
*Photo 1 of T2 yew and S3 elder. Taken 13.03.25.*

| Tree number | BS category | Species | Comments - all to remove to facilitate the proposal |
|---|---|---|---|
| T2 | B2 | Yew | Early mature, 6m high and seen from Coleridge Road. |
| S3 | C2 | Elder | Small shrub providing no visual amenity beyond the garden. |

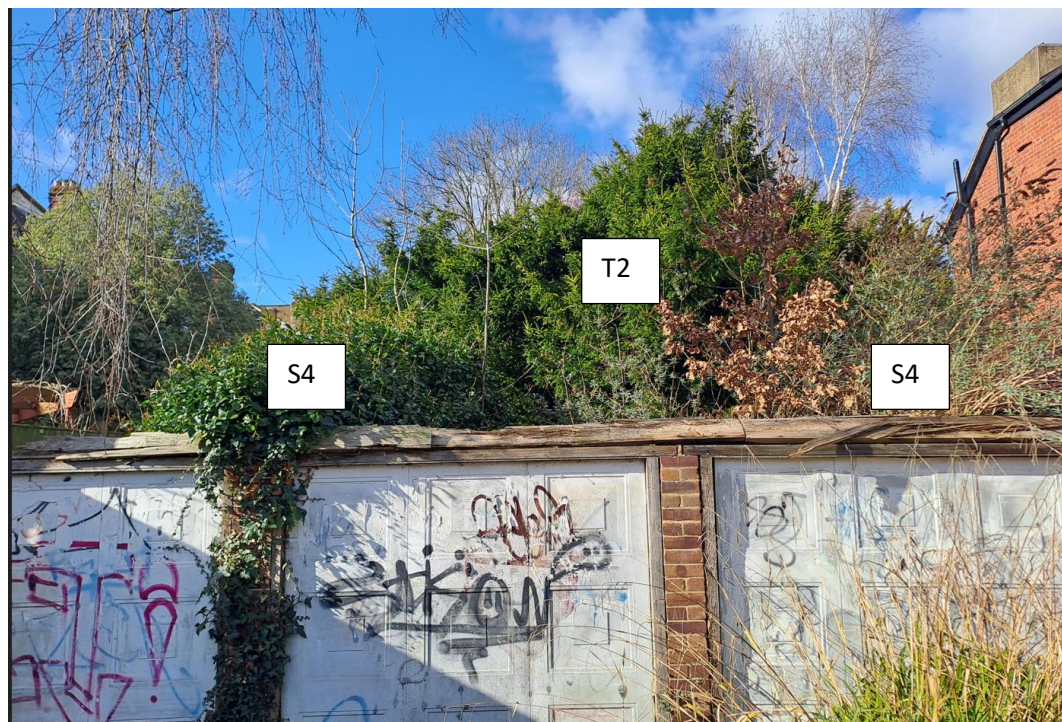
*Photo 2 of T2 yew and S4 saplings and butterfly bushes. Taken 13.03.25.*

| Tree number | BS category | Species | Comments - all to remove to facilitate the proposal |
|---|---|---|---|
| S4 | U | Mixed saplings and butterfly bushes | Self sown, growing in a narrow gap between rear of garage and garden in an unsustainable location. |

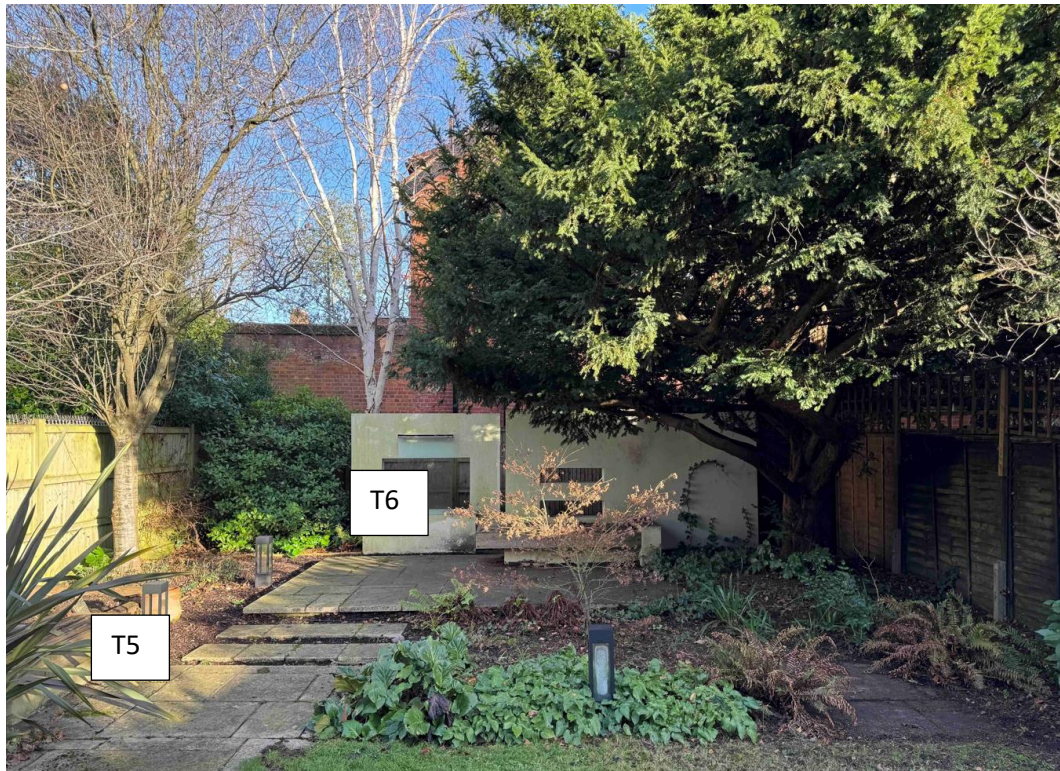
*Photo 3 of T2 yew, T5 plum and T6 birch. Received recently from the client.*

| Tree number | BS category | Species | Comments - all to remove to facilitate the proposal |
|---|---|---|---|
| T5 | C2 | Plum | Unremarkable garden tree visible from adjacent garden. |
| T6 | C2 | Birch | Growing in narrow gap between garden internal wall and boundary. Top of tree is visible from Coleridge Road in the mid background. |

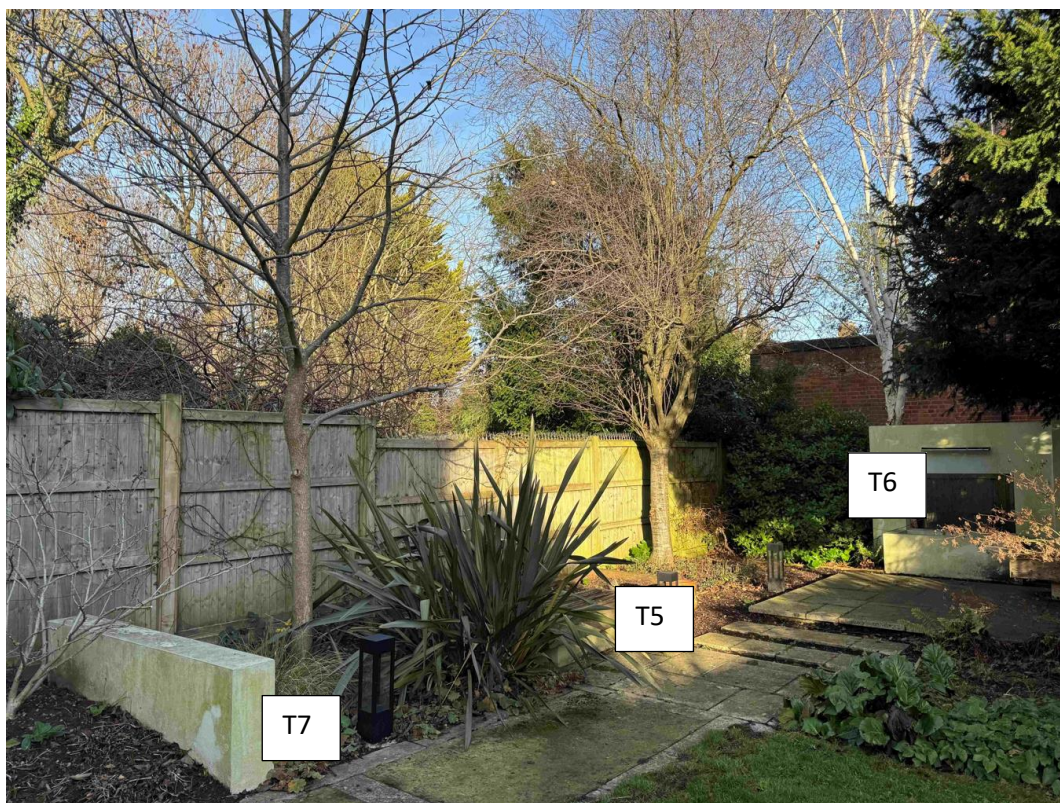
*Photo 4 of T2 yew, T5 plum, T6 birch and T7 Turkish hazel. Received recently from the client.*

| Tree number | BS category | Species | Comments - all to remove to facilitate the proposal |
|---|---|---|---|
| T7 | C2 | Turkish hazel | Unremarkable young garden tree visible from adjacent garden.<br><br>Unrealistically close to the proposed building to survive construction and it would outgrow its new situation. |
