# Site Investigation Report

194327.1.4.USI

Auger were commissioned by Sedgwick International UK to undertake a site investigation and CCTV inspection of the underground drainage within the area of concern (AOC) at the property.

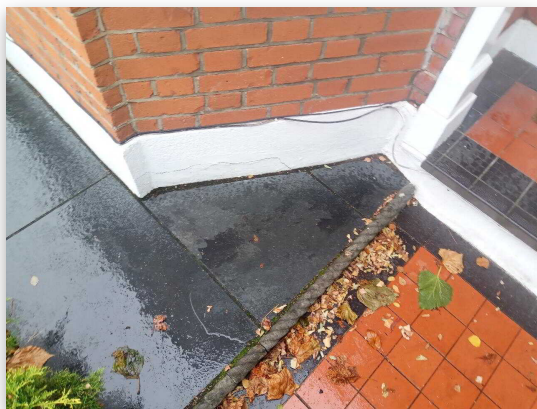
Fig 1.1: Trial Hole 1 Location

TH1 was undertaken in the desired location, we were able to expose the footings and we collected the requested soil and root samples.
