# Site Investigation Report

148967.2.TSI

Auger were commissioned by Questgates to undertake a site investigation within the area of concern (AOC) at the property.

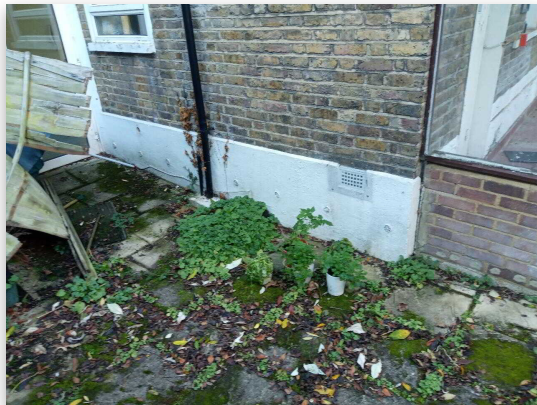
Fig 1.1: Trial Hole 1 Location

TH1 was undertaken in the desired location, we were able to expose the footings and we collected the requested soil and root samples.
