# Basement Impact Appraisal

## **PHASE 1 GEOTECHNICAL DESK STUDY**

**6A Denmark Terrace  
London  
N2 9HG**

| <i>Document Type</i> | Report on a Phase 1 Risk Assessment |

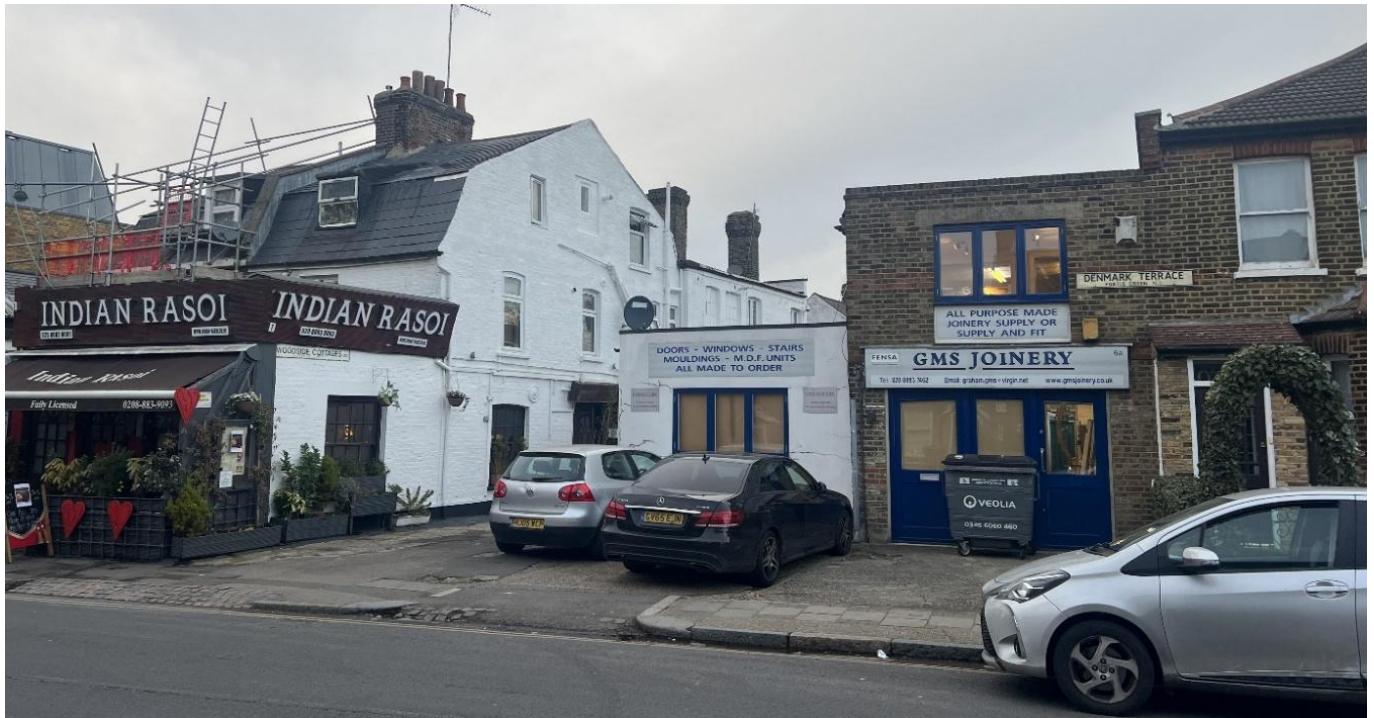
#### EXISTING SITE PLAN

The site is currently in use as a joinery work shop by GMS joinery Ltd. There is a parking forecourt at the front and small yard area at the front. The current buildings are single and two storey. The area is predominantly residential in character, with the site forming the terminus of a row of terraced houses on Fortis Green.

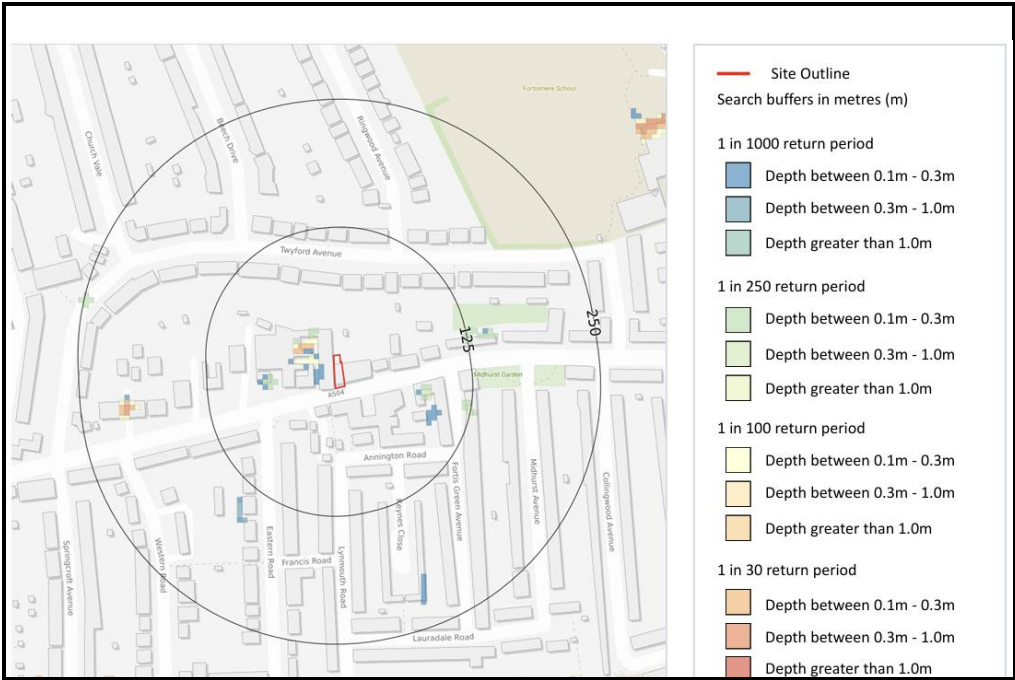
Surface water flooding Highest risk on site Negligible Highest risk within 50m 1 in 30 year, 0.1m - 0.3m Ambiantal Risk Analytics surface water (pluvial) FloodMap identifies areas likely to flood as a result of extreme rainfall events, i.e. land naturally vulnerable to surface water ponding or flooding. This data set was produced by simulating 1 in 30 year, 1 in 100 year, 1 in 250 year and 1 in 1,000 year rainfall events. Modern urban drainage systems are typically built to cope with rainfall events between 1 in 20 and 1 in 30 years, though some older ones may flood in a 1 in 5 year rainfall event.
