# GeoShield Verification Report 4

GEO105182

Cranford House,  
100 Woodside Avenue,  
Haringey,  
LONDON  
N10 3JA

Block A - External Wall Upstand & Lift Pit Area

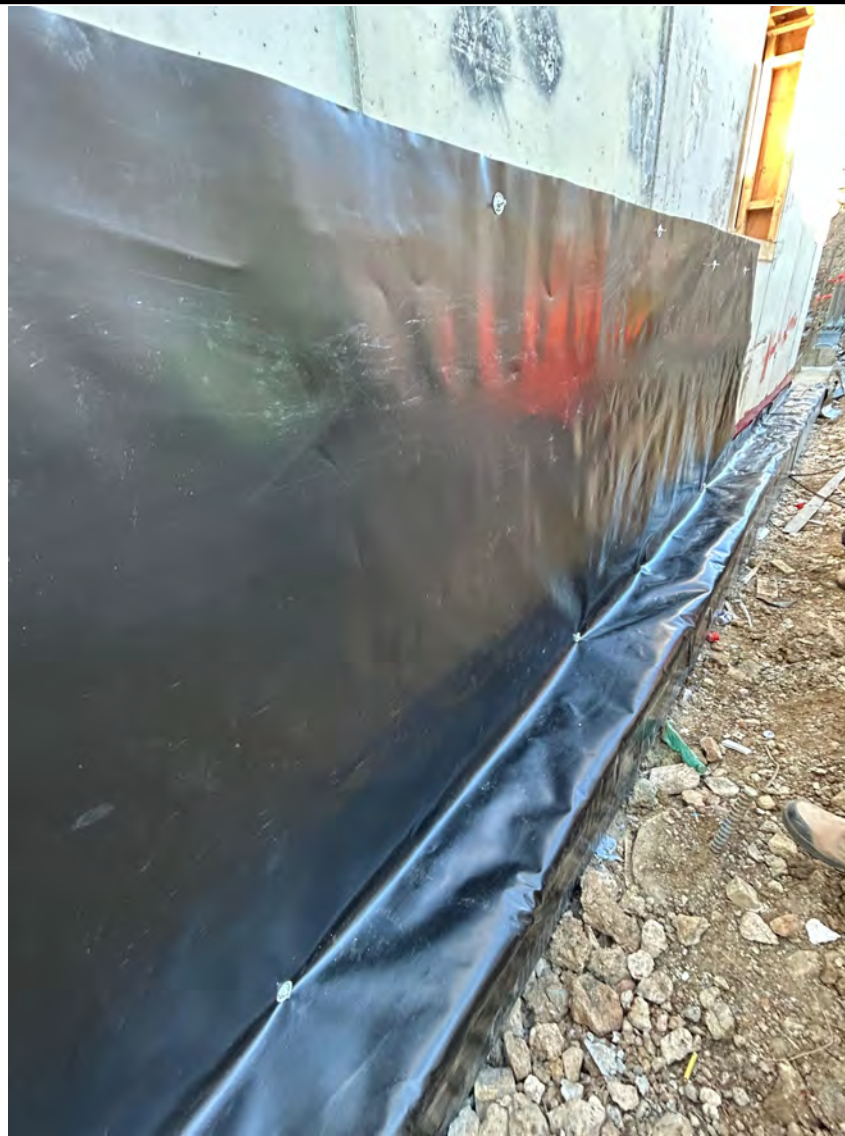
The photograph above displays an overview of the external wall upstand in Block A where today's verification inspection took place on site.

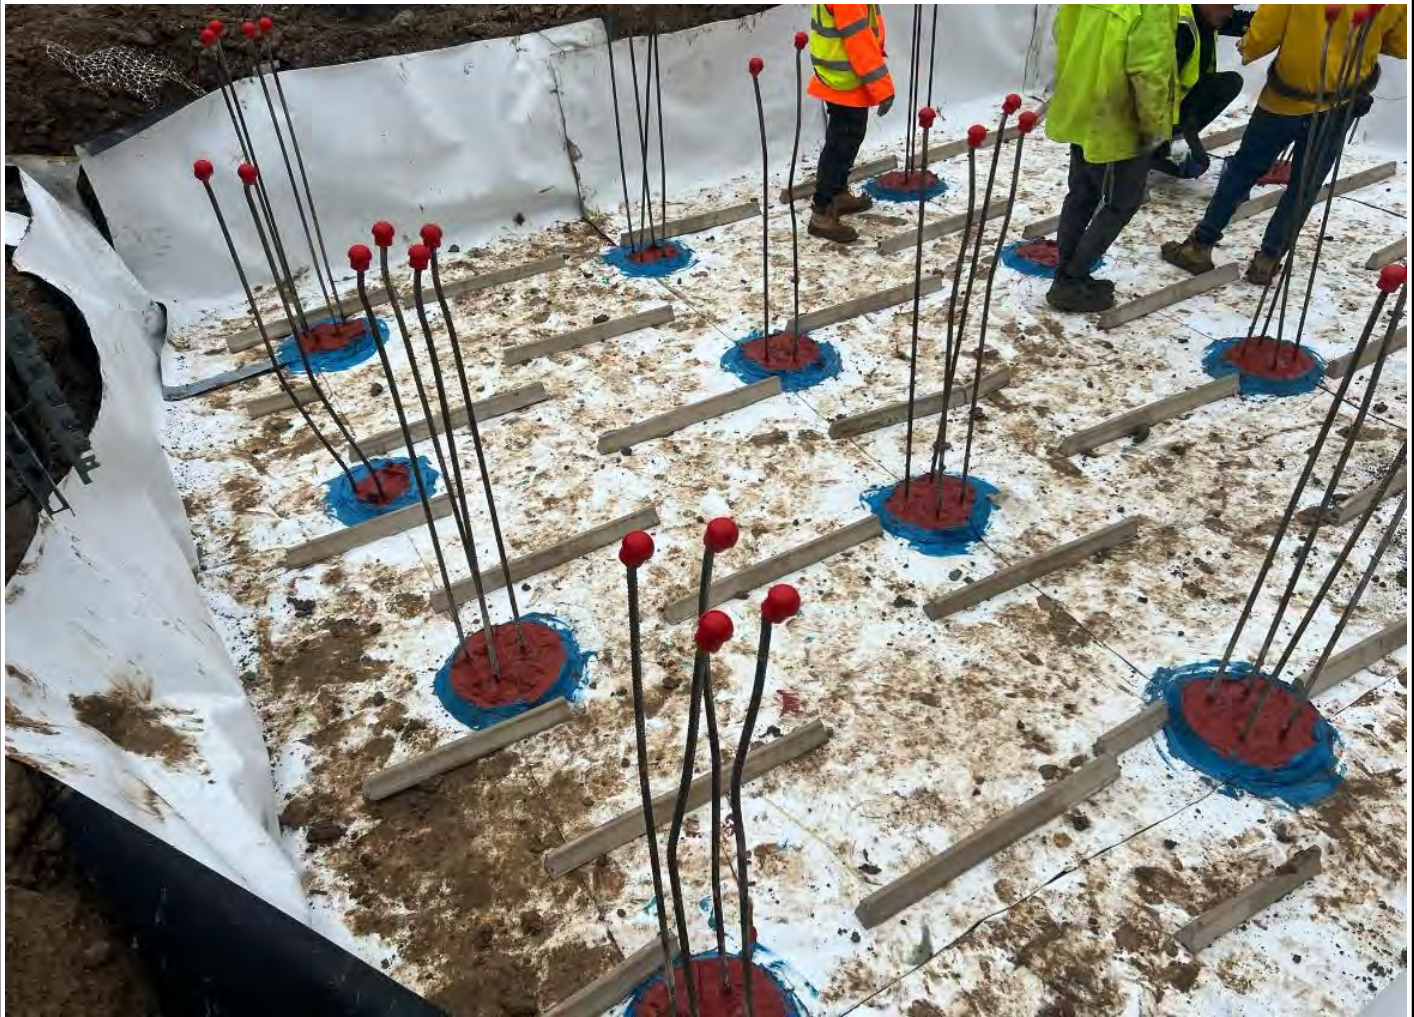
The photograph above displays an overview of the lift pit area in Block A where today's verification inspection took place on site.

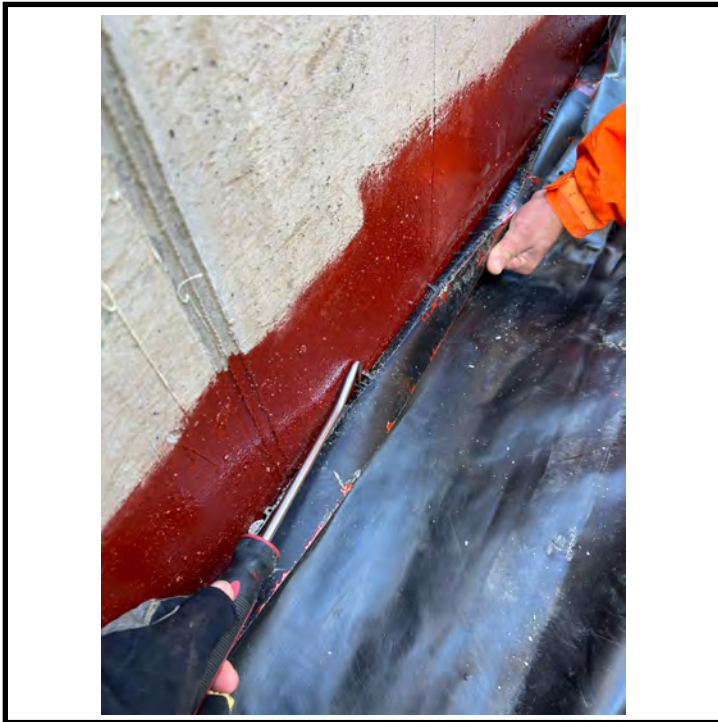
Premcrete CombiSeal Plus Gas Barrier has been installed across a section of the external wall upstand within Block A. Prior to the installation of the Premcrete CombiSeal Plus Gas Barrier, a liberal coat of Premcrete Hydroprufe LG has been applied upon the clean concrete surfaces around the toe and upstand.

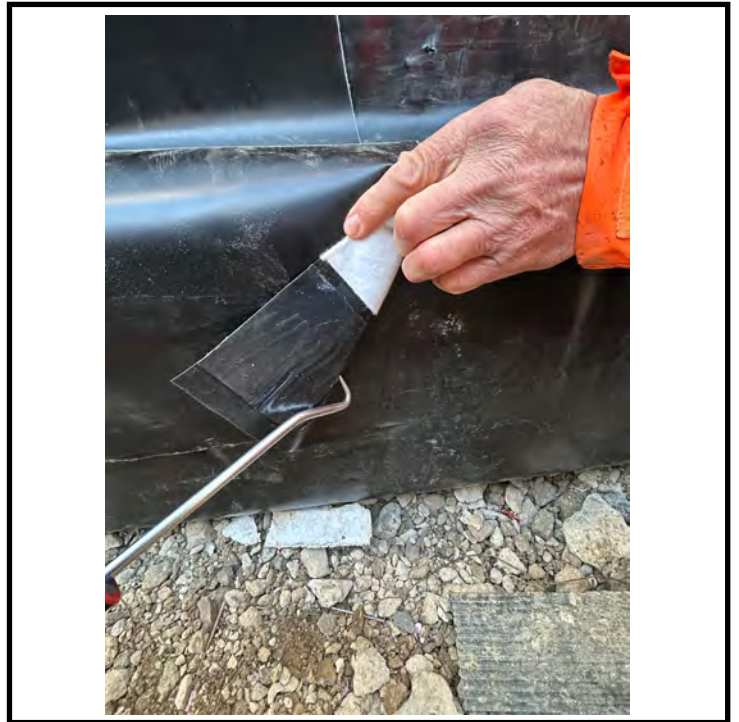
Once cured, the Premcrete CombiSeal Plus Gas Barrier has been applied upon the Hydroprufe LG surfaces. All overlaps between the adjacent sheets of Premcrete CombiSeal Plus Gas Barrier have been sealed via the preformed adhesive zip lap joints, or alternatively Premcrete CombiSeal Tape from beneath.

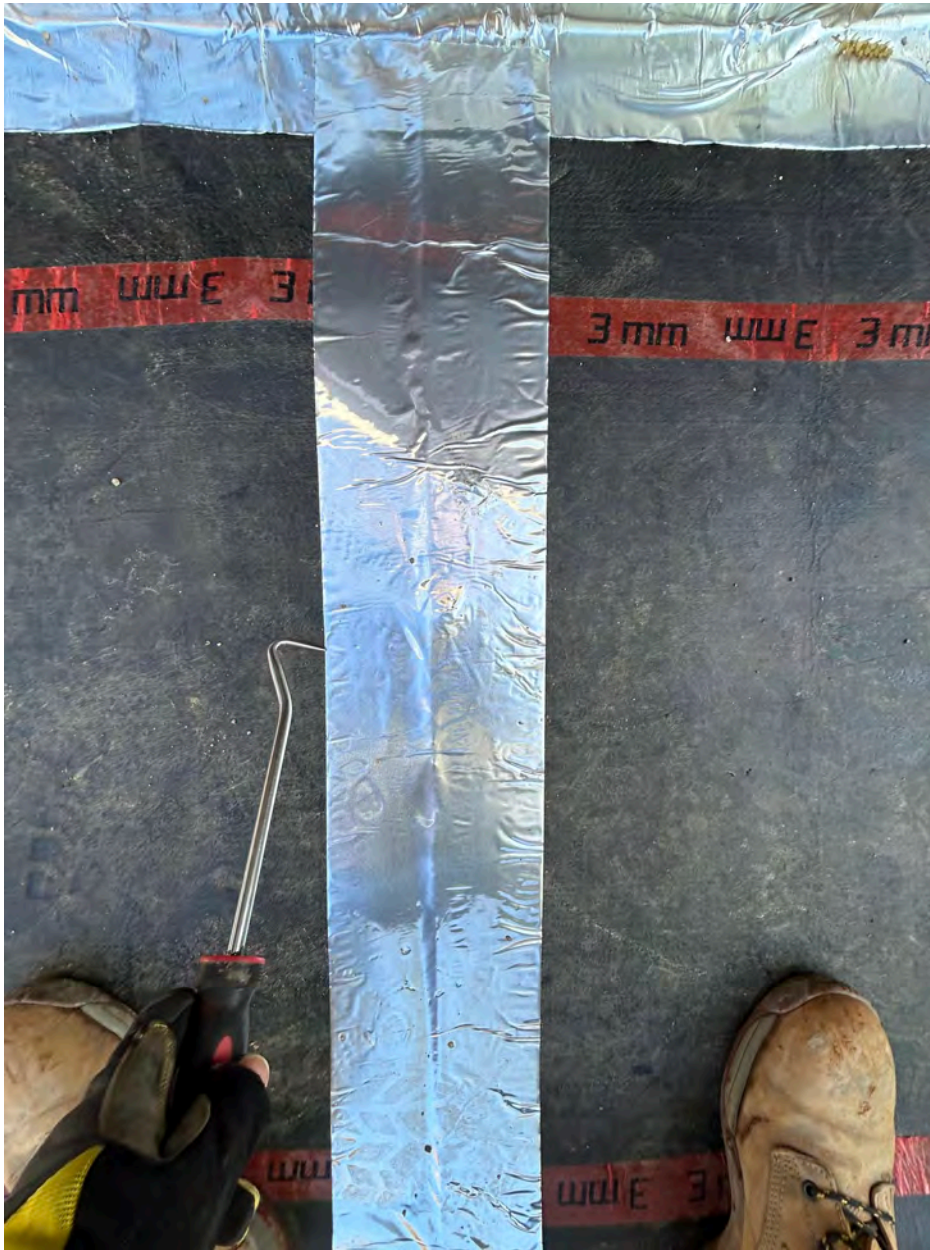
Protection Boards have been placed over the Premcrete CombiSeal Plus Gas Barrier and secured in place using Premcrete HCR Girth Tape. Thorough visual inspections, supported by mechanical point stress testing, also known as pick and probe testing, conducted upon all aspects of the Premcrete CombiSeal Plus Gas Barrier installation, identified no faults or defects.

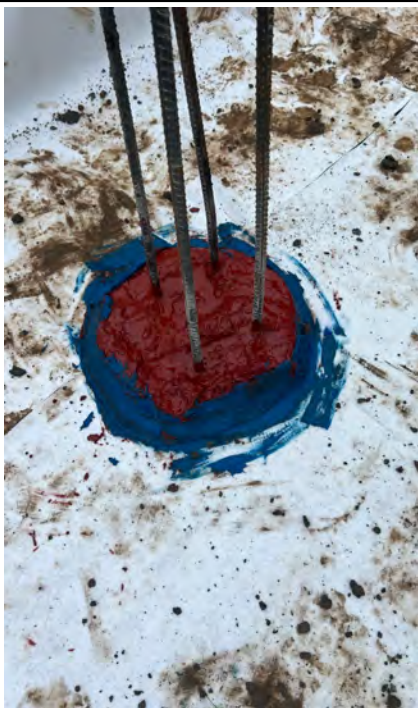
Following the installation of the Premcrete CombiSeal Plus Gas Barrier to the Lift Pit area, a number of pile caps required sealing. All pile caps have received a liberal coat of Hydroprufe LG, a liquid gas membrane which has been left to cure prior to the Premcrete CombiSeal Plus Gas Barrier being installed.

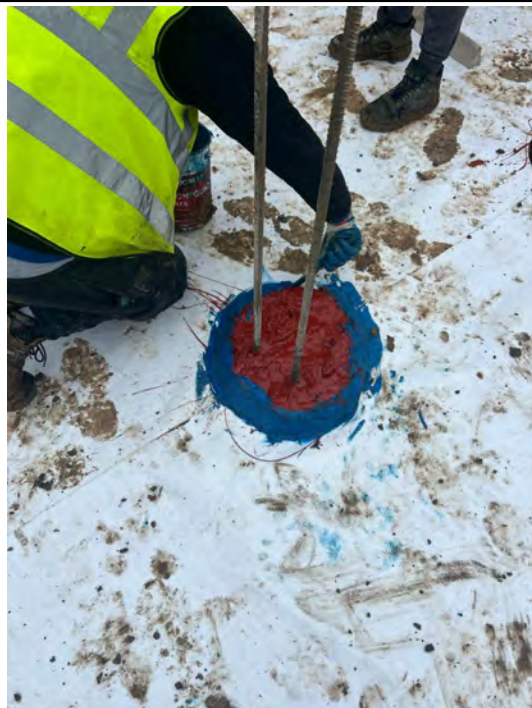
The Premcrete CombiSeal Plus Gas Barrier is cut tightly around the circumference of each pile cap and a continuous fillet of Twinseal Compound GR is applied using a 150mm paint brush to ensure that both the Premcrete CombiSeal Plus Gas Barrier and the pile cap were sufficiently covered.

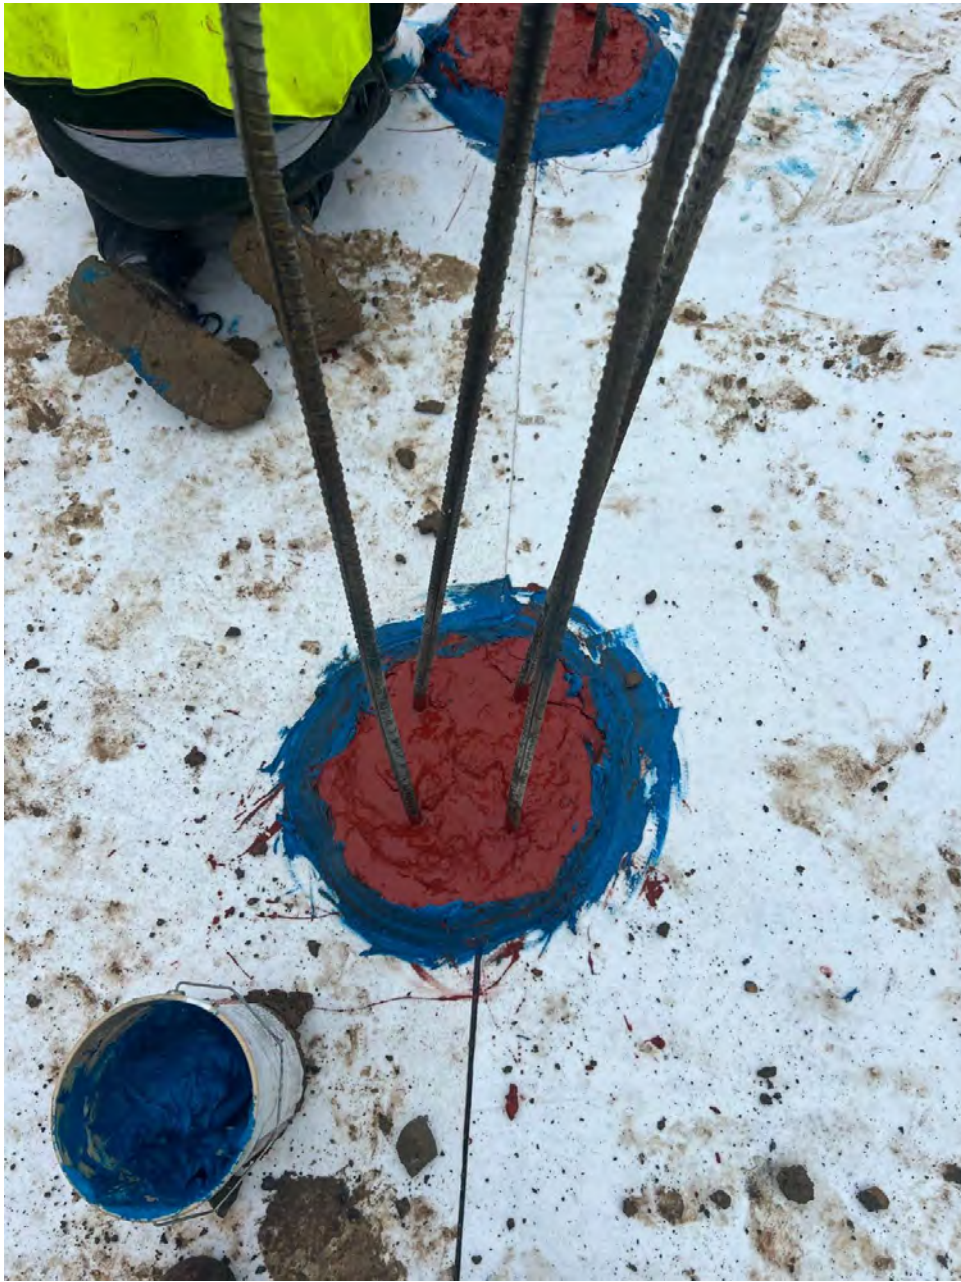
The pile caps were subjected to visual inspections and mechanical point stress testing throughout the area referenced. No faults or defects were identified during the testing procedures conducted upon the pile caps.

Tested and verified in accordance with CIRIA 735.

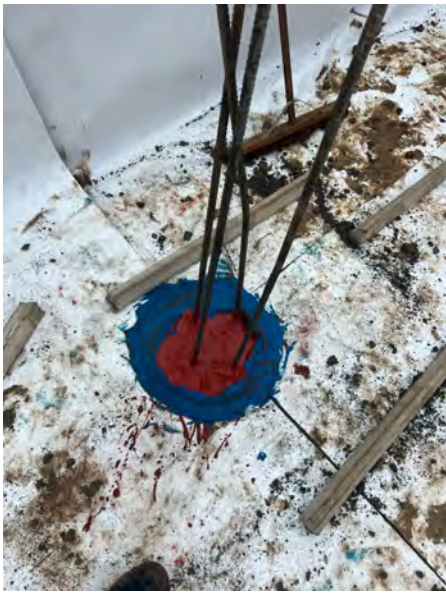
A pile cap within the lift pit, sealed with Hydroprufe LG and Twinseal Compound GR.

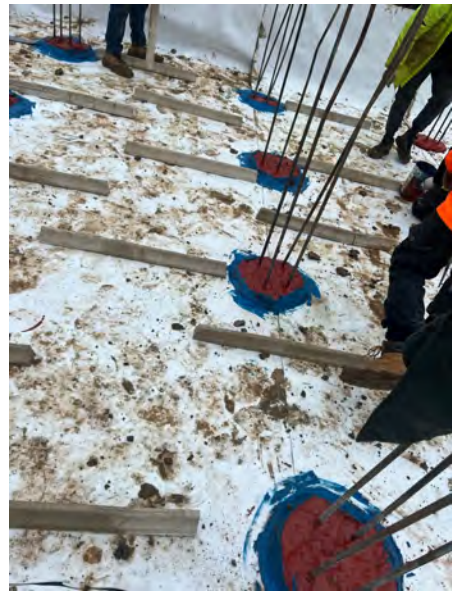
An overview of typical pile cap detailing within the lift pit.

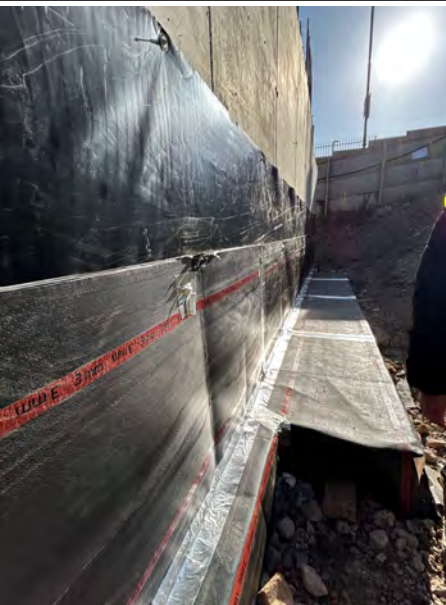
An alternative overview of the Premcrete CombiSeal Plus Gas Barrier installation to the external wall.

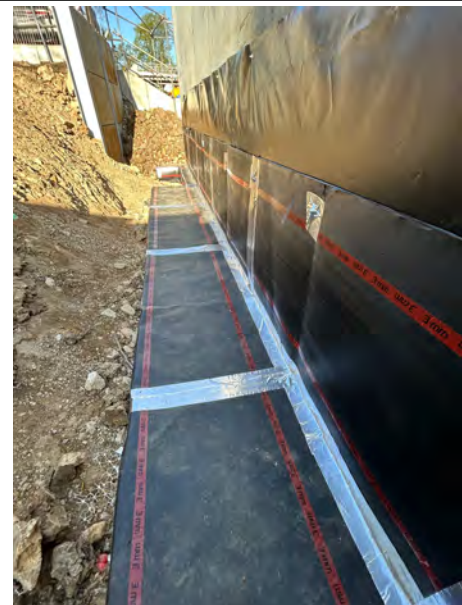
Protection Boards installed over the Premcrete CombiSeal Plus Gas Barrier around the external wall.
