## ADDITIONAL SITE PHOTOS - CURRENT CONDITION

Project Address: **122 Hewitt Avenue, N22 6QE**

**Window Assessment @ 122 Hewitt Avenue:**

**122 Hewitt Avenue, London N22 6QE**  
 Typical Window Section Details (Proposed)  
 Drawing no. HEW-PL-DET-001  
 RK. Rev PL01. 17/05/2026

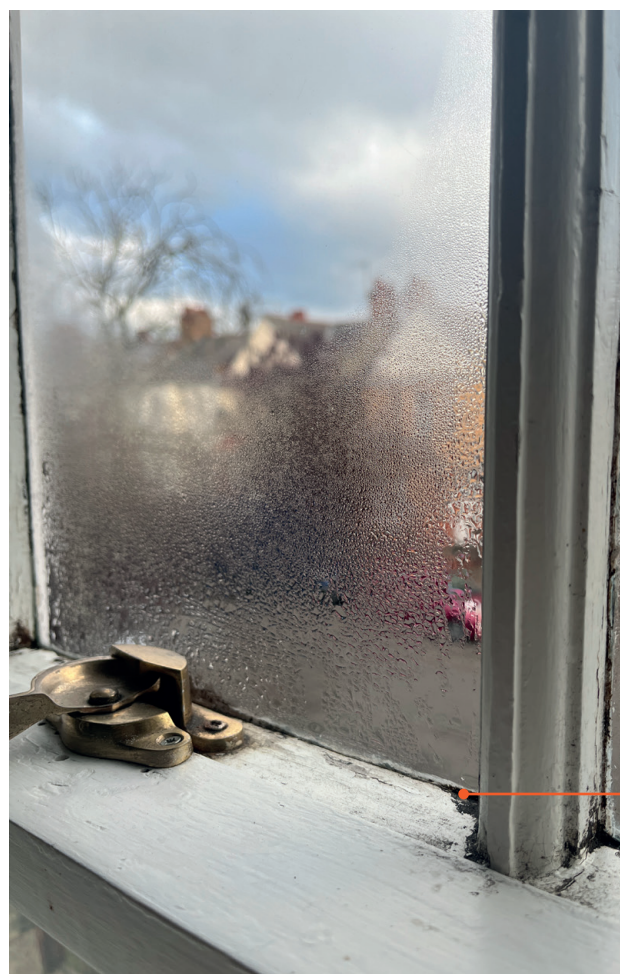
PHOTO 01

Photo 01 is taken on a spring morning, shows condensation forming on the glass because the large temperature difference between inside and outside has caused the internal surface to drop below the dew point.

In the winter months, when heating is in use, the level of condensation increases significantly, leading to mould growth, as visible in photos 01 and 03, despite the occupants' best efforts to manage moisture through using a dehumidifier and regularly removing condensation.

Note, this issue does not occur on other windows which are double glazed in the same house.

Our recommendation is to replace the windows with conservation compliant timber joinery, 145mm sash boxes, slimline 20mm glazing units & identical glazing bar design - which replicate the existing period features whilst being double glazed and draught free.

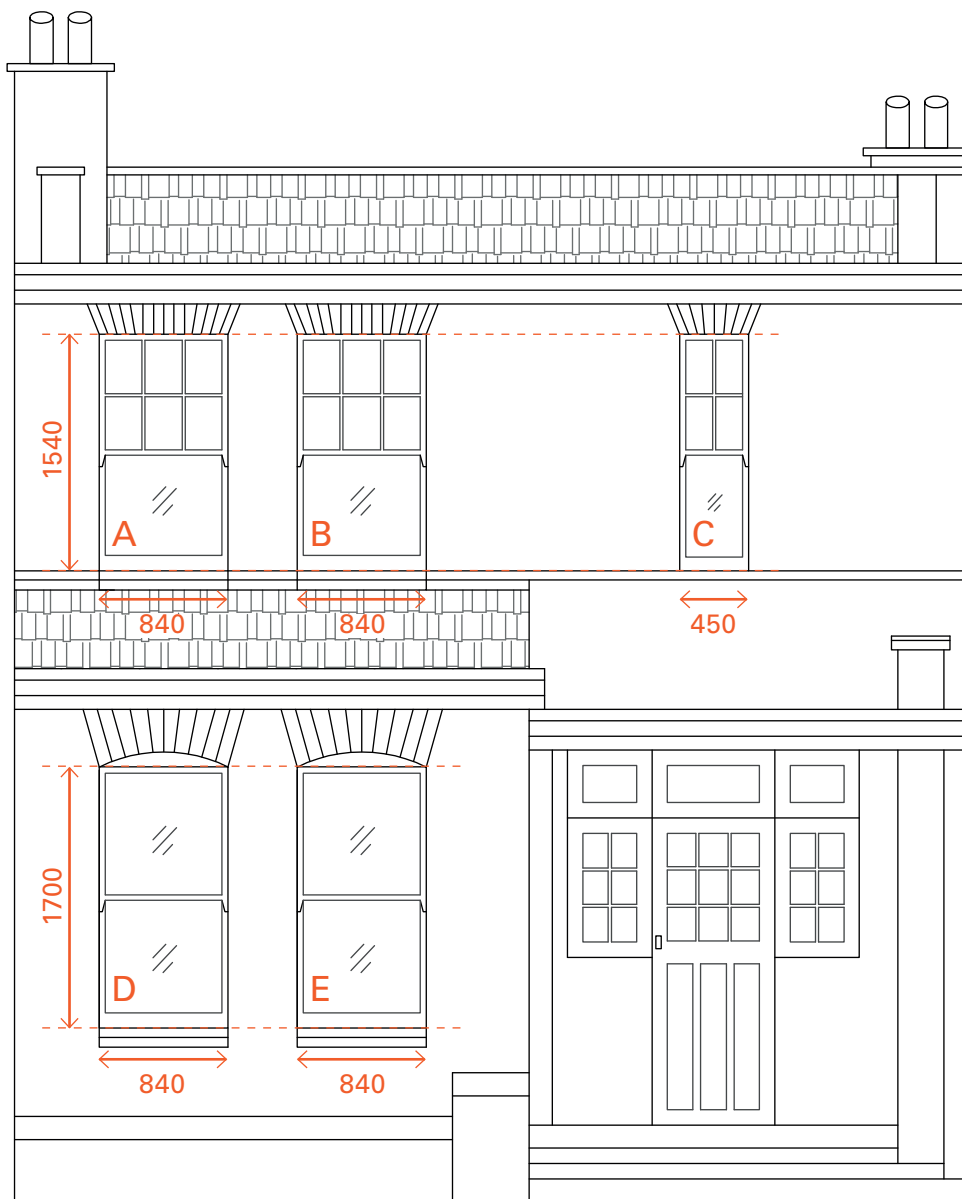
**EXISTING FRONT ELEVATION**

**122 Hewitt Avenue, London N22 6QE**

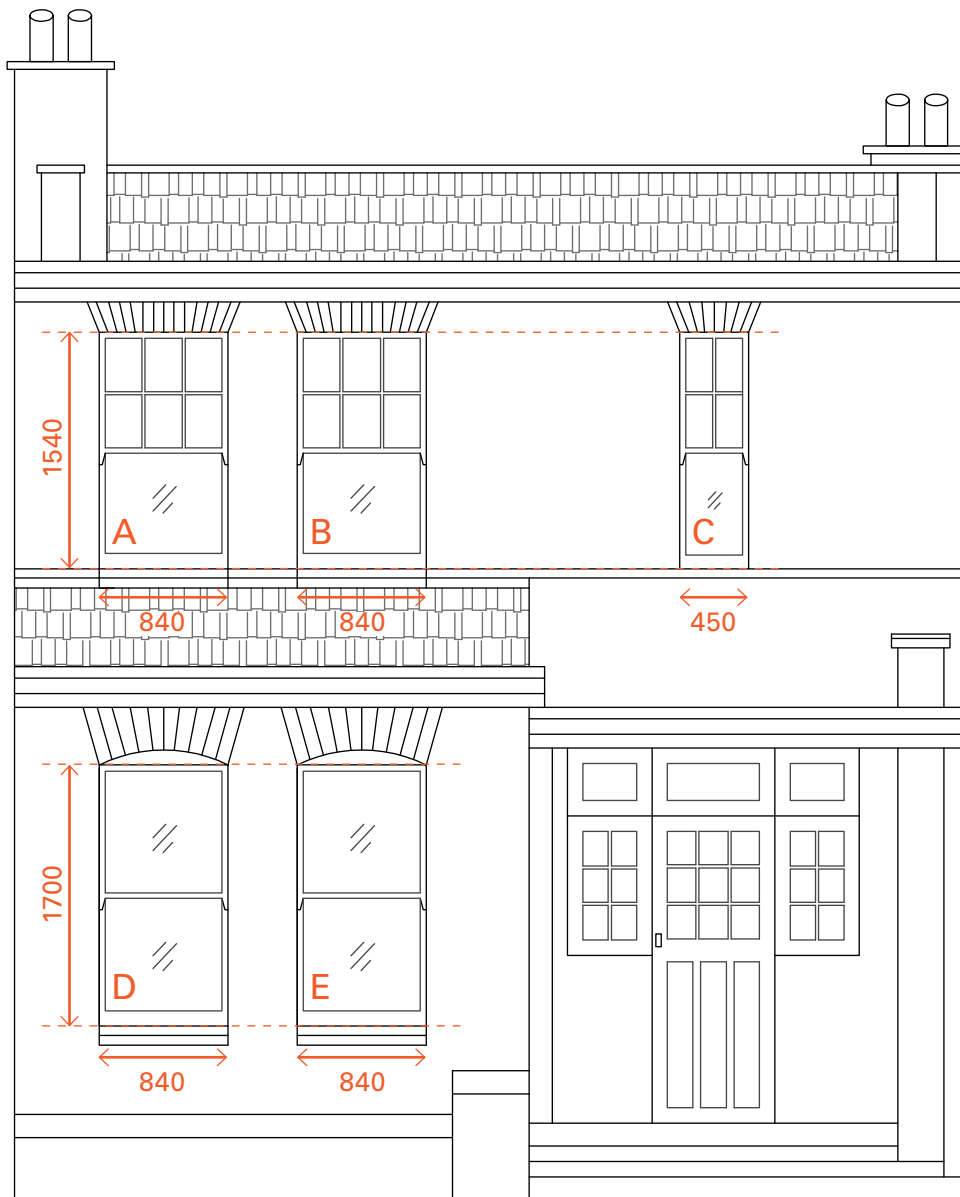
Drawing no. HEW-PL-ELEV-003

The six windows to be replaced are:

- A. Front of house, upper floor, main bedroom
- B. Front of house, upper floor, main bedroom
- C. Front of house, upper floor, main bedroom
- D. Front of house, ground floor, living room
- E. Front of house, ground floor, living room
- F. Rear of house, ground floor, dining area

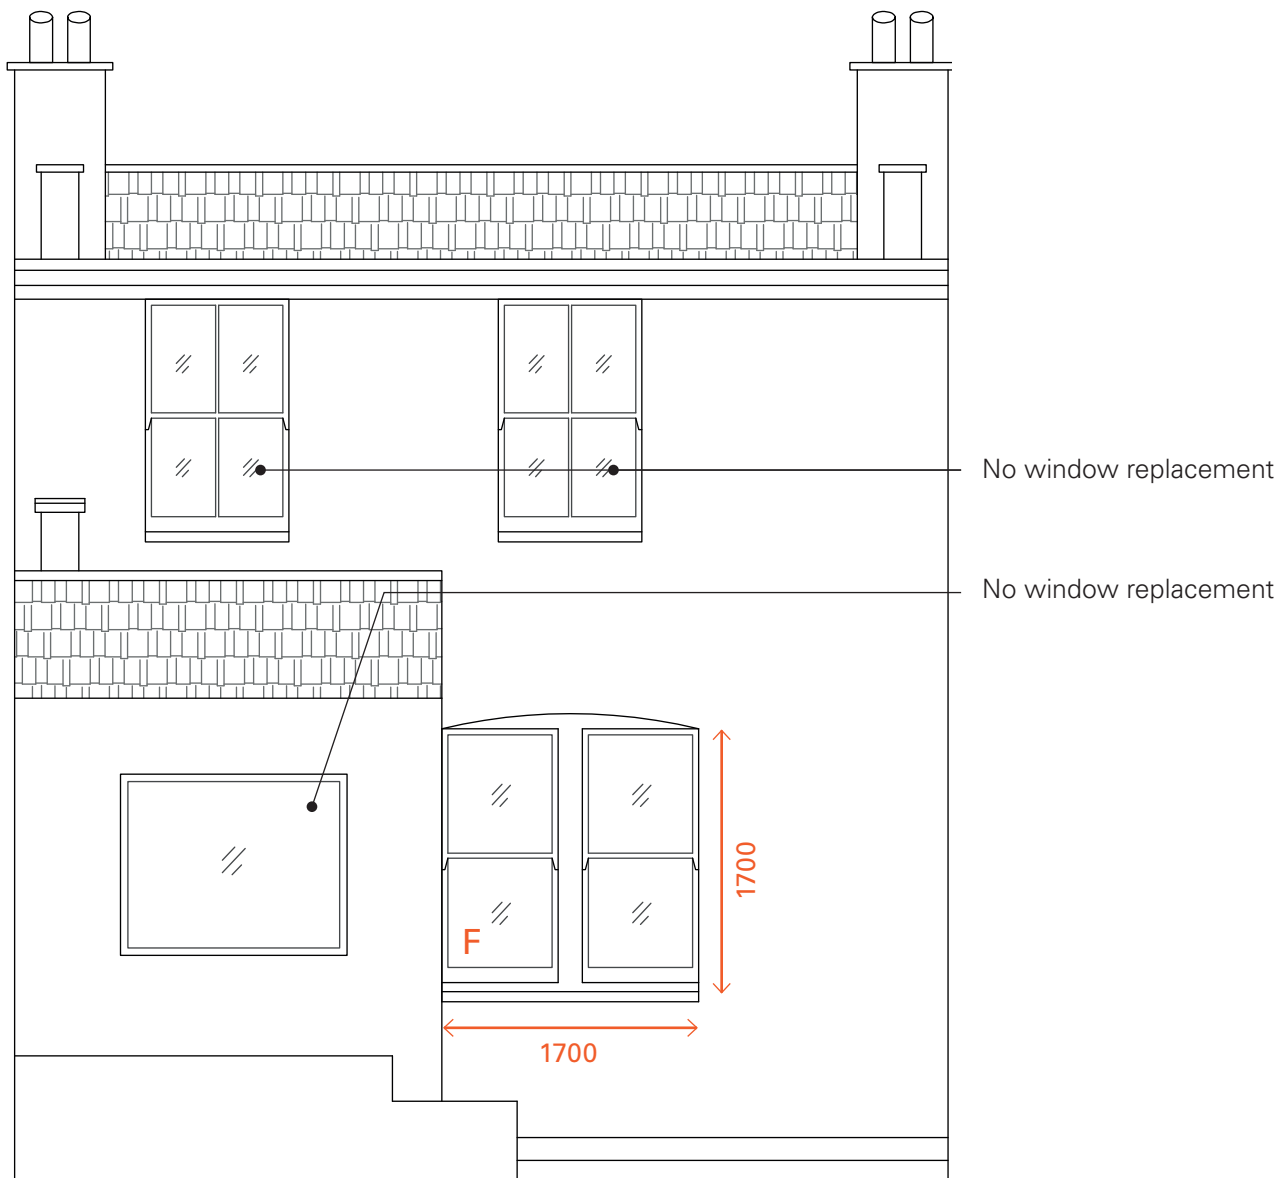
Drawing no. HEW-PL-ELEV-004

The six windows to be replaced are:

- A. Front of house, upper floor, main bedroom
- B. Front of house, upper floor, main bedroom
- C. Front of house, upper floor, main bedroom
- D. Front of house, ground floor, living room
- E. Front of house, ground floor, living room
- F. Rear of house, ground floor, dining area

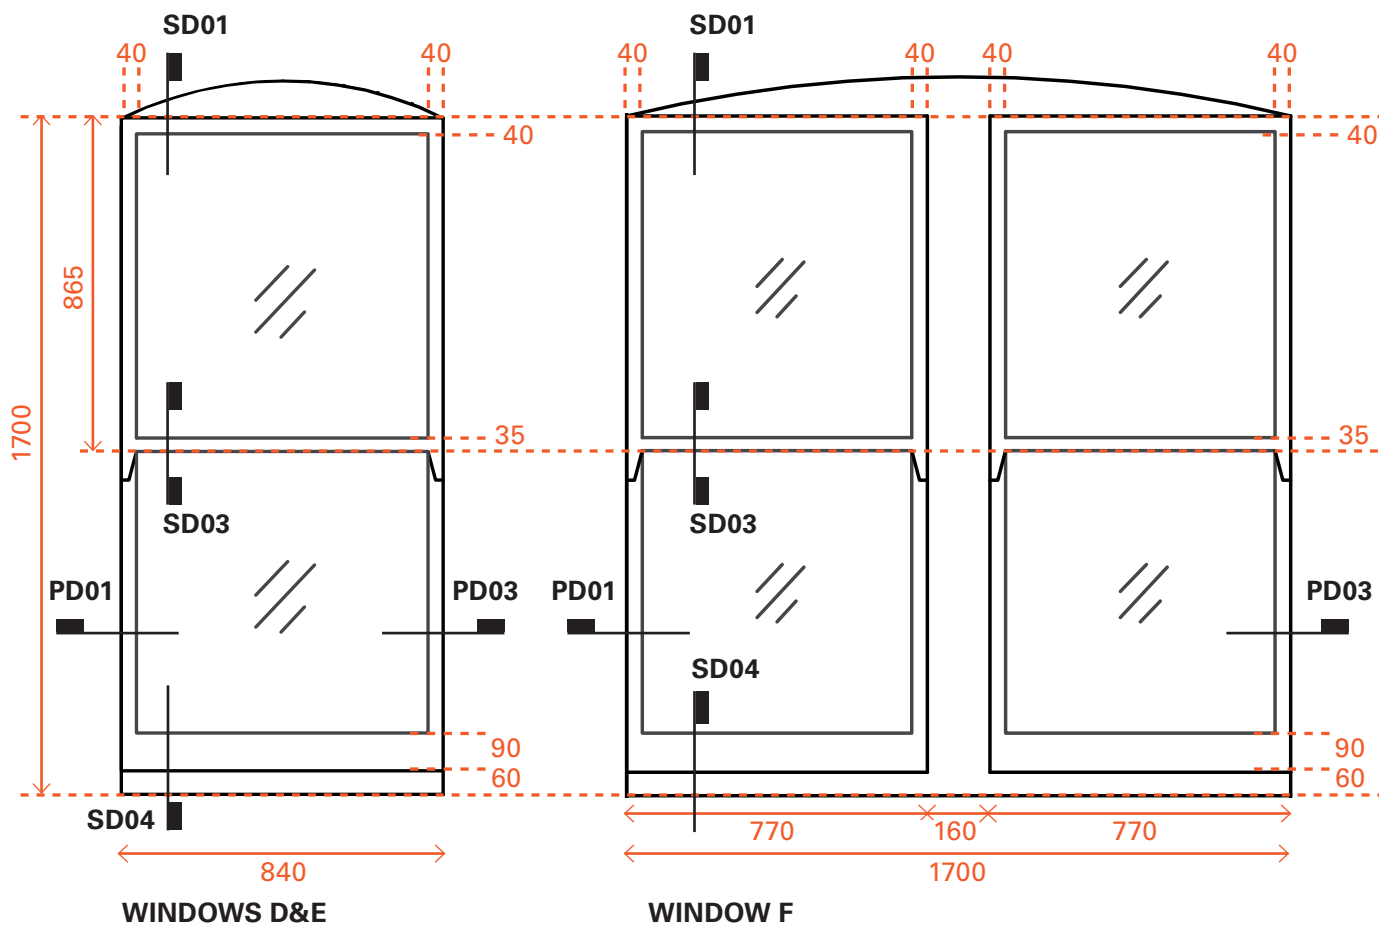
Drawing no. HEW-PL-SCH-001

All dimensions stated for the proposed windows are based on site recorded measurements of the existing windows

Window Schedule (Proposed)

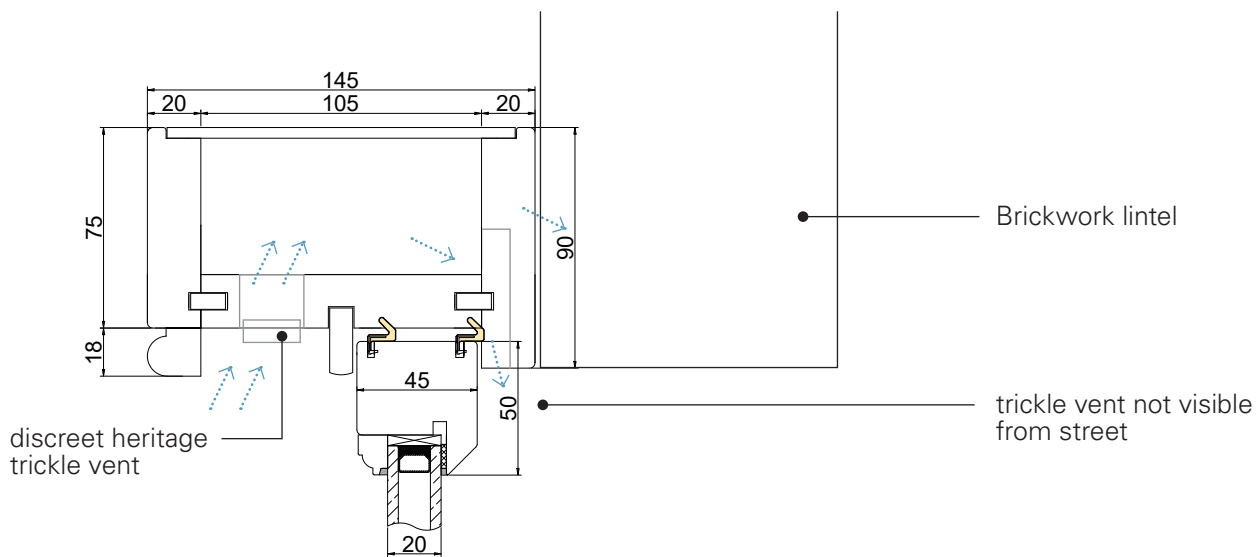
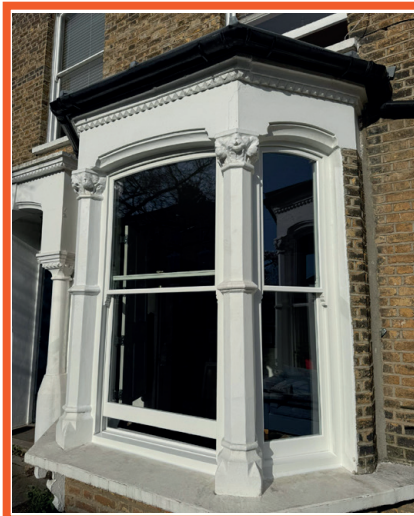
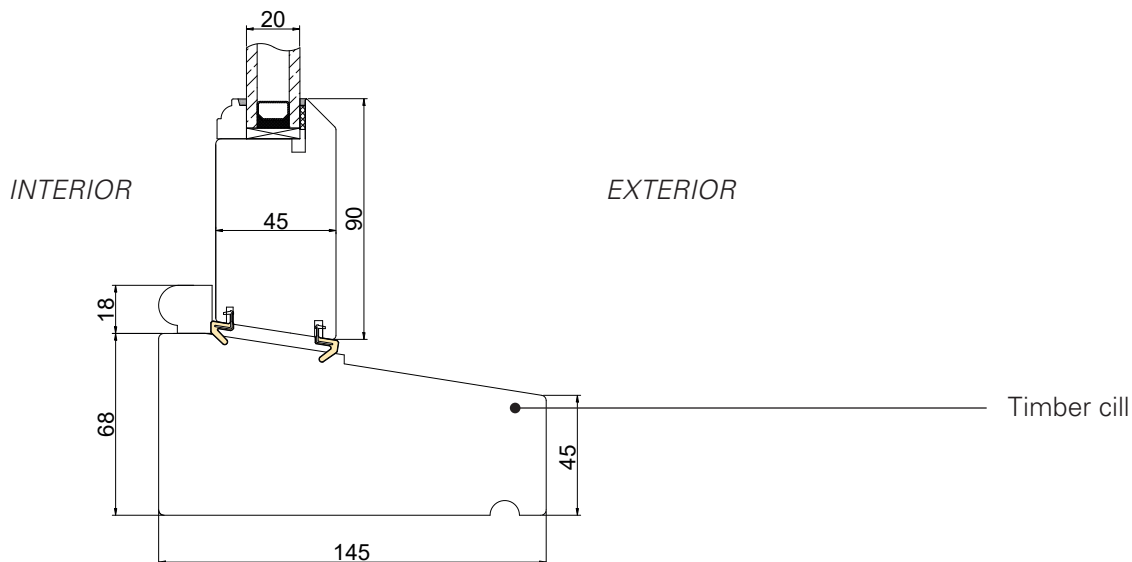
**SECTION DETAIL 01 (SD01)**

**SECTION DETAIL 02 (SD02)**

**SECTION DETAIL 03 (SD03)**

**SECTION DETAIL 04 (SD04)**

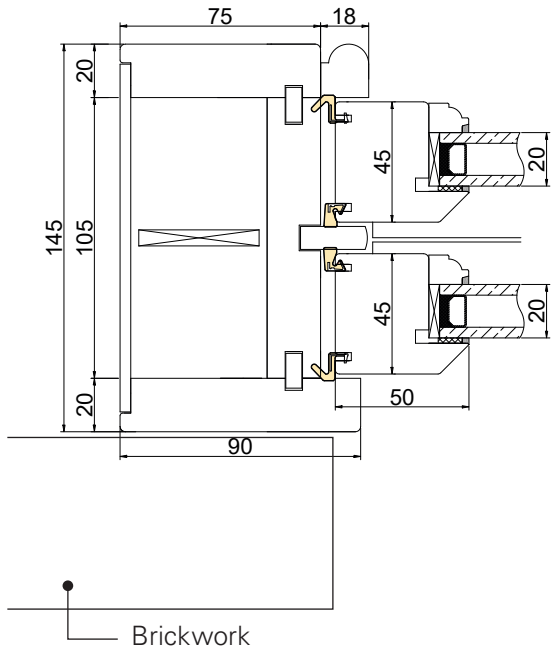
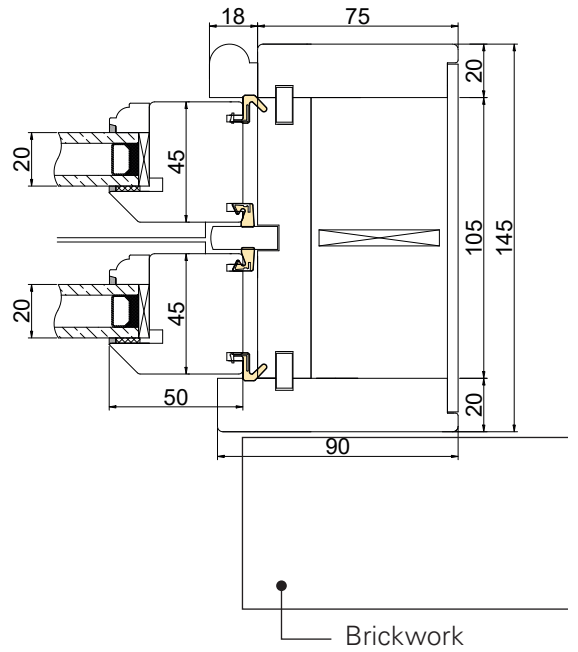
**122 Hewitt Avenue, London N22 6QE**  
Typical Window Plan Details (Proposed)  
Drawing no. HEW-PL-DET-002  
RK. Rev PL01. 17/05/2026

PLAN DETAIL 01 (PD01)

PLAN DETAIL 02 (PD02)

PLAN DETAIL 03 (PD03)

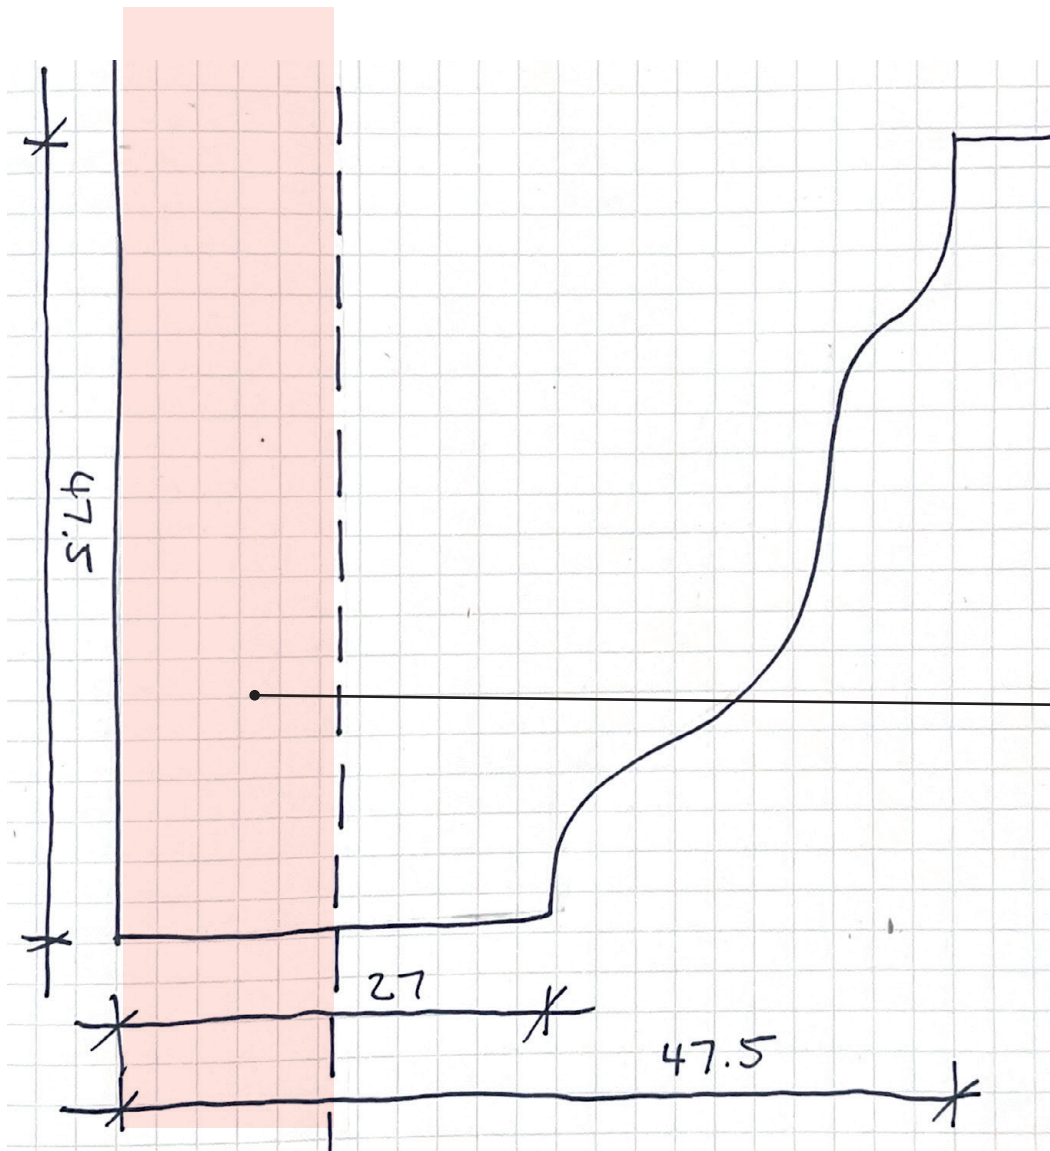
**122 Hewitt Avenue, London N22 6QE**  
 Typical Window Plan Details (Proposed)  
 Drawing no. HEW-PL-DET-003  
 RK. Rev PL01. 17/05/2026

The dimensions of the proposed sash horn match those measured on site

Area shaded is the part of the sash horn concealed behind a timber trim from view

## PROPOSED SASH HORN

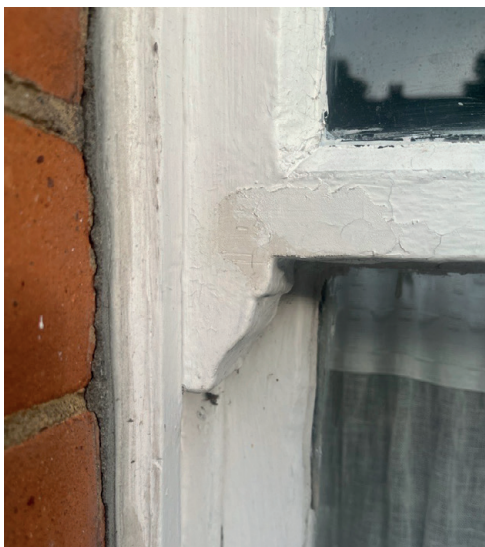
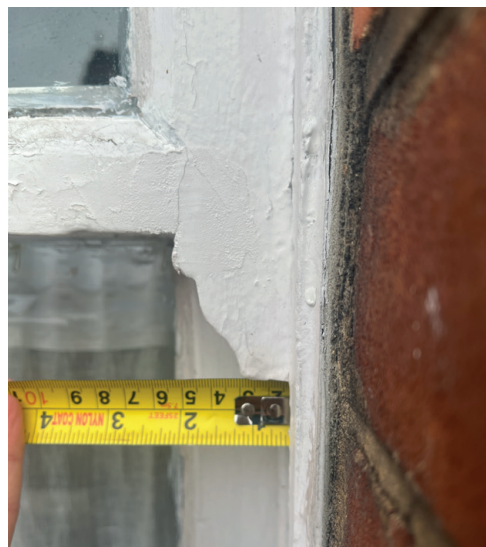
Photos of the existing sash horns to the front facade windows
