# Appendix K. Phase 1 Remediation Summary

# TECHNICAL NOTE

## NGET Former Depot, Tottenham

| Phase 1 Remediation Update | 100113407 | 27 April 2026 |

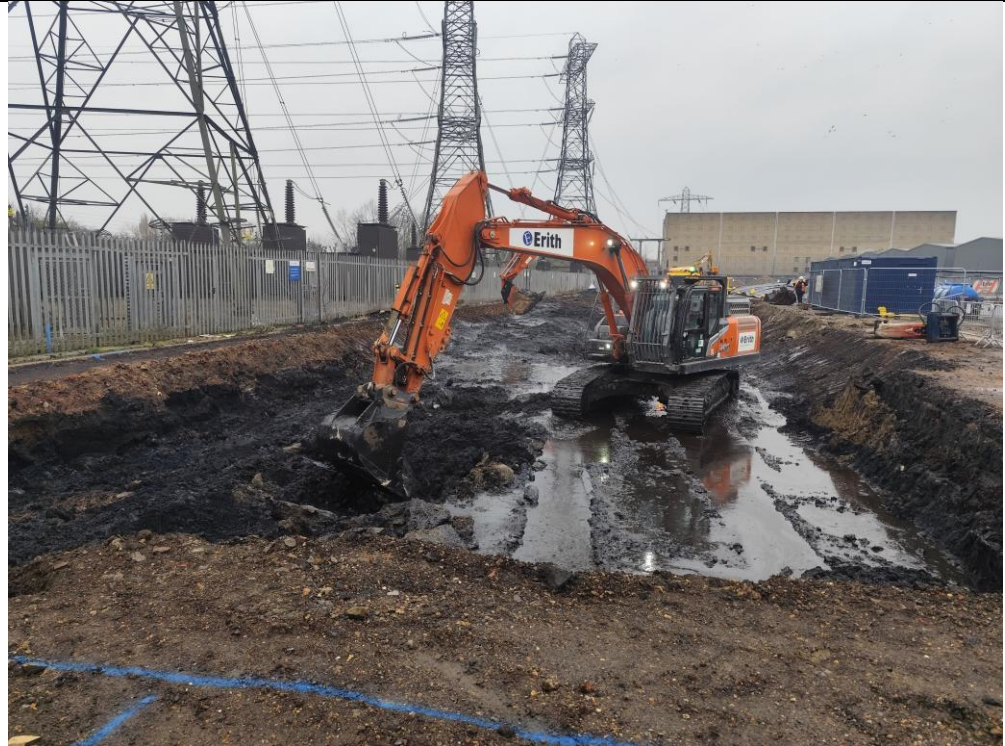
**Photo**  
**No. 1**

Phase 1 Remediation  
footprint (north):  
Northern excavation  
into hydrocarbon  
stained unsaturated  
Made Ground.

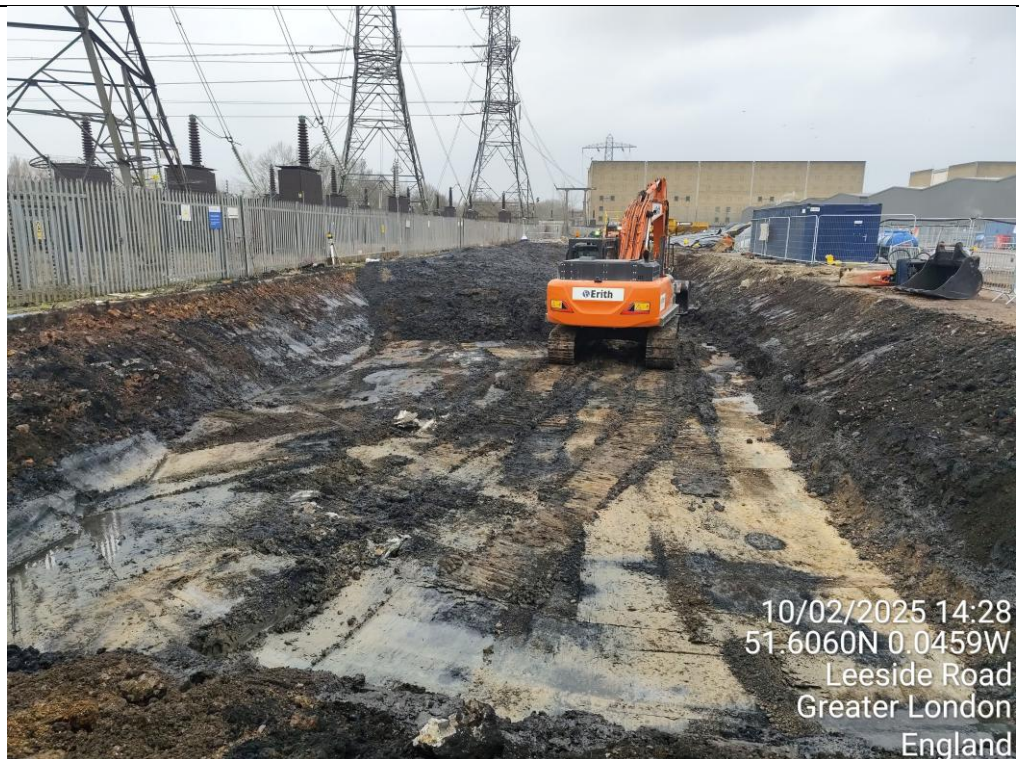
**Photo**  
**No. 2**

Phase 1 Remediation  
footprint (north):  
Clean cohesive  
superficial deposits  
(Alluvium) at base of  
excavation. Excavation  
extended to 2.0m in  
places to chase out  
gross contamination.

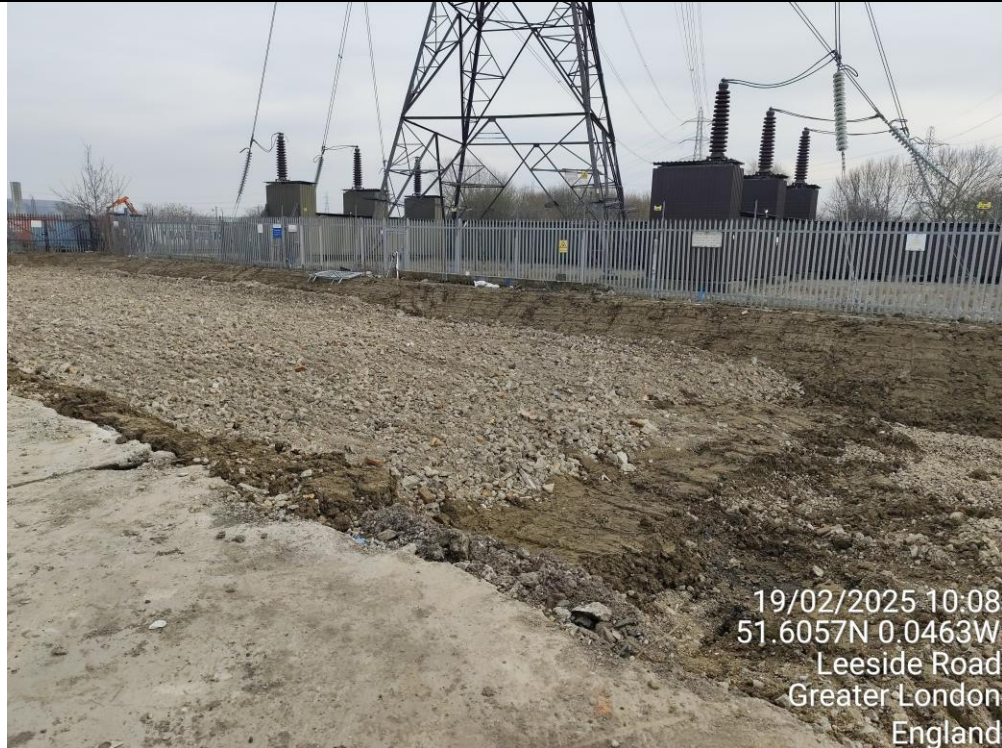
**Photo**  
**No. 3**

Phase 1 Remediation  
footprint (north):  
Northern section being  
backfilled with clean  
6F2 after validation  
sampling.

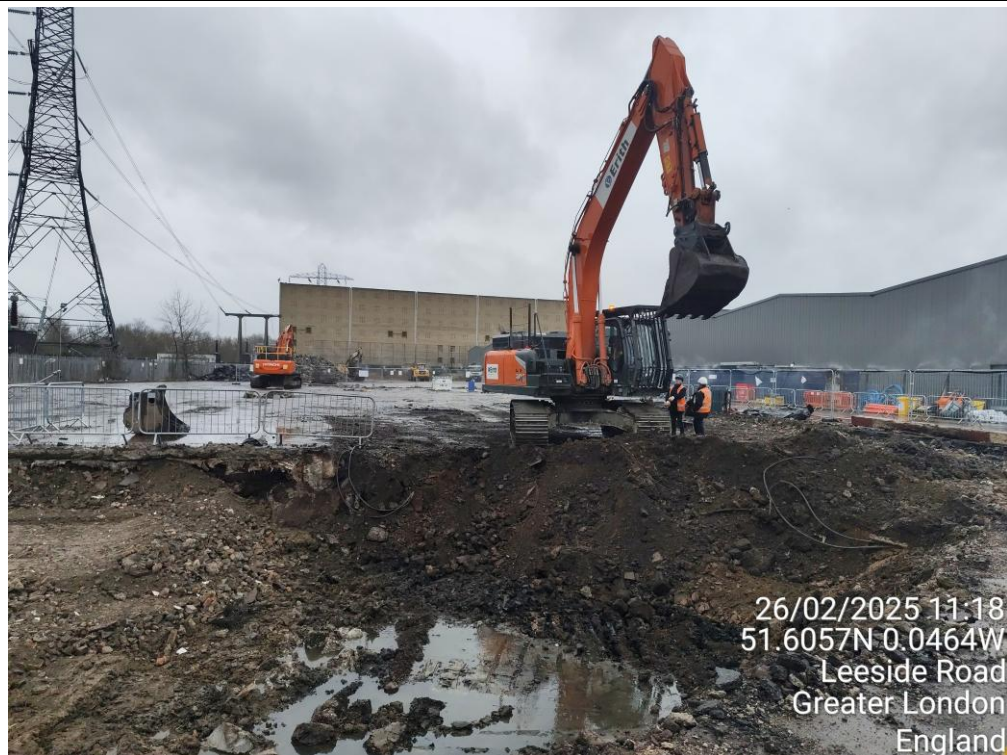
**Photo**  
**No. 4**

Phase 1 Remediation  
footprint (north):  
Central section being  
excavated.

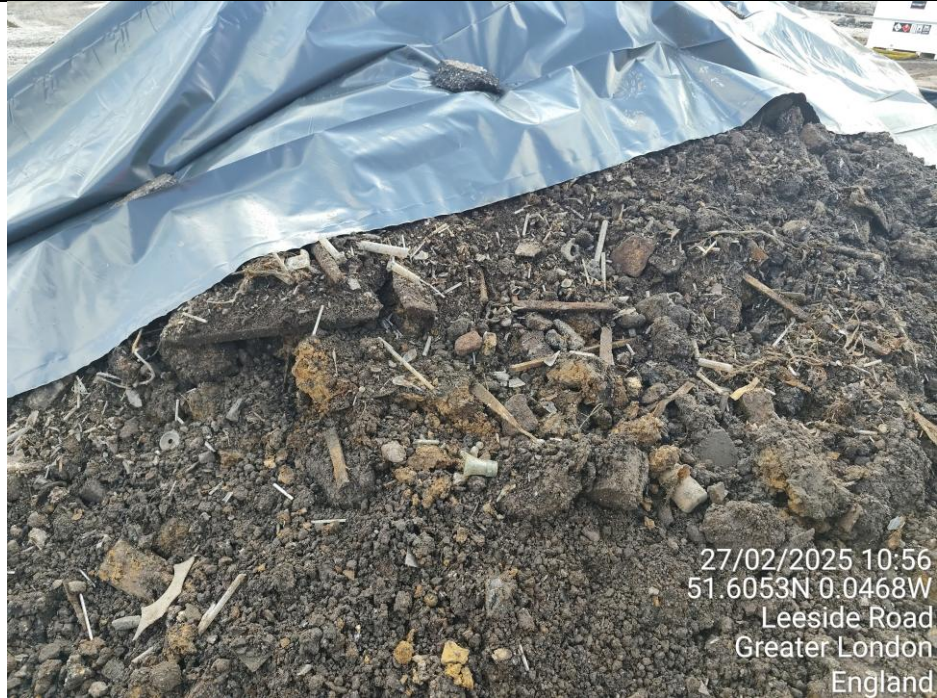
**Photo**  
No. 5

Phase 1 Remediation footprint (north): Waste soils with laboratory waste (broken conical flasks, test tubes, syringes and thermometers) encountered in the central section.

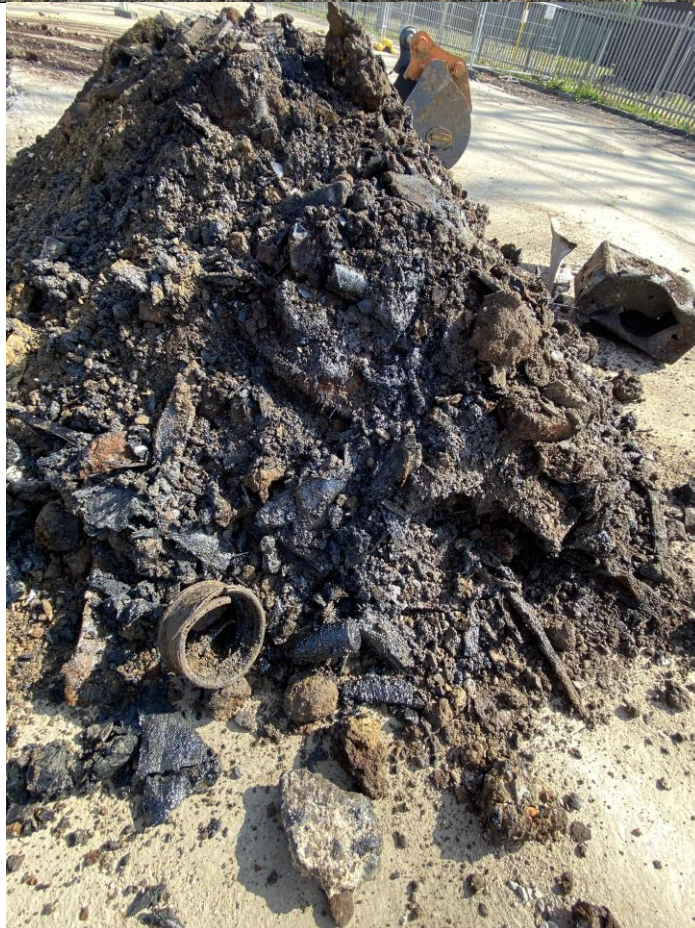
**Photo**  
No. 6

Phase 1 Remediation footprint (south): Trial trench works. Arisings from TT7 towards the east of the footprint comprising of Made Ground with tar present from 0.9 m to 1.6 m bgl.

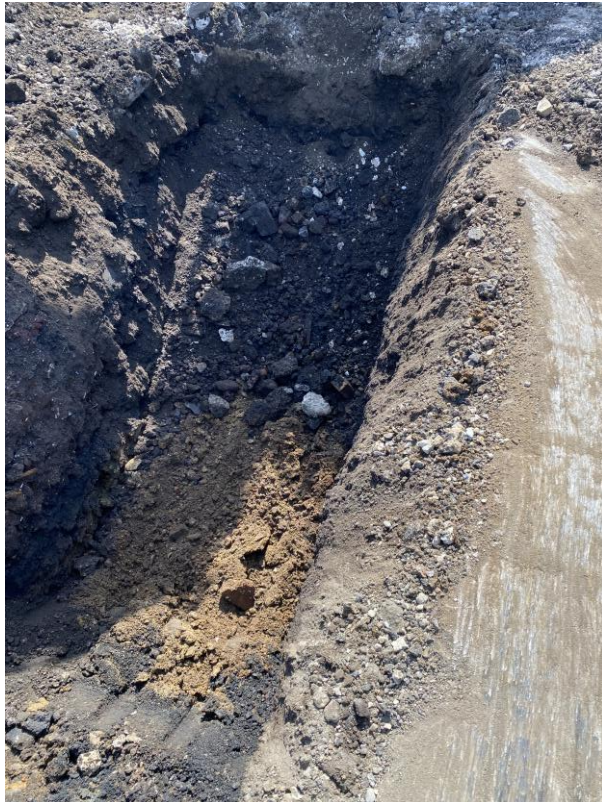
**Photo No. 7**      **Date: 24 April 2025**

Phase 1 Remediation footprint (south):  
Trial trench works. TT1 in the west of the footprint comprising of ashy Made Ground. Hydrocarbon odours were noted.

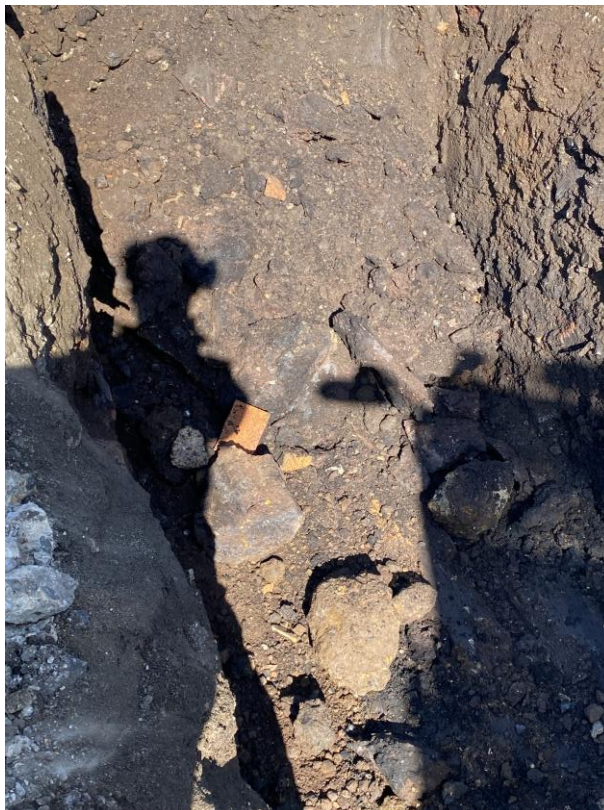
**Photo No. 8**      **Date: 24 April 2025**

Phase 1 Remediation footprint (south):  
Trial trench works. TT5 in the west of the footprint comprising of Made Ground with black staining.

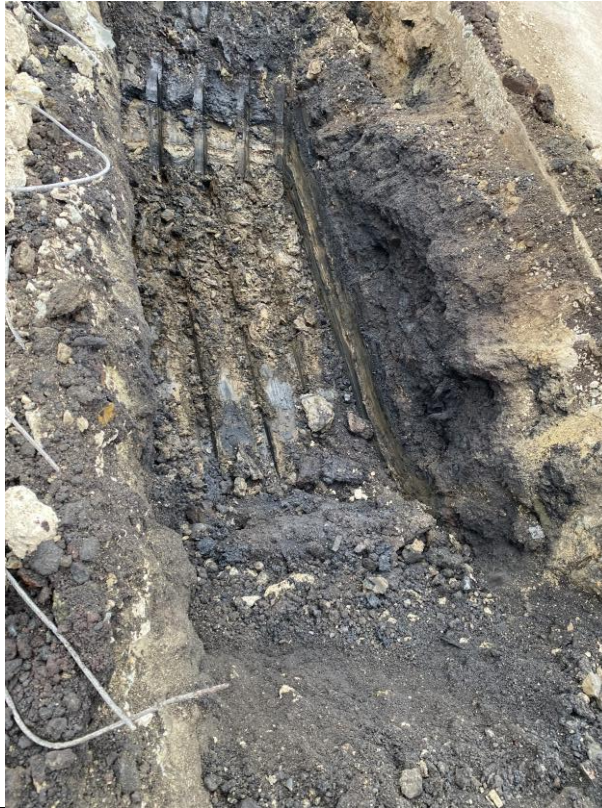
**Photo No. 9**      **Date: 24 April 2025**

Phase 1 Remediation footprint (south): Trial trench works. TT8 in the east of the footprint comprising of Made Ground with tar. The cohesive natural deposits were encountered at 1.5m bgl.

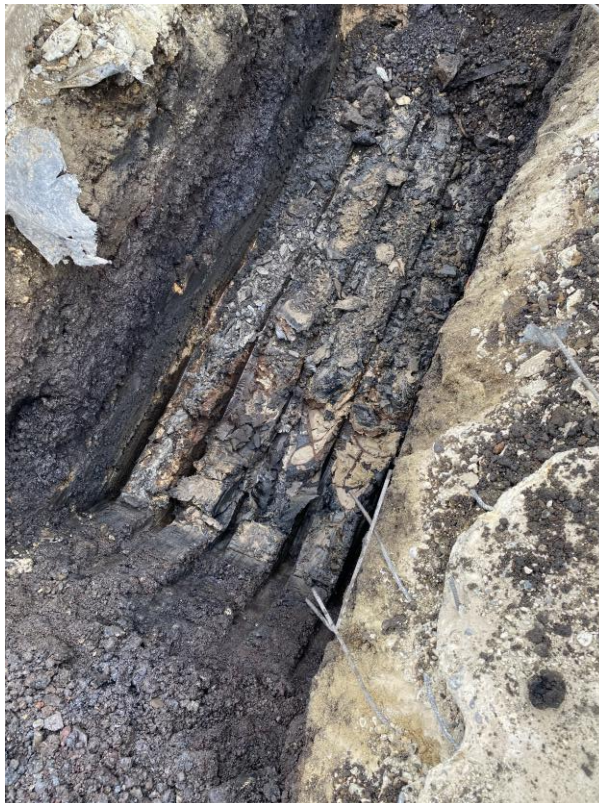
**Photo No. 10**      **Date: 6 May 2025**

Phase 1 Remediation footprint (south): Trial trench works. TT16 in the south east of the footprint comprising of Made Ground with tar present from 1.7 to 1.9 m bgl. Soils had a very strong hydrocarbon odour from 1.4 m to 1.9 m bgl.

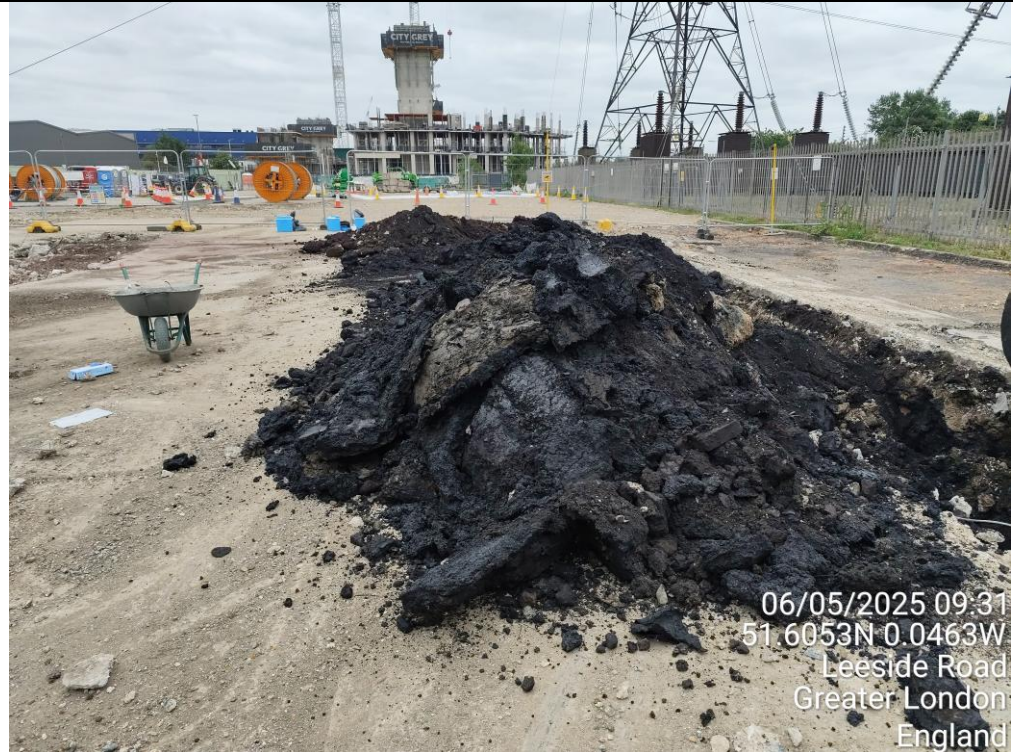
**Photo No. 11**      **Date:** 6 May 2025

Phase 1 Remediation footprint (south):  
Trial trench works.  
Arisings impacted with tar from TT16 in the south east of the footprint.

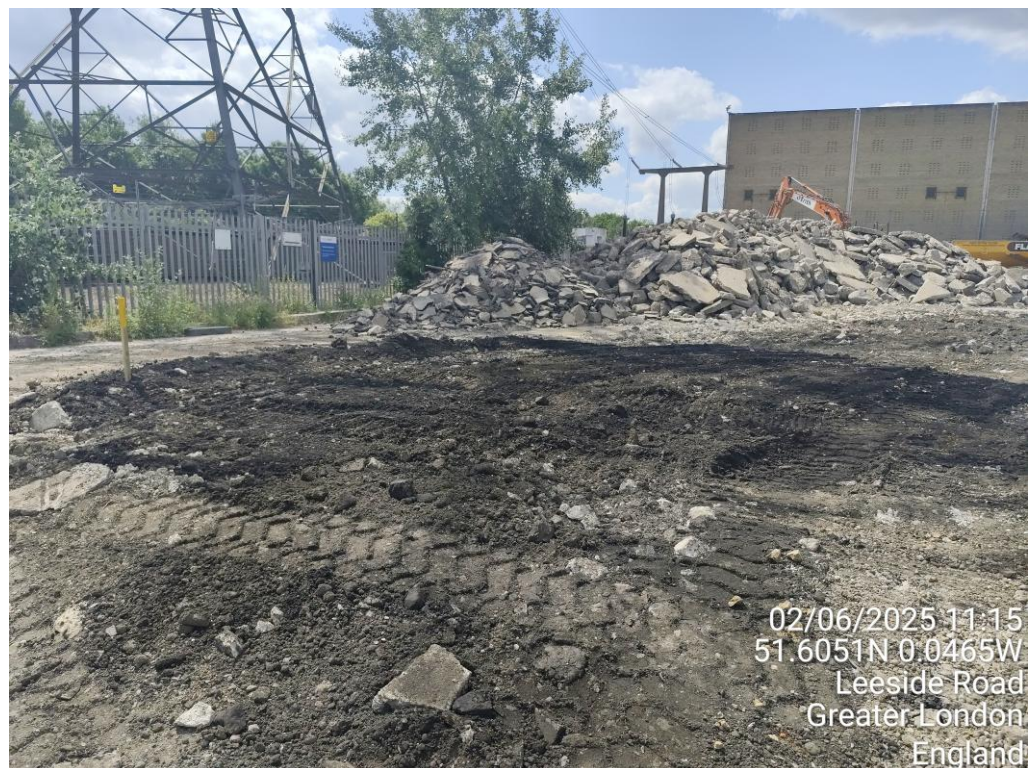
**Photo No. 12**      **Date:** 2 June 2025

Pylon footprint:  
Breaking out the concrete of the footprint.

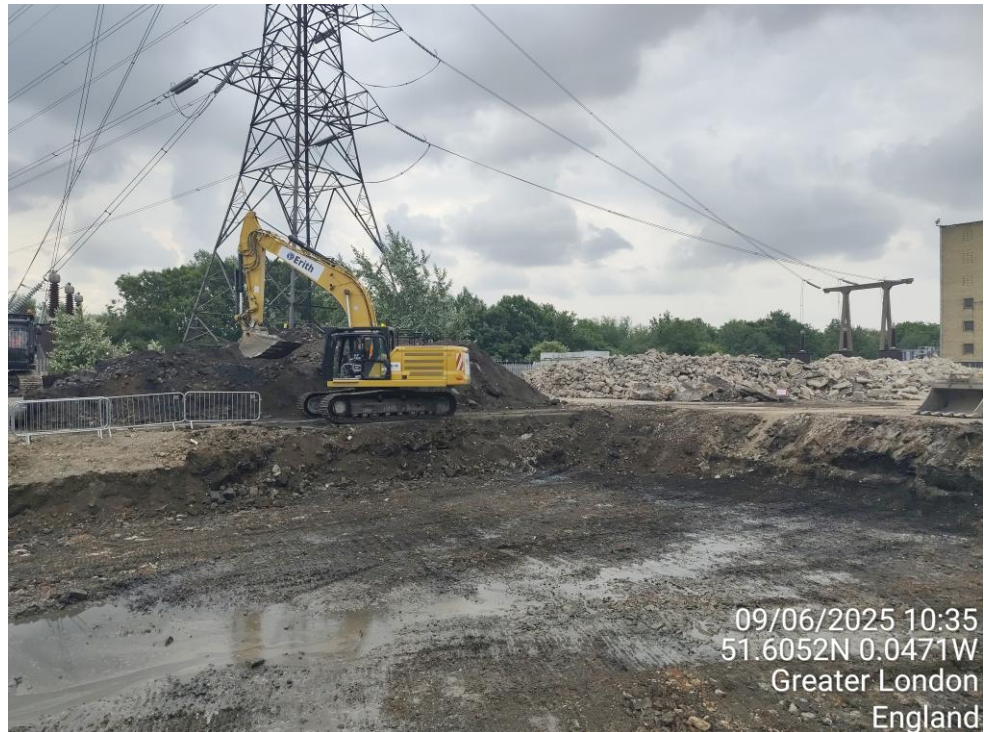
**Photo No.**  
13

**Pylon footprint:**  
Formation level at 1.7 m bgl. Lower levels of hydrocarbon impact and were observed in this area. Tar was not encountered during the excavation.

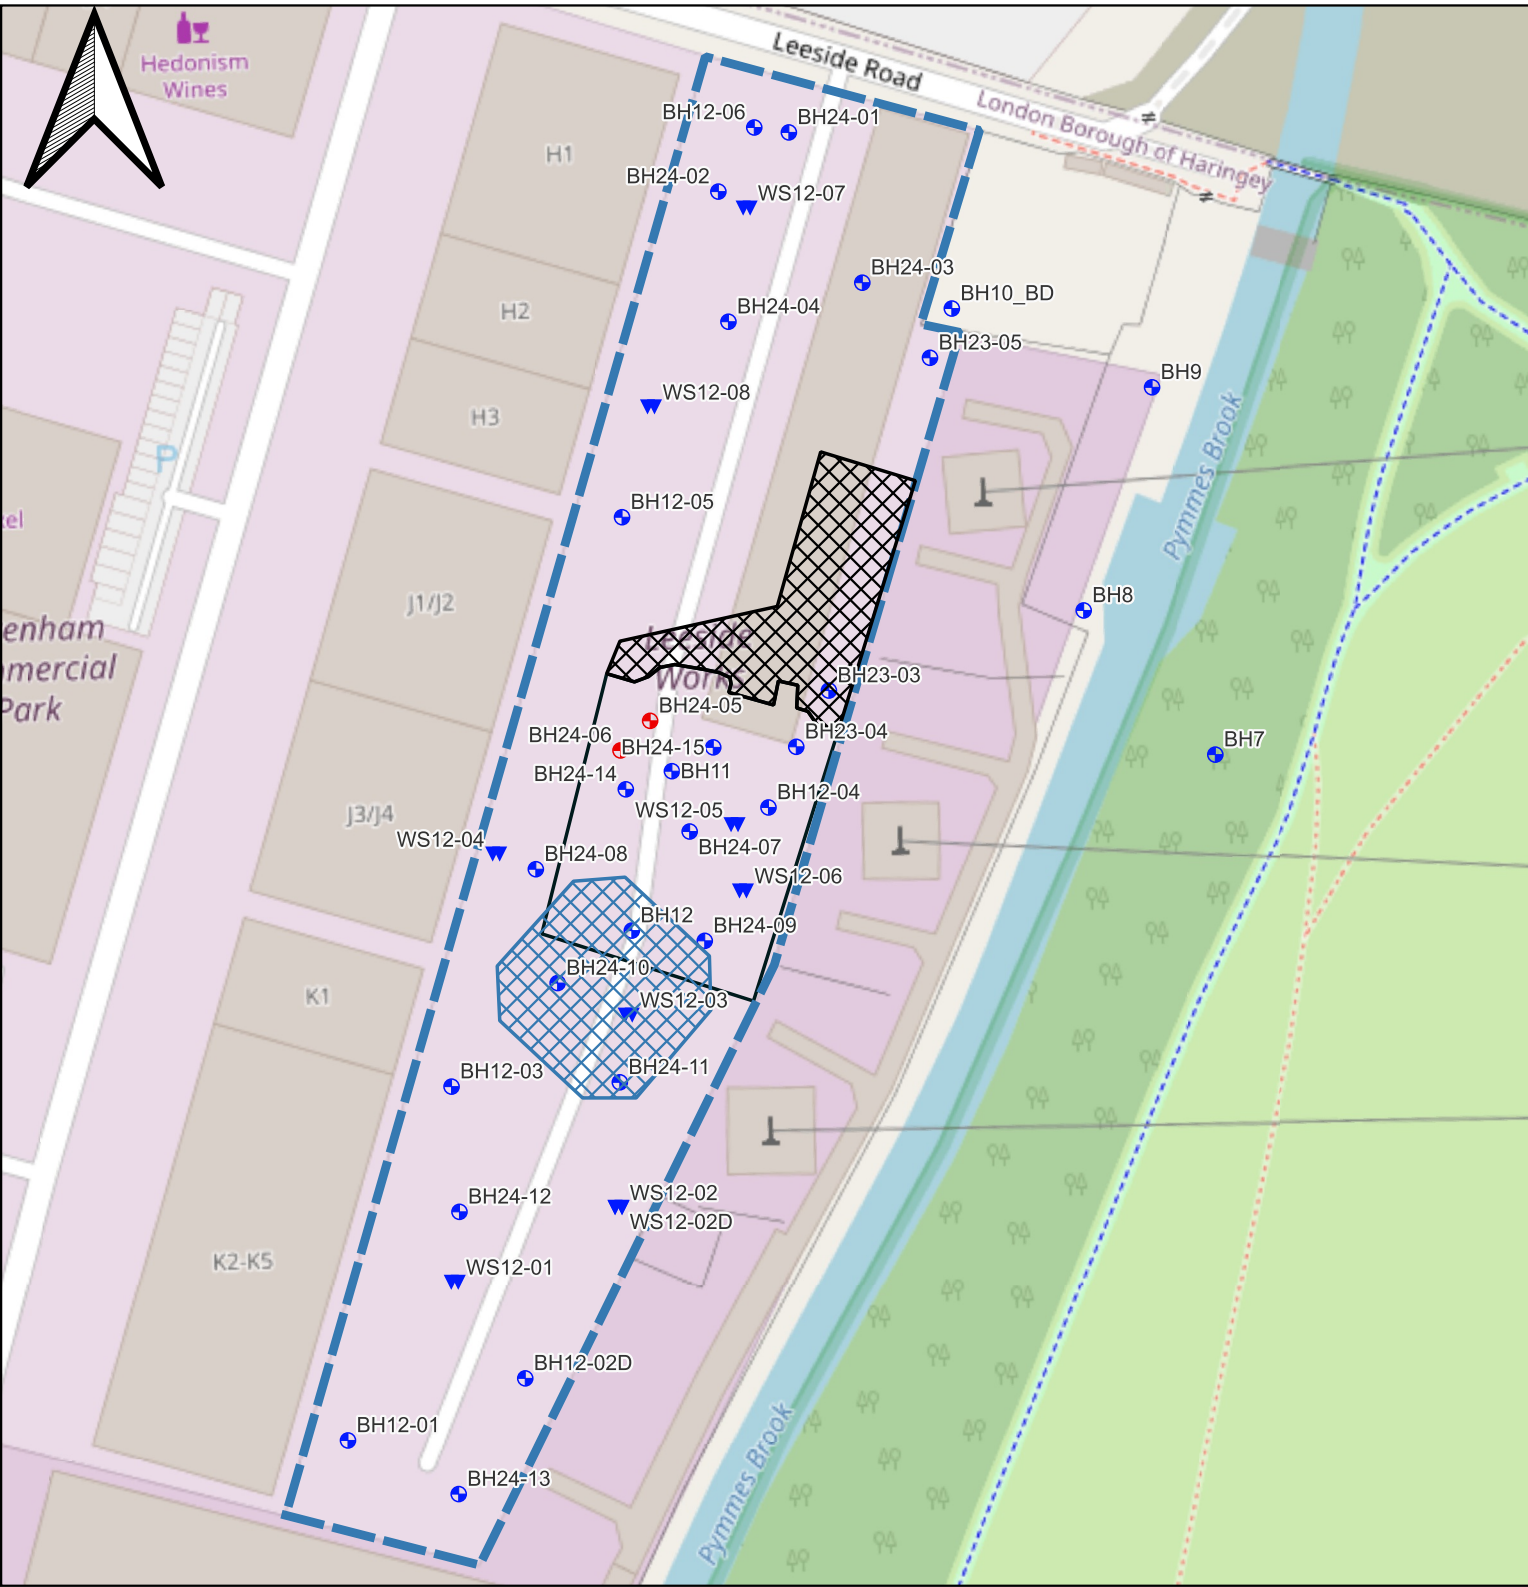
Drawing Title  
Figure 1:  
Phase 1 Remediation Areas

At this stage, NGET saw an opportunity to maximise efficiencies on site, and Erith were instructed to excavate soils within the footprint of the proposed pylon. This was seen to be beneficial to the future construction programme for the pylon. This area is shown on Figure 1, in the south of the Phase 1 remediation trench extending southward. The same design and principles contained within the Remediation Strategy [1] were applied. The excavation was extended to 1.7 m bgl and perched water was encountered that prevented further excavation in this area. A total volume of around 1,750 m<sup>3</sup> was excavated and the final excavation levels are shown on Erith's excavation plan, provided in Appendix A. Validation samples are provided in the Phase 1 Remediation Validation report, that will be provided under a separate cover.

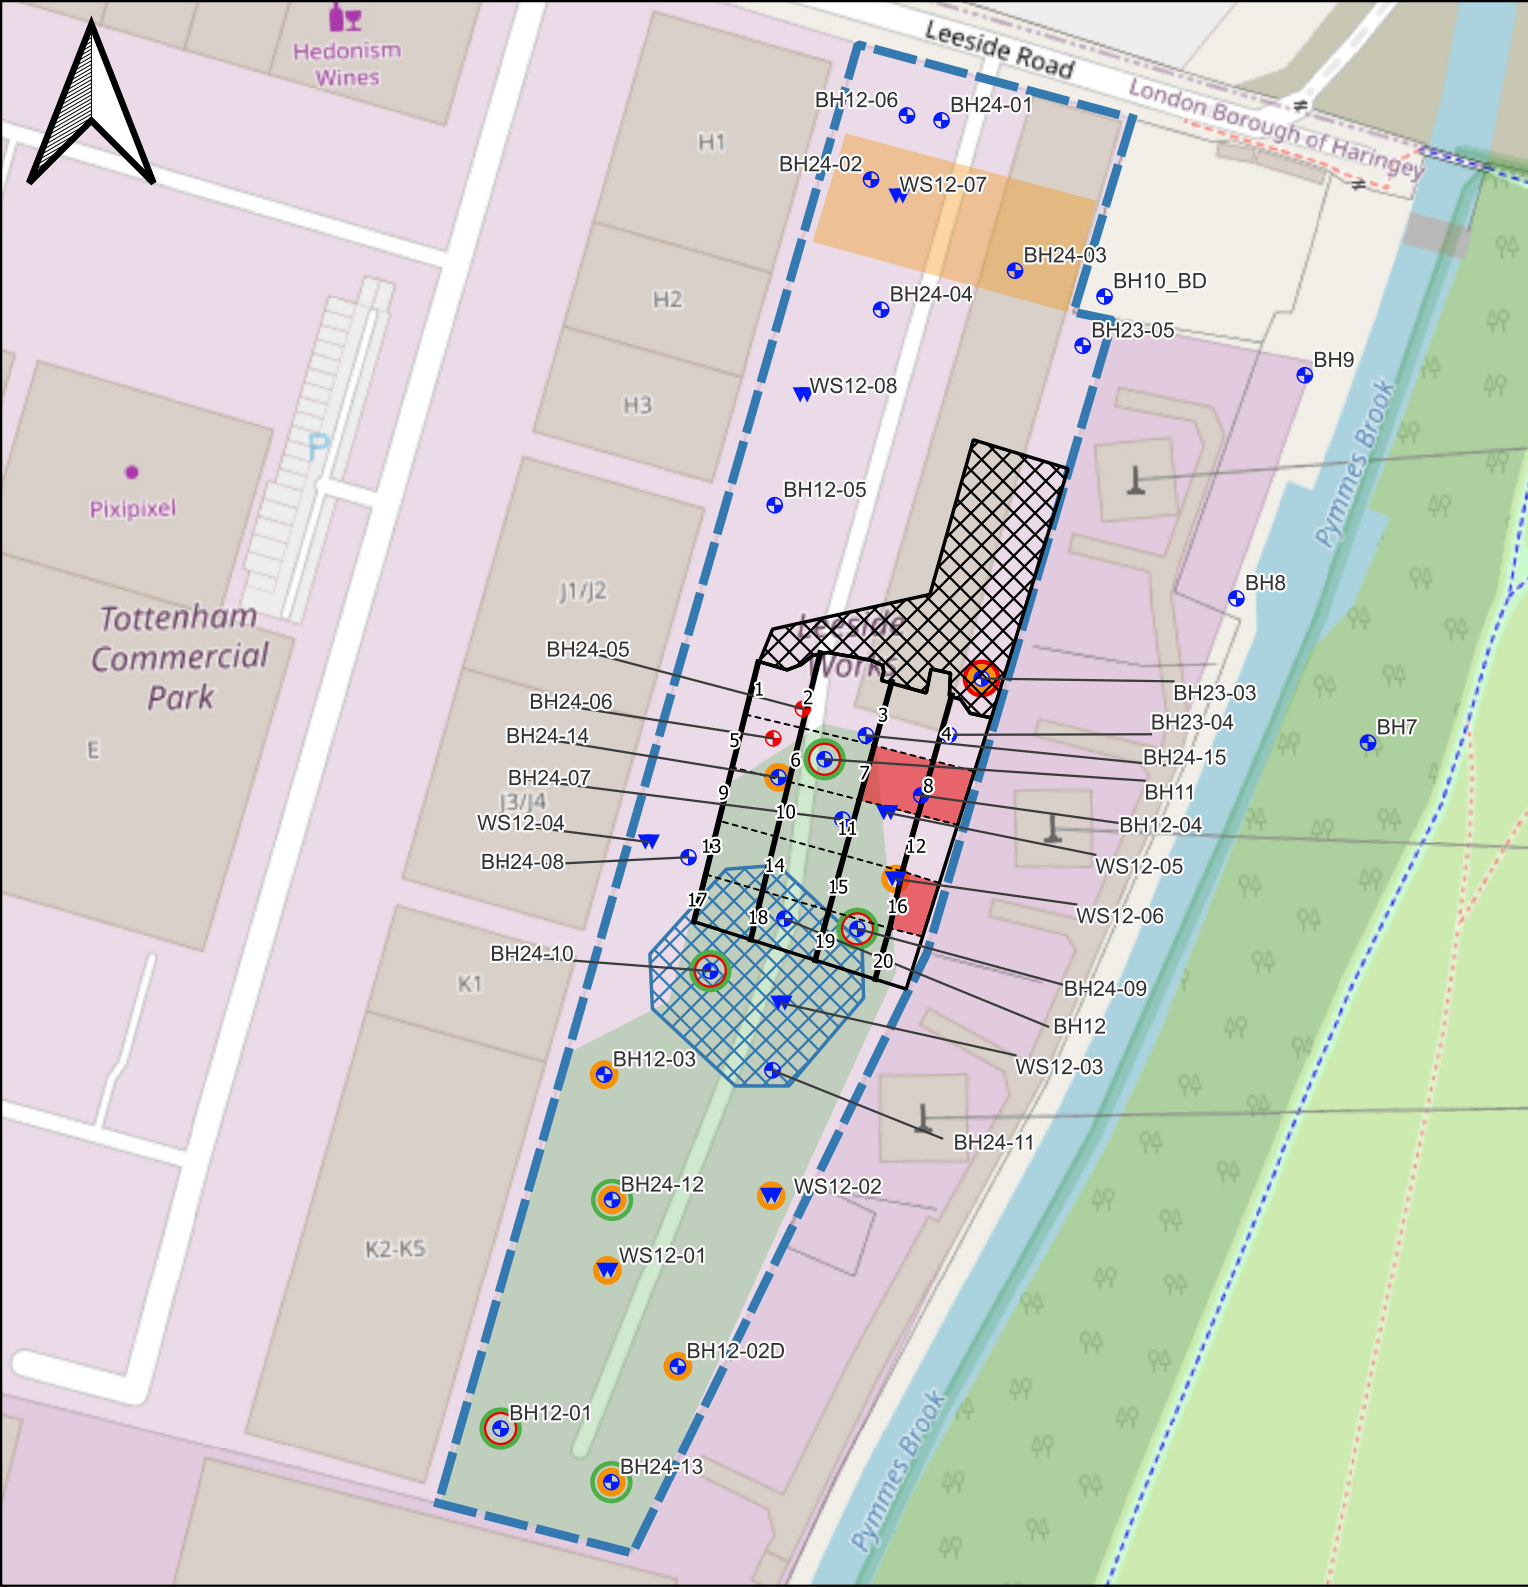
Figure 2:  
Phase 2 Remediation - Outline Proposals

During the pause in works, the remediation contractor (Erith) utilised the time on site to excavate trial trenches on a 10 m grid across the remaining southern area of the footprint for waste soils classification purposes, to inform the disposal route. These are shown on Figure 2 and on Erith's trial pit plan, included in Appendix A. Erith completed these works in line with a Sampling Plan for Waste Classification and Assessment as set out by the Environment Agency's WM3 [5].

Two areas of grossly contaminated soils were encountered in the very east of the footprint evidenced by the presence of visual tar, and very strong hydrocarbon odours. These areas are shown on Figure 2. One of these corresponds with an area where NAPL was encountered in the Made Ground as part of previous investigations [2], [3] and a possible tank. These trial trenches are presented in the photolog in Appendix B. Based on visual and olfactory evidence only, the trial trench exercise indicated soils were contaminated across the remainder of the footprint but to a far lesser extent, evidenced by a reduced appearance of tarry residues and hydrocarbon odours.

Areas of gross contamination identified in the unsaturated zone, within the remainder of the Phase 1 remediation footprint (as shown on Figure 2) shall be mitigated as part of the Phase 2 remediation. Information on this shall be provided in the Phase 2 Remediation Detailed Design, that shall be prepared under a separate cover and submitted to the regulators as part of the DCO process.

- Two areas of gross contamination in the east of the former Phase 1 remediation footprint, identified as part of the trial trenching exercise, shall be excavated as part of the Phase 2 remediation. Gross contamination shall be chased out laterally and with depth. NAPL shall be removed, where encountered. These indicative areas are shown on Figure 2.
- Following a comprehensive review of all site data as part of a detailed quantitative risk assessment [6] and remediation options appraisal in 2025 [7], no additional exceedances of the accepted risk based criteria have been identified in the remainder of the Phase 1 footprint. This is also confirmed by visual and olfactory observations from the Phase 1 trial trenching exercise where residual 'gross contamination' was not considered to be present. On this basis, no further remediation within the Phase 1 remediation footprint is recommended
