# 6A GRANGE ROAD, LONDON

Basement Impact Assessment

Revision K

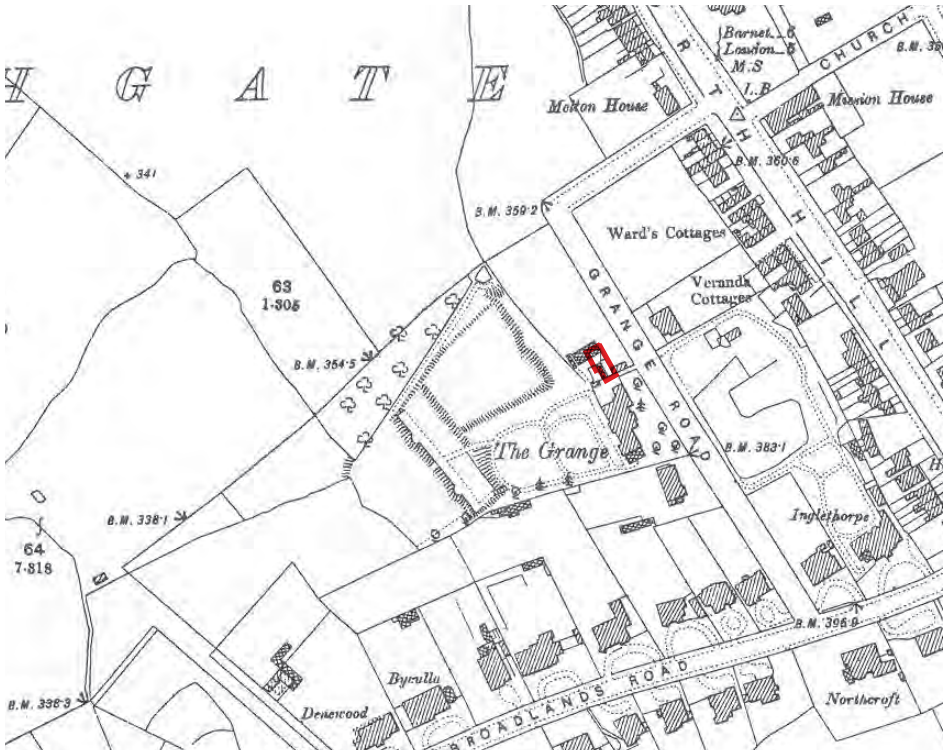
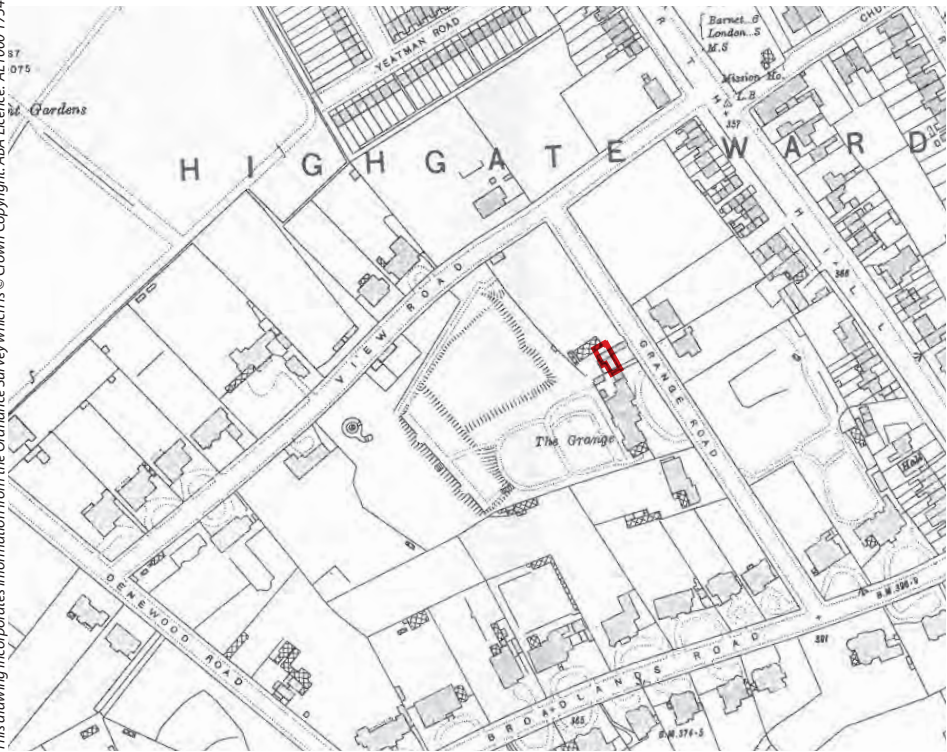
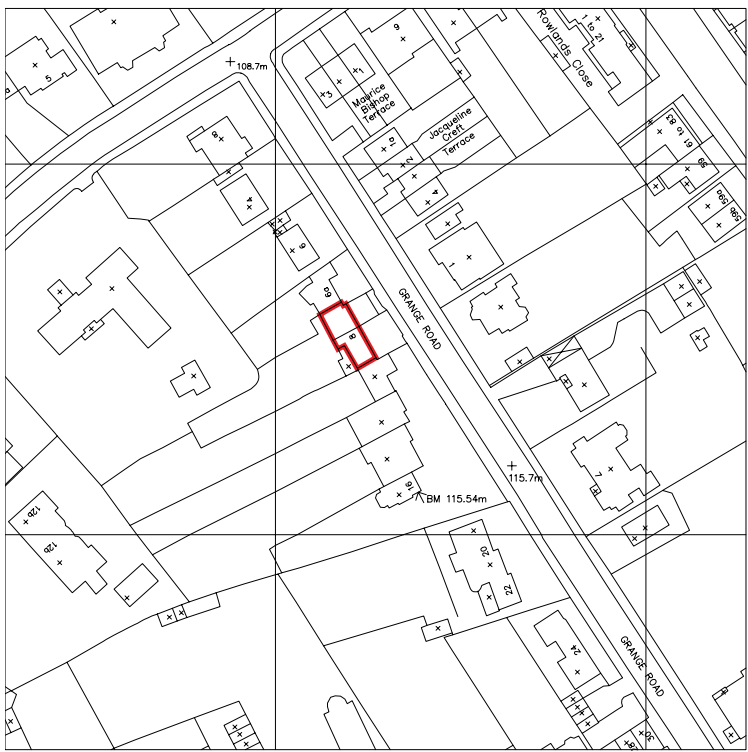
| 8 GRANGE ROAD, HIGHGATE | |
|---|---|
| 1675/100/001 | |

1869  
The site sits within the vicinity of North Hill, located West of North Road which is already relatively established with small-medium scale residential developments. Generally larger houses are situated away from North Hill and Archway Road, within the fields that make up the majority of the surrounding area. The site is undeveloped.

1894  
There has been some medium density development to the area around the site, including the formation of Grange Road. A notable house, The Grange, has been constructed to the West of the road, reportedly under the direction of architect John Groom. The original section of 8 Grange Road is understood to have comprised the gardeners cottage of this estate.

1913  
Widespread development of the surrounding area has taken place, notably the formation of Derewood Road and View Road to the West and North of the site respectively. The Grange appears to remain in place as a single property although it is likely that remodelling works were carried out with the development of other houses along Grange Road.

2010  
The Grange is no longer a single property and appears to have been divided into separate residences between No. 8 to No. 16. No. 8 has been extended to the North and West and now shares a party wall with No. 6a. Extensive refurbishment works are also taking place at No. 10, including front and rear extensions. A number of buildings along Grange Road are understood to have basement levels.

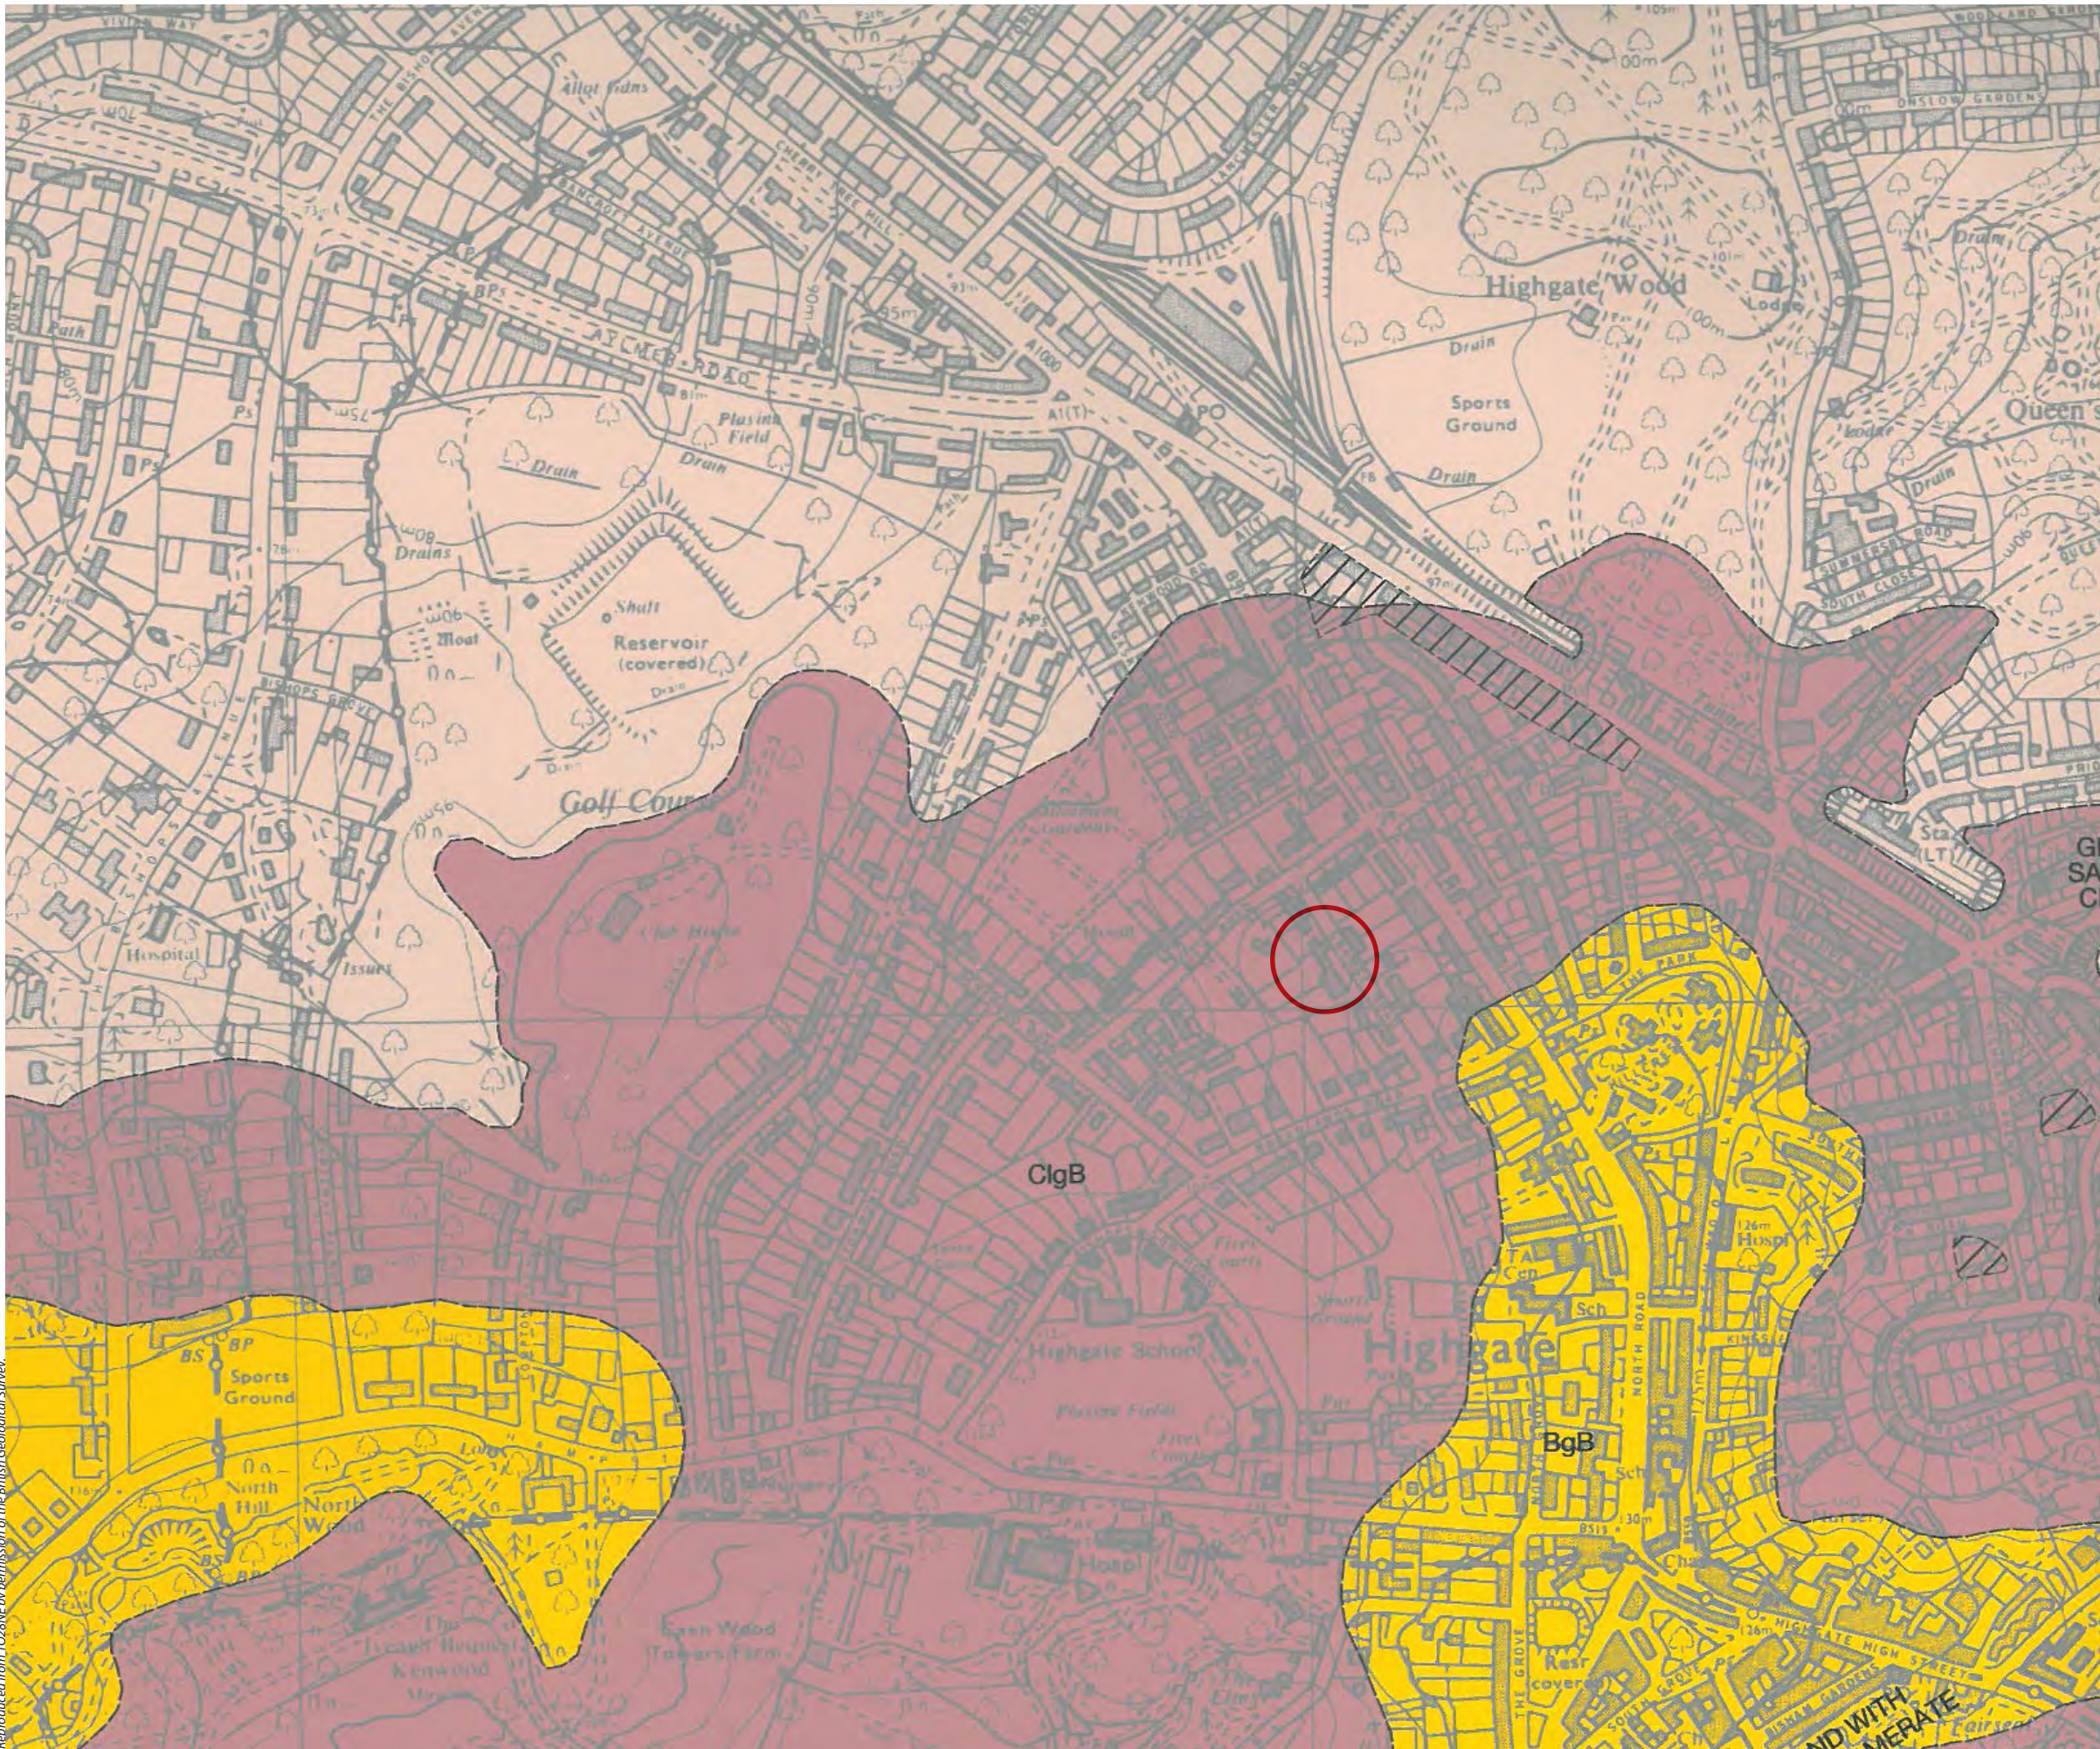
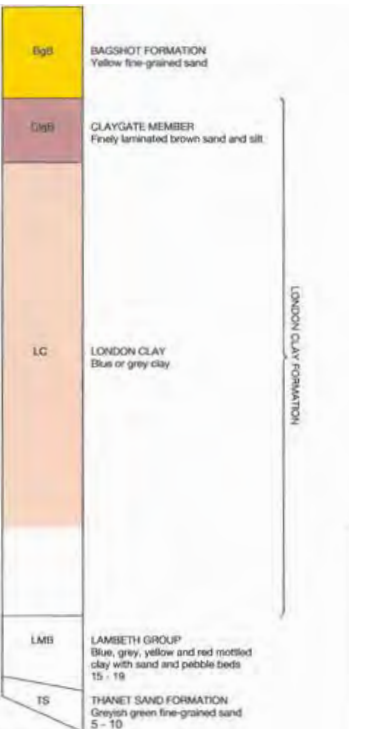
**LOCAL GEOLOGY AND GROUND CONDITIONS**

1. This drawing is to be read in conjunction with all other relevant architects and engineers drawings
2. The information on this drawing is taken from the 1890 British Geological Survey map TQ28NE. Reproduced by permission of the British Geological Survey.

Information on the BGS borehole logs available in the area have also been reviewed and are summarised on drawing 1675/100/003. This shows the geological profiles roughly following the topography, with the Claygate Beds thinning as the ground levels decrease to the North. The Bagshot Sand formation is generally found at higher elevations (to the South) and not present near the site.
