# North London Cricket Club, 13 Montenotte Road, London, N8 8RL

## Bat Report

Report Ref: 14236.BatReport.vf

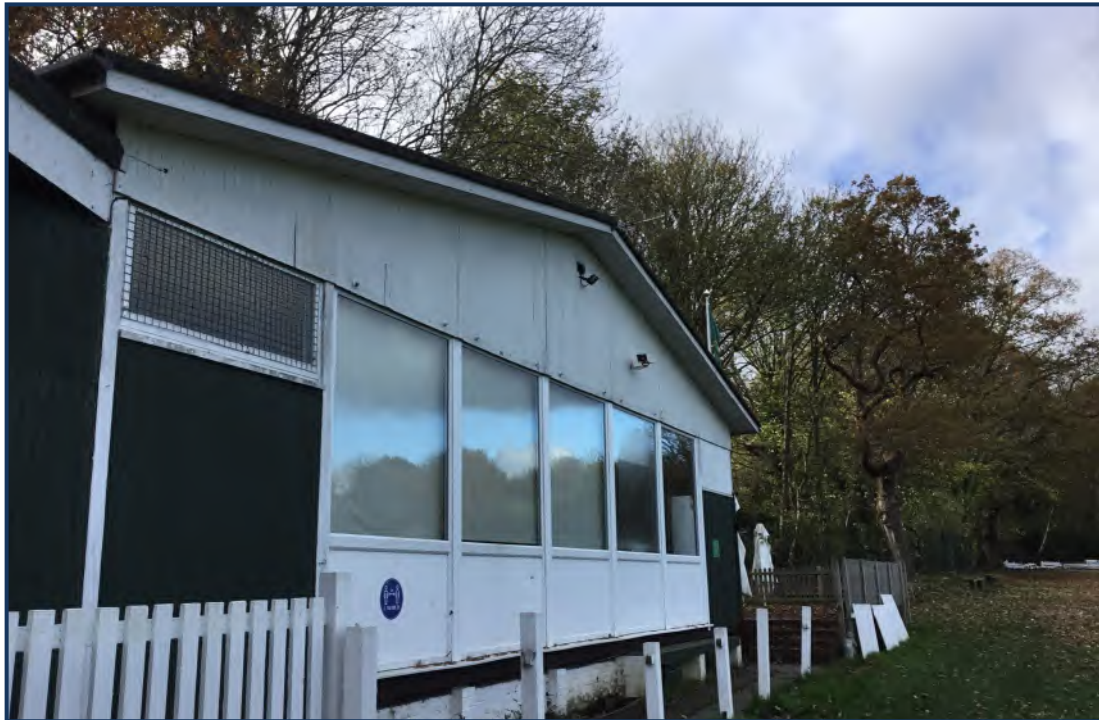
PHOTOGRAPH 1: Building B1 - Northern Elevation

- 4.1.3. Building B1 is located within the southern edge of the site (see Photograph 1). The building acts as a bar and social area for the cricket club. The building is a timber frame from the 1970s with a gable roof. The building has wooden cladding over the gable ends and cladding sides, the roof is slightly pitched covered with bitumen felt. There are windows around all elevations of the building, particularly the northern elevations. To the west, there is a concrete extension to the building which is used as a cellar/storeroom for the bar (see Photograph 3).

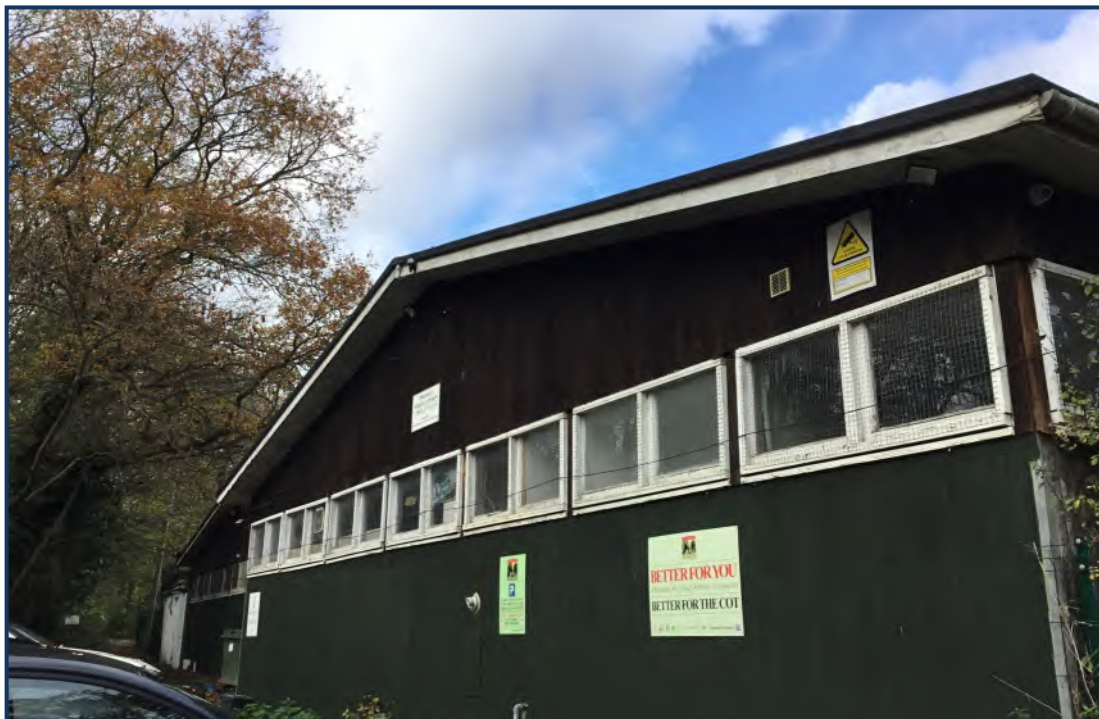
PHOTOGRAPH 2: Building B2 - Southern Elevation

- 4.1.4. Building B2 of similar construction is directly adjacent and eastward of building B1 along the southern edge of the site (see Photograph 2). The building serves as changing rooms and shower facilities for the club. The building has a raised wooden veranda on the northern elevation (see Photograph 4). The building has wooden cladding over the gable ends and cladding sides, and the roof is covered with bitumen felt. There are windows around all elevations of the building (see Photograph 5). There is an outdoor corridor separating B1 and B2 in the centre with a flat roof and gated entrance.

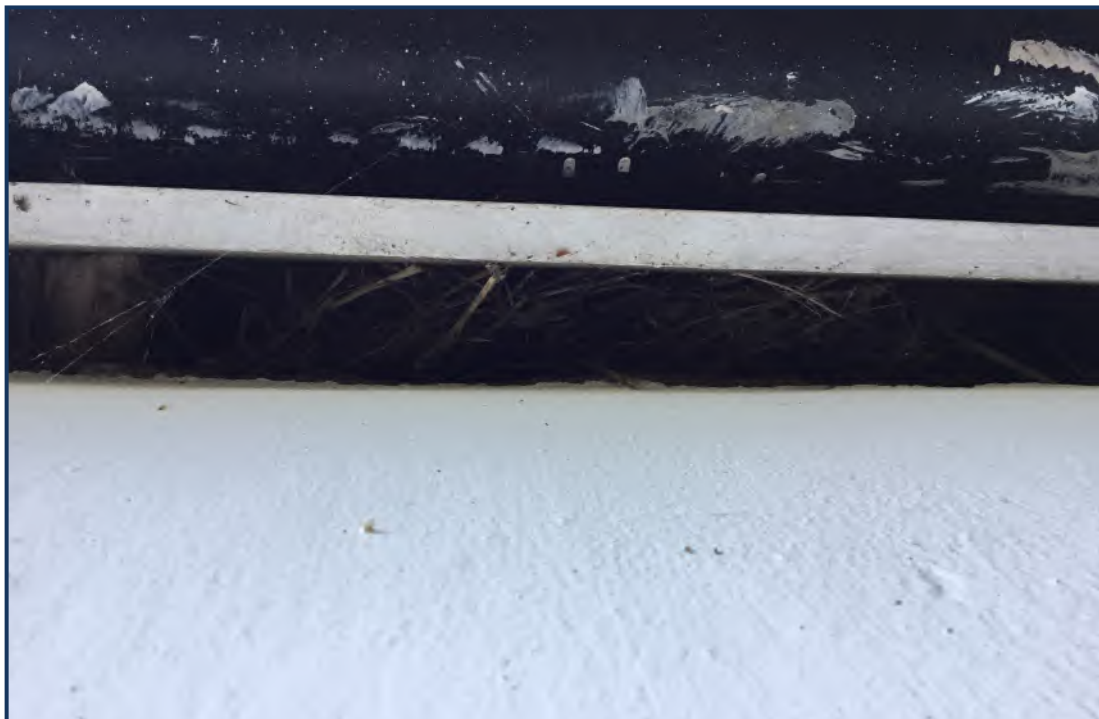
PHOTOGRAPH 6: Building B1 - Gap in Barge Board

| Building Reference | Potential Roosting Feature | Photograph Ref. | Overall Suitability |
|---|---|---|---|
| B1 | Gap between barge board and wall of storage area | P6 | Moderate |

- 6.3.5. Where possible and safe to do so, a licenced ecologist will check identified PRFs with an endoscope prior to demolition.
- 6.3.6. New roost provisions in the form bat boxes (see Appendix 1) will be installed within the wider site ownership on retained trees prior to any work to serve as a suitable site to deposit bats, should they be found during the process, as well as ensuring that future roost opportunities shall be provided post-demolition. The boxes shall be retained in-perpetuity. Wall-mounted bat boxes (see Appendix 2) should also be considered affixed to the new facade of the pavilion to provide further roosting opportunities for bats.

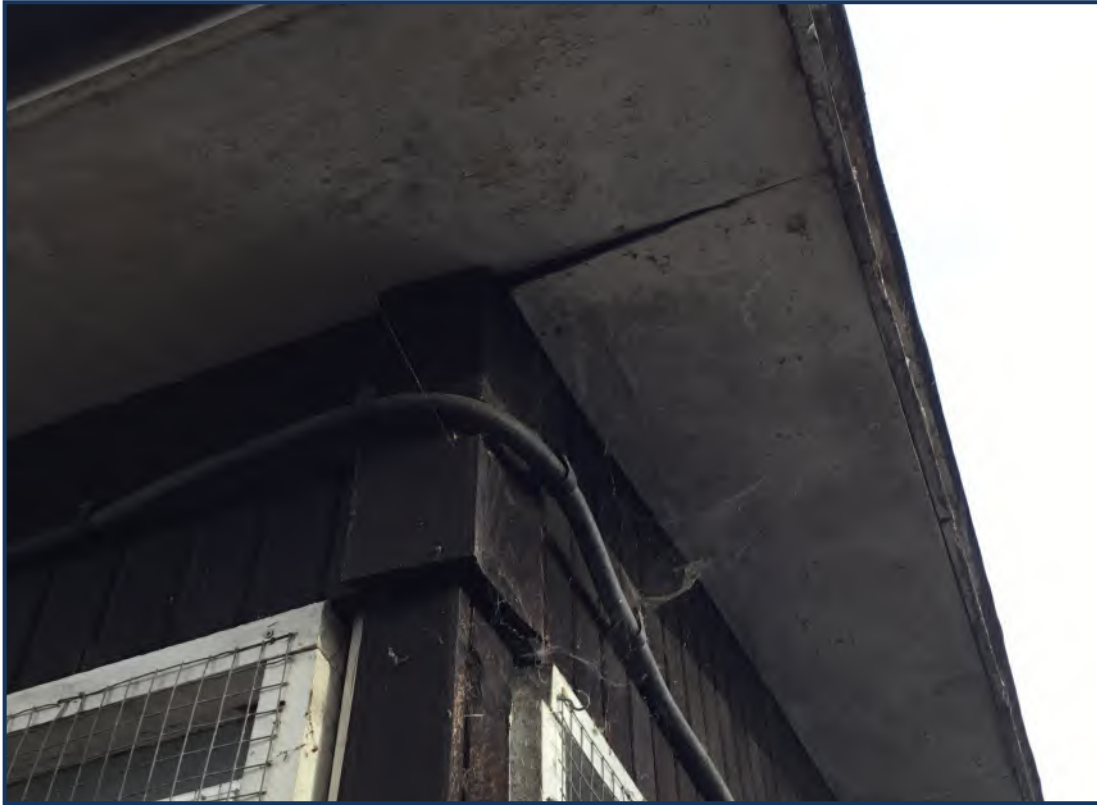
PHOTOGRAPH 7: Building B1 - Gap in Soffit Board

| Building Reference | Potential Roosting Feature | Photograph Ref. | Overall Suitability |
|---|---|---|---|
| | Cracks in soffit board above window | P7 | |

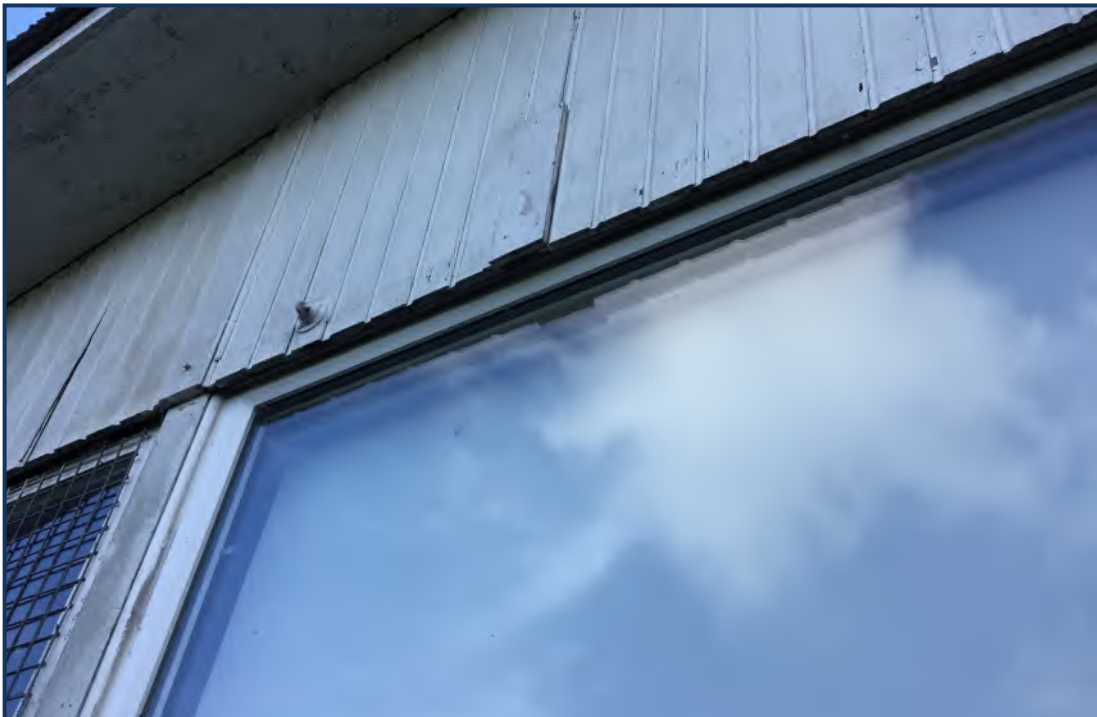
PHOTOGRAPH 8: Building B1 - Gaps in Cladding

| Building Reference | Potential Roosting Feature | Photograph Ref. | Overall Suitability |
|---|---|---|---|
| | Gaps in cladding | P8 | |

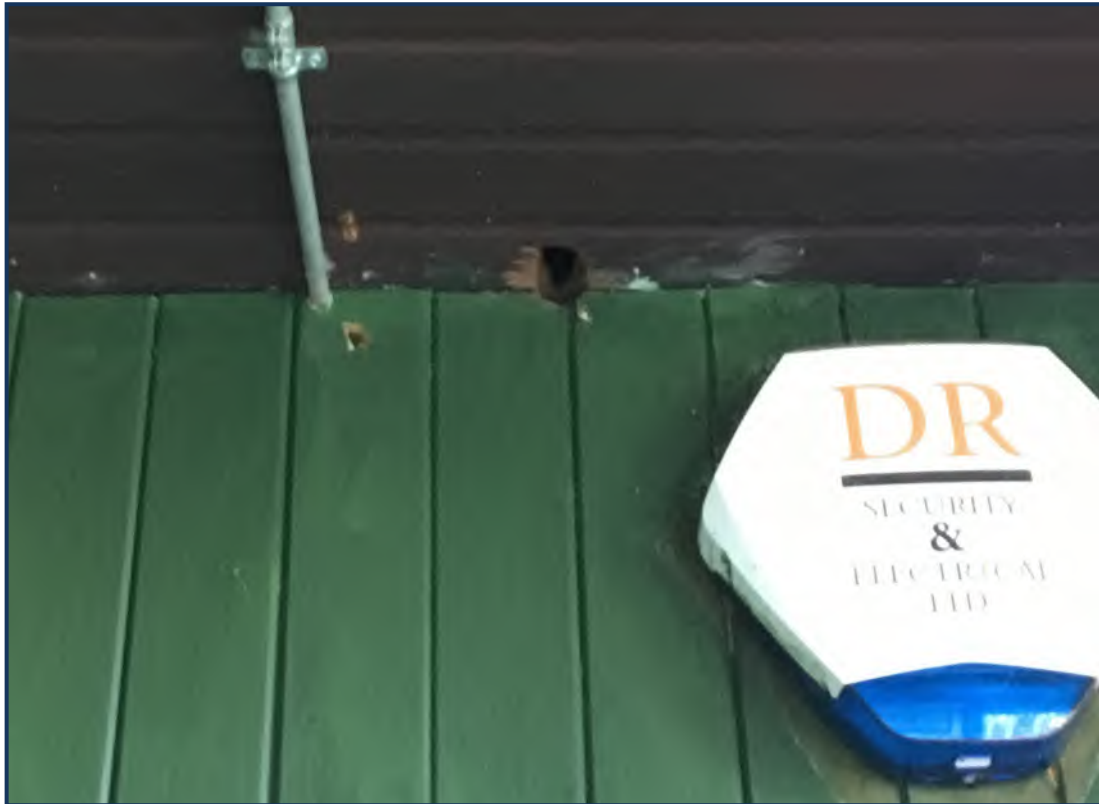
PHOTOGRAPH 9: Building B1 - Gap in Wood

| Building Reference | Potential Roosting Feature | Photograph Ref. | Overall Suitability |
|---|---|---|---|
| | Hole in woodwork | P9 | |

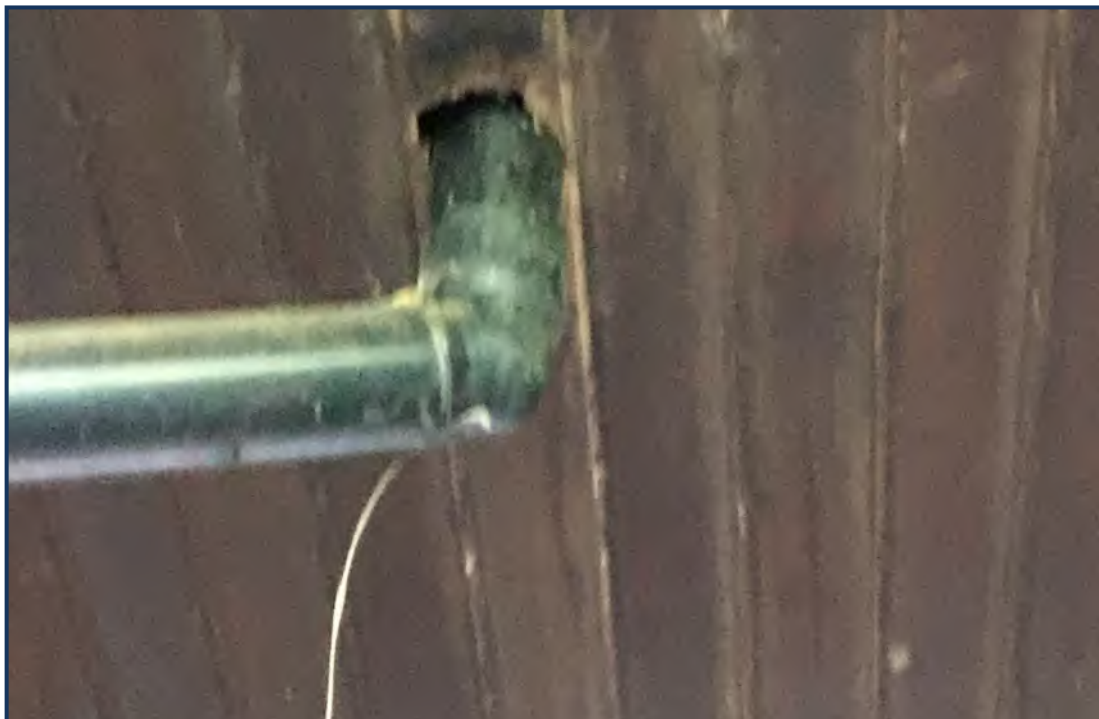
PHOTOGRAPH 10: Building B1 - Gap near Pipe

| Building Reference | Potential Roosting Feature | Photograph Ref. | Overall Suitability |
|---|---|---|---|
| | Gap between pipes and ceiling | P10 | |

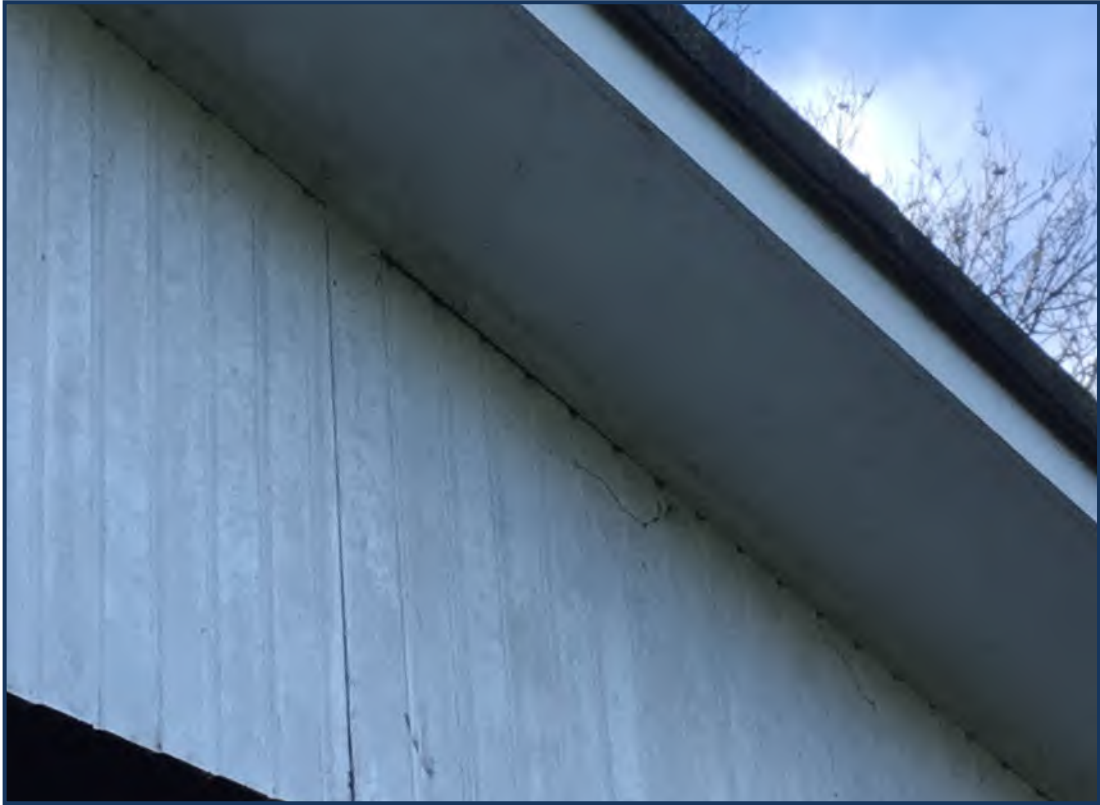
PHOTOGRAPH 11: Building B2 - Gaps in Gable Facade

| Building Reference | Potential Roosting Feature | Photograph Ref. | Overall Suitability |
|---|---|---|---|
| B2 | Gaps along gable facade | P11 | Moderate |

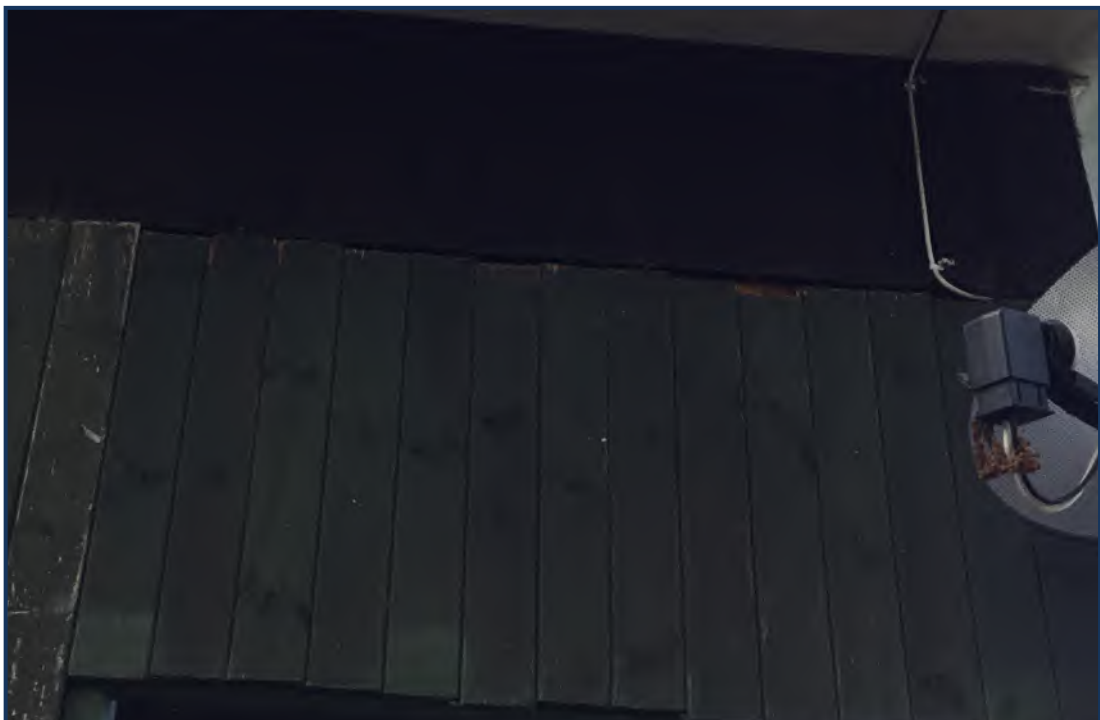
PHOTOGRAPH 12: Building B2 - Gap between External Wall and Barge Board

| Building Reference | Potential Roosting Feature | Photograph Ref. | Overall Suitability |
|---|---|---|---|
| | Gaps between bargeboards and external wall | P12 | |

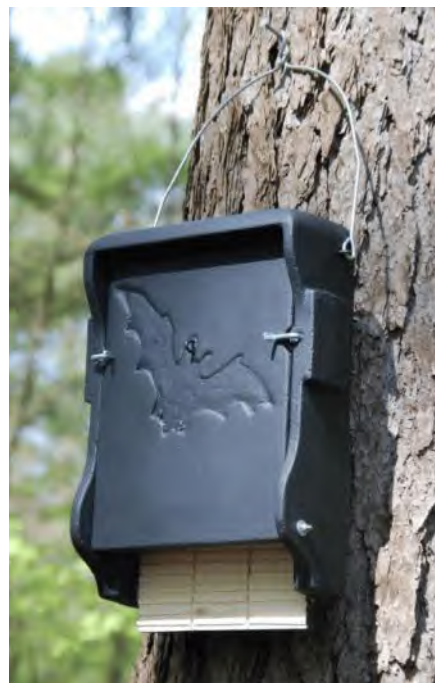
The 75% wood sawdust, clay and concrete mixture is ideal, being durable whilst allowing natural respiration and temperature stability. These boxes are rot and predator-proof and extremely long lasting.

*Please note that this box is designed to be affixed to a wall or tree.*

*Due to the weight, it is unsuitable for fences or sheds.*

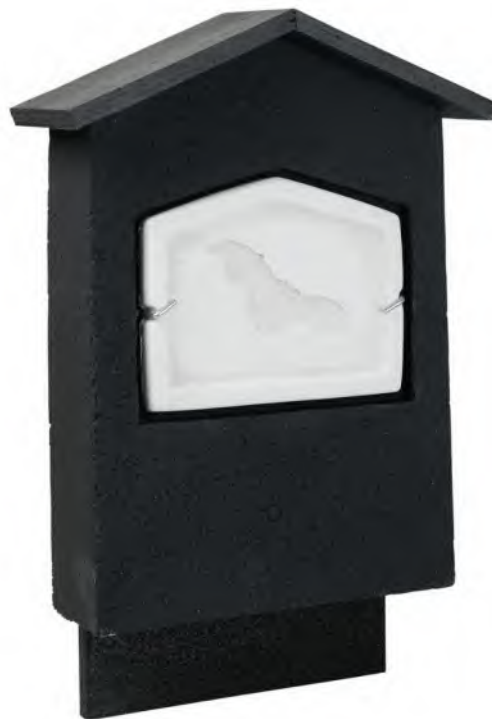
This box is made from 'woodcrete', a unique durable combination of wood, concrete, and clay which will not leak, rot or warp, and maintains a suitable internal temperature throughout the seasons.

*Please note that this heavy box must be affixed securely onto the tree.*

*Due to the weight, it is unsuitable for fences or sheds.*

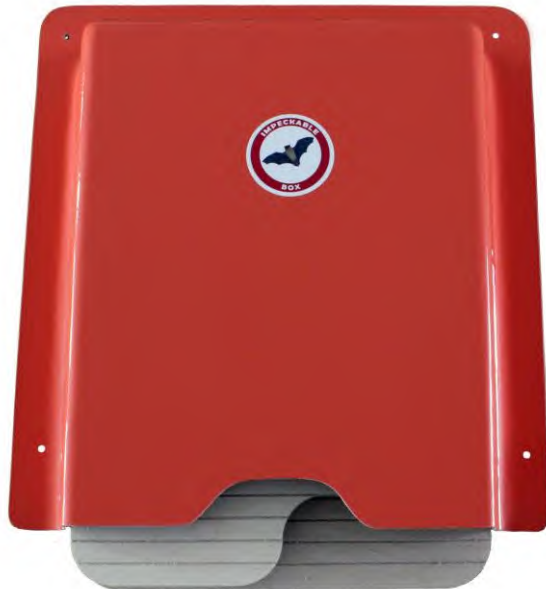
40cm long/high and;  
28.5cm wide.

The gap between both boards is 2cm and also the gap between the front board and the fibreglass cover will be 2cm.
