**CRE8 STRUCTURES LLP**  
**505-511 ARCHWAY ROAD, LONDON, N6**  
**4HX**

**GEO TECHNICAL AND**  
**GEOENVIRONMENTAL DESK STUDY**  
**REPORT**

505-511 ARCHWAY ROAD, LONDON, N6 4HX

## GEOTECHNICAL AND GEOENVIRONMENTAL DESK STUDY REPORT

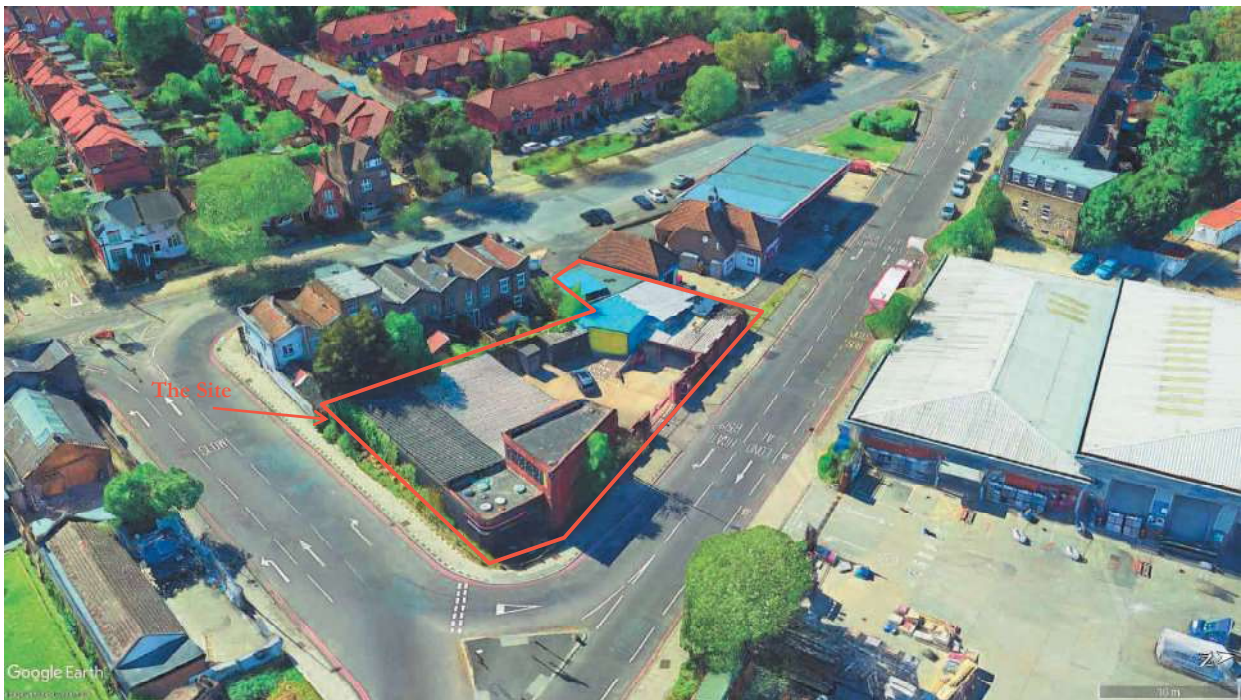
Figure 3

Existing site (3D view)

The footprint of the site shown in the figure is approximate

The site is currently occupied by commercial buildings on the southeast and northwest side and a central hard standing car park area (see Figure 2 and Figure 3). The building heights range from 1 to 2 storeys. The businesses on site appears to include a hand car wash service, window tinting service and car performance garage.

The site is surrounded by a number of residential and/or commercial properties (see Figures 2 and 3):

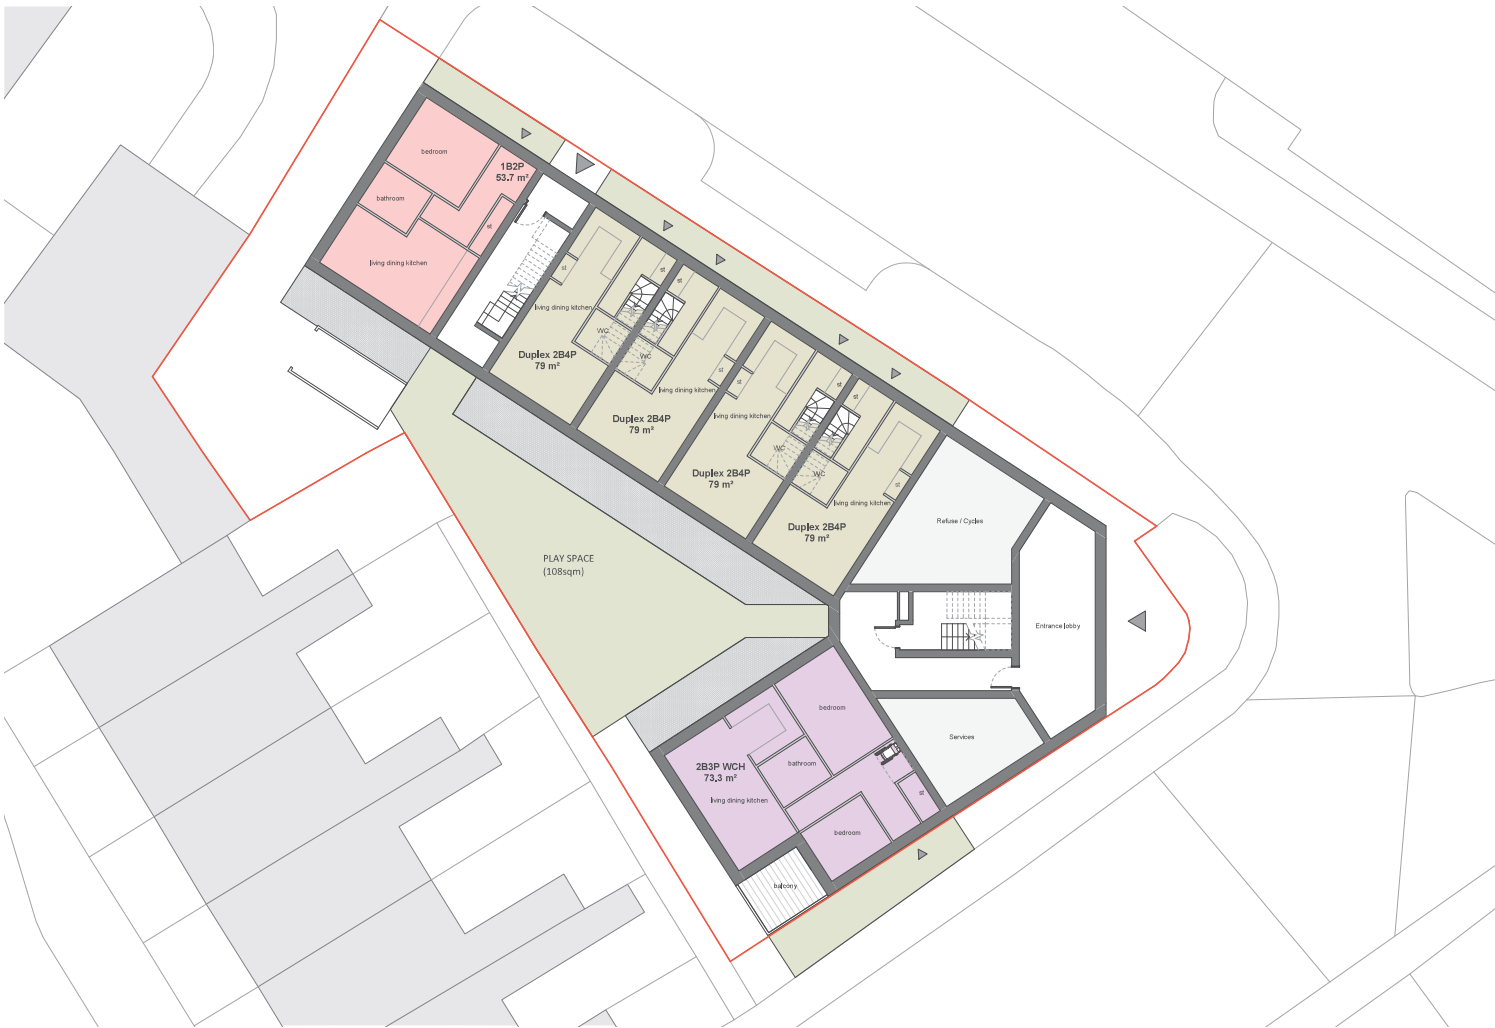
Indicative block and flat layout - Ground floor

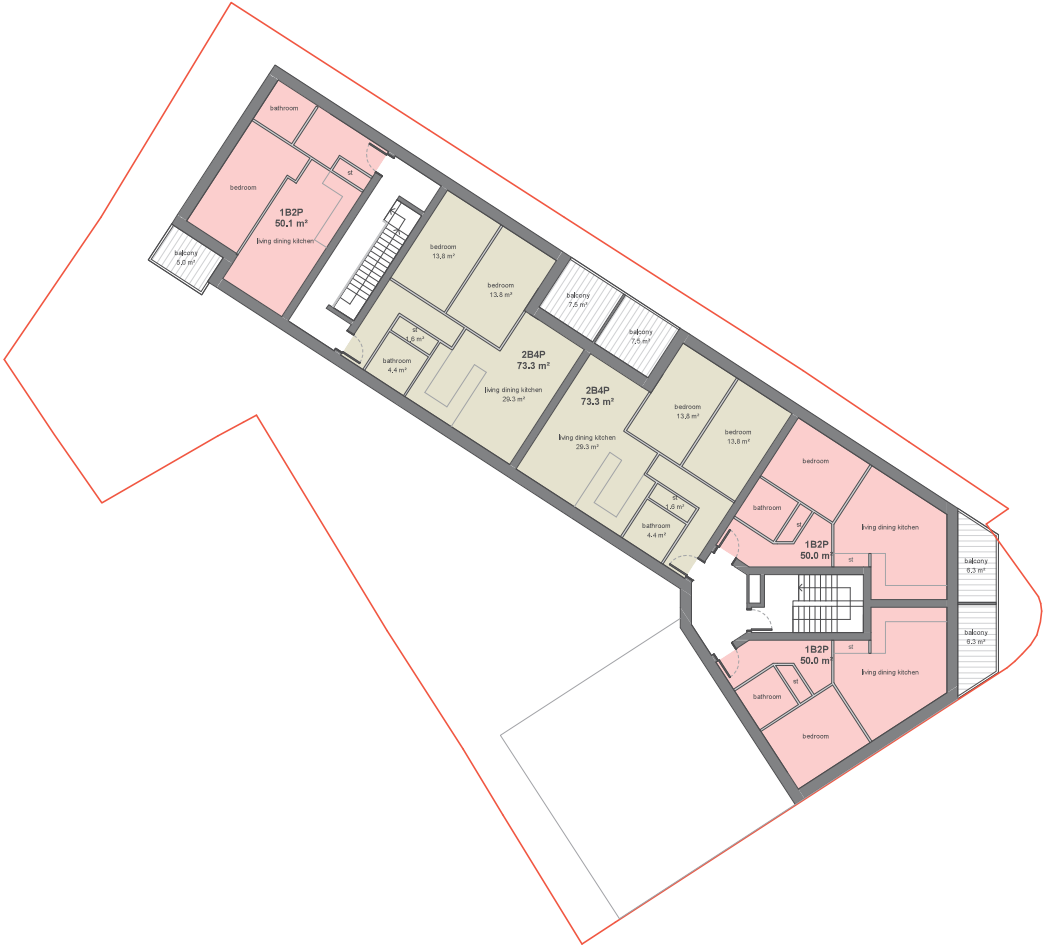
Indicative block and flat layout - Third floor plan
