# 98 High Street, Hornsey. N8 7NT

HERITAGE/ CONSERVATION STATEMENT IN SUPPORT OF RESTORATION OF FRONT FAÇADE; LOFT CONVERSION AND ERECTION OF REAR DORMER; CONSTRUCTION OF MEWS HOUSE TO REAR; RECONFIGURATION OF EXISTING 2 X FLATS WITHIN A CONSERVATION AREA.

Section 73 Application revision.  
July 2026

# Conservation Schedule and Renovation Strategy

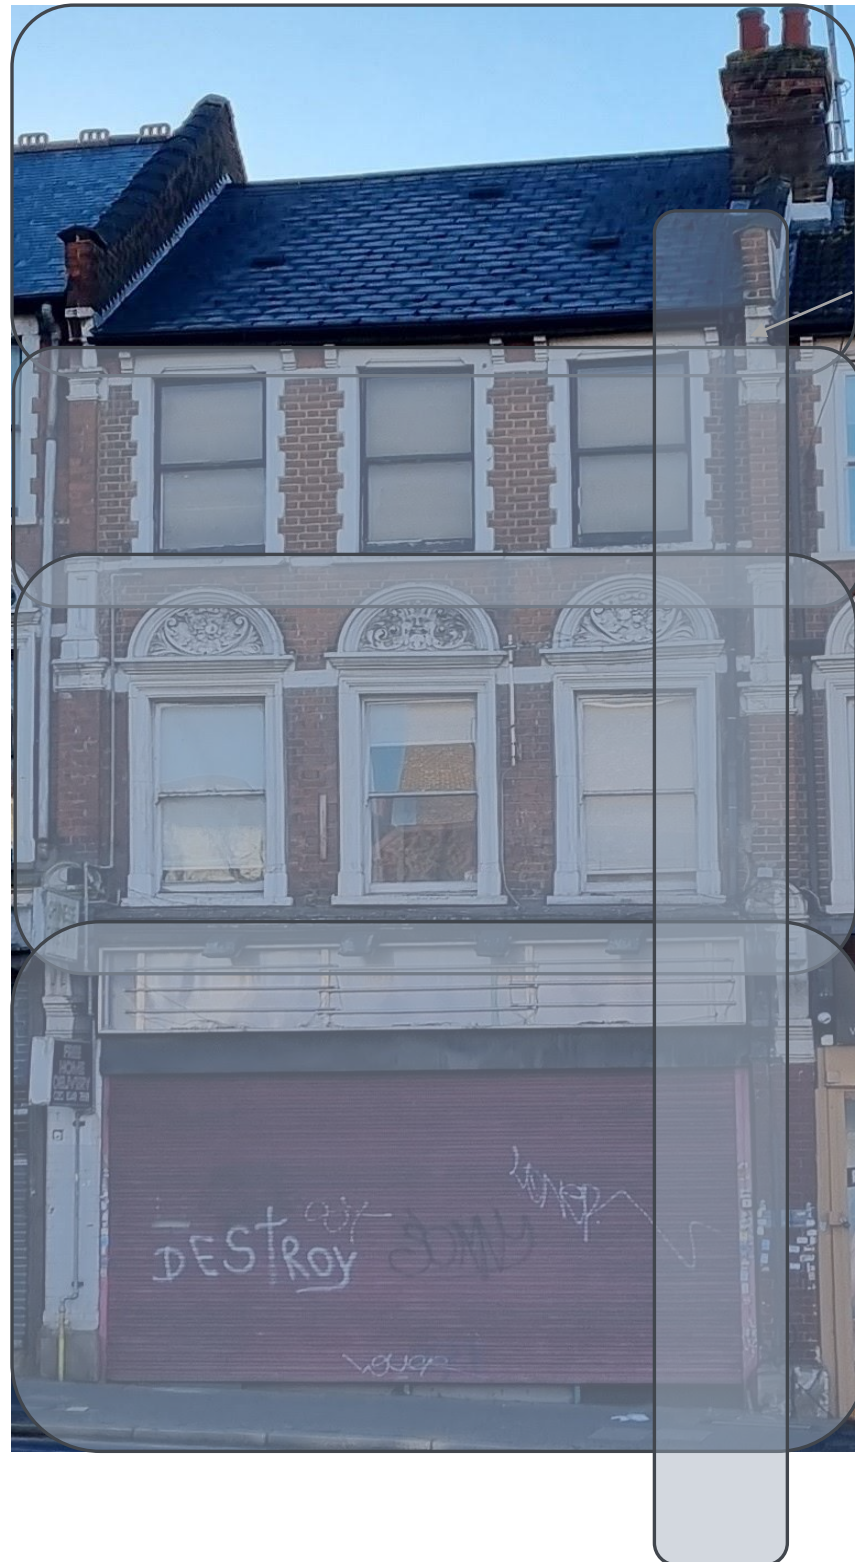
## Attic

We are aware the roof was replaced 20 years or so ago, but on removal, we realised in what bad condition both the tiles and purlins where so we have replaced the roof in order to give the property another 50 years plus of life. Installation of 2no heritage roof lights by Fakro (or similar) will not interfere with the current ventilation system.

The chimney pots seem to require cowlings to be placed for weathering reasons. Flaunching, pointing and flashing to the chimney stack will be reviewed and a plan of repair outlined.

Our proposal would see restoration of the front facade, cleaning and repair only, and a thorough review of the mortar pointing to the upstand/ parapet on boundary walls, and chimney brickwork.

**Task One** – Review roof slates and ridge tiles.

Approach – Any hand loose tiles to be removed and/or secured.

Resolve – Using an approved carpenter/ roofer for replacement works

**Task Two** – Review flaunching/ pointing general and hogging associated on the parapets.

Approach – Any hand loose mortar to be removed and mechanically agitated to ensure remaining mortar is stable and secure.

Resolve – Produce an approved sample for each areas prior to re-mortar to ensure close colour and material match.

**General** – The windows will be replaced with similar like for like hardwood windows.

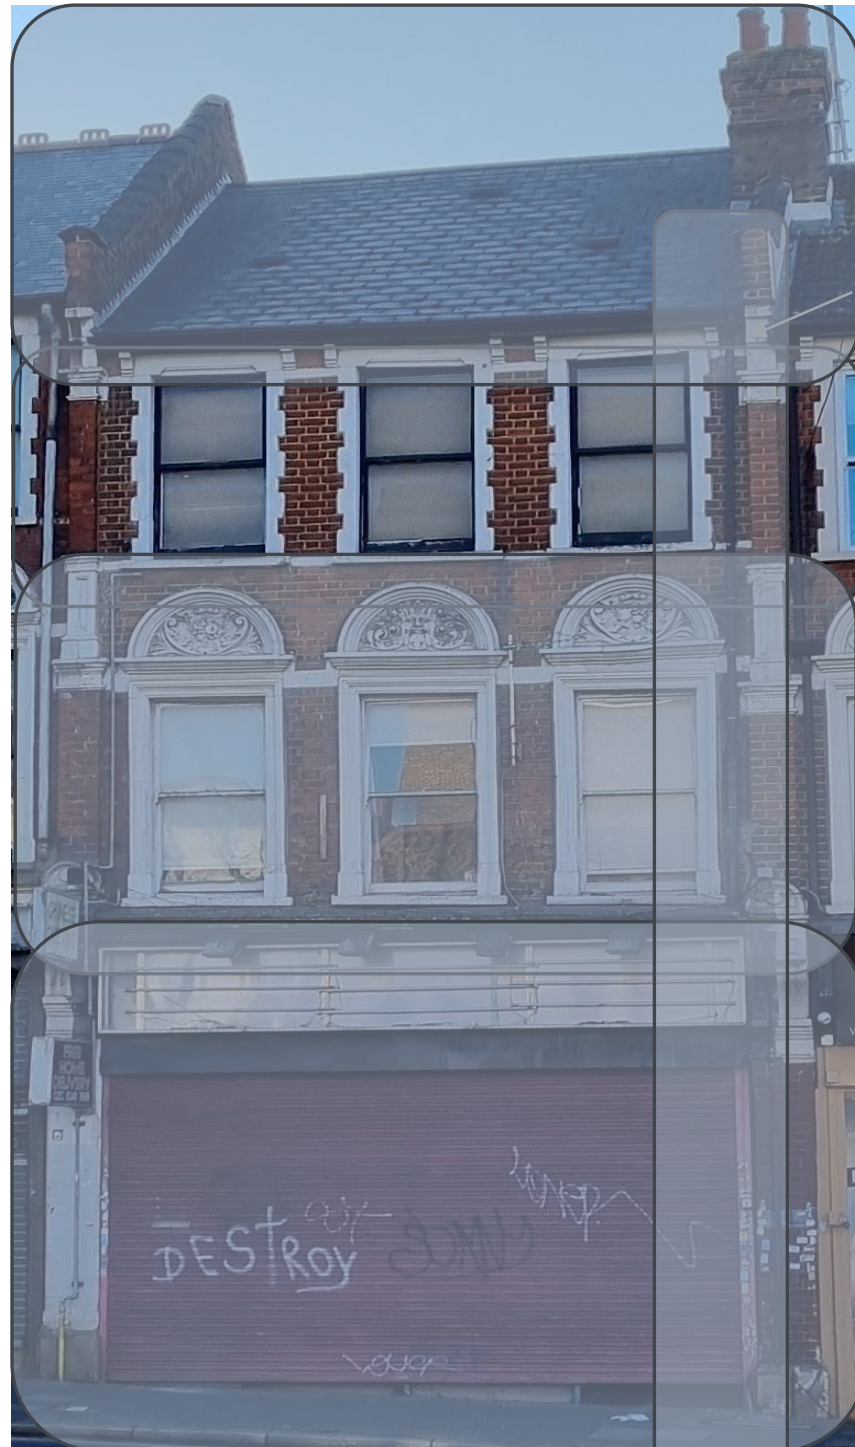
## Upper floor

The upper floor façade has a poorly kept stone head, transom, jamb and cill details which will be stripped back to stone and repaired then re-protected with a proprietary paint finish. The Flemish bond brick work either side will be reviewed for any major damage to either brick or mortar and renovation considered.

The decorative dentals that threshold between the attic storey and the upper floor look in good condition, but they will be treated as the stone window surround.

**Task** – Review pointing generally.

**Approach** – Any hand loose mortar to be removed and mechanically agitated to ensure remaining mortar is stable and secure.

**Resolve** – Produce an approved sample for each areas prior to re-mortar to ensure close colour and material match.

**Task** – Review stone surround to the window.

**Approach** – Using light acid paint remover, continue application until substantial paint is removed to expose the stone behind.

**Resolve** – After neutralizing, embark on stonemason process or repair and re-sculpture and major dents or damage. When renovated to a good level, re-paint white.

**General** – The windows will be replaced with similar look alike hardwood framed.

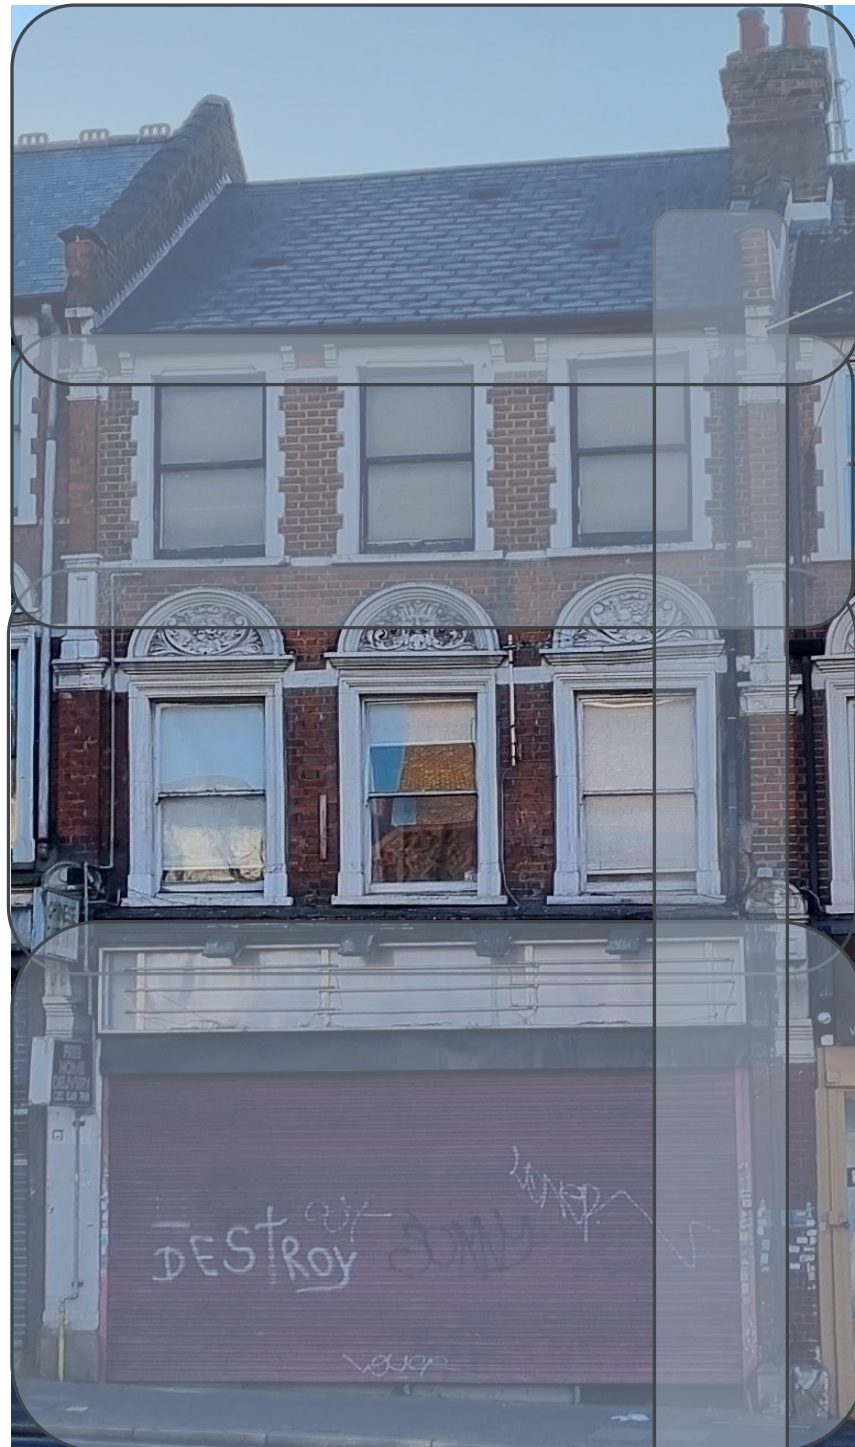
## Piano Nobile

The green man /foliate head has a long history spanning pre-classic to contemporary culture. As well as Judo/Christian connections, foliate head has strong roots in late European Iron Age culture and often depicts rebirth and represents the cycle of new growth that occurs every spring.

In architecture, without dismissing the root meaning, foliate head was often used as a decorative architectural ornament/motif. In the form of a mascarón. Early use on ecclesiastical buildings considered these mascarons to frighten away evil spirits; but over time the concept was adapted to become purely decorative.

Either side we have cornucopia, set in and around scroll detailing & presented in what could be considered pulvinated friezes, to celebrate good health. Celebratory reliefs like these are both popular and encouraged. We will look to restore and

**Task** – Review pointing generally.

Approach – Any hand loose mortar to be removed and mechanically agitated to ensure remaining mortar is stable and secure.

Resolve – Produce an approved sample for each areas prior to re-mortar to ensure close colour and material match.

**Task** – Review stone surround to the window.

Approach – Using light paint remover, continue application until substantial paint is removed to expose the stone behind.

Resolve – After neutralizing, embark on stonemason process or repair and re-sculpture any major dents or damage. When renovated to a agreed level, re-paint and seal white.

**General** – The windows will be replaced with similar like for like hardwood windows.

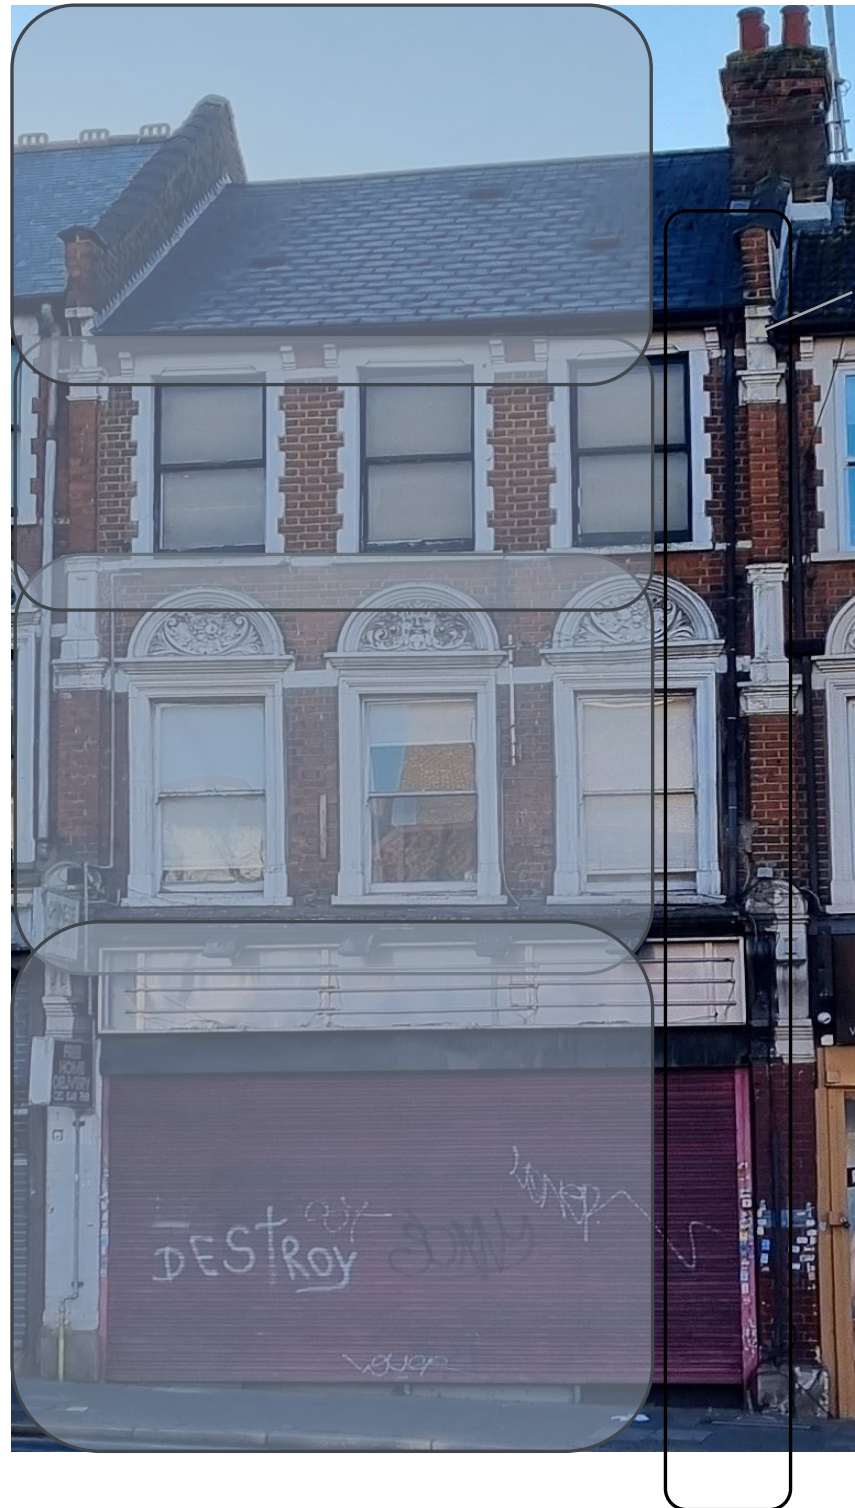
## Broken Column

The inflection given by these concentrations of details to compliment each floor of decoration adds context to connect each dwelling and produces a harmonious visual form of strength, holding up the ornate entablatures found going up the building.

These stucco reliefs pass the school of thought and education from which generations have understood the meaning of dwelling houses. The motifs offer comfort through familiarity; interest through various broken entablature pieces with corning and column heads

**Task** – Review pointing generally.

Approach – Any hand loose mortar to be removed and mechanically agitated to ensure remaining mortar is stable and secure.

Resolve – Produce an approved sample for each areas prior to re-mortar to ensure close colour and material match.

**Task** – Review stone surround to the window.

Approach – Using light acid paint remover, continue application until substantial paint is removed to expose the stone behind.

Resolve – After neutralizing, embark on stone mason process or repair and re-sculpture and major dents or damage. When renovated to a good level, re-paint white.

**General** – The windows will be replaced with similar like for like hardwood windows.
