## **ASHLEY HOUSE, TOTTENHAM HALE**

### PHASE 1 GEOTECHNICAL AND GEOENVIRONMENTAL DESK STUDY

P452287-WW-ZZ-XX-RP-G-000001

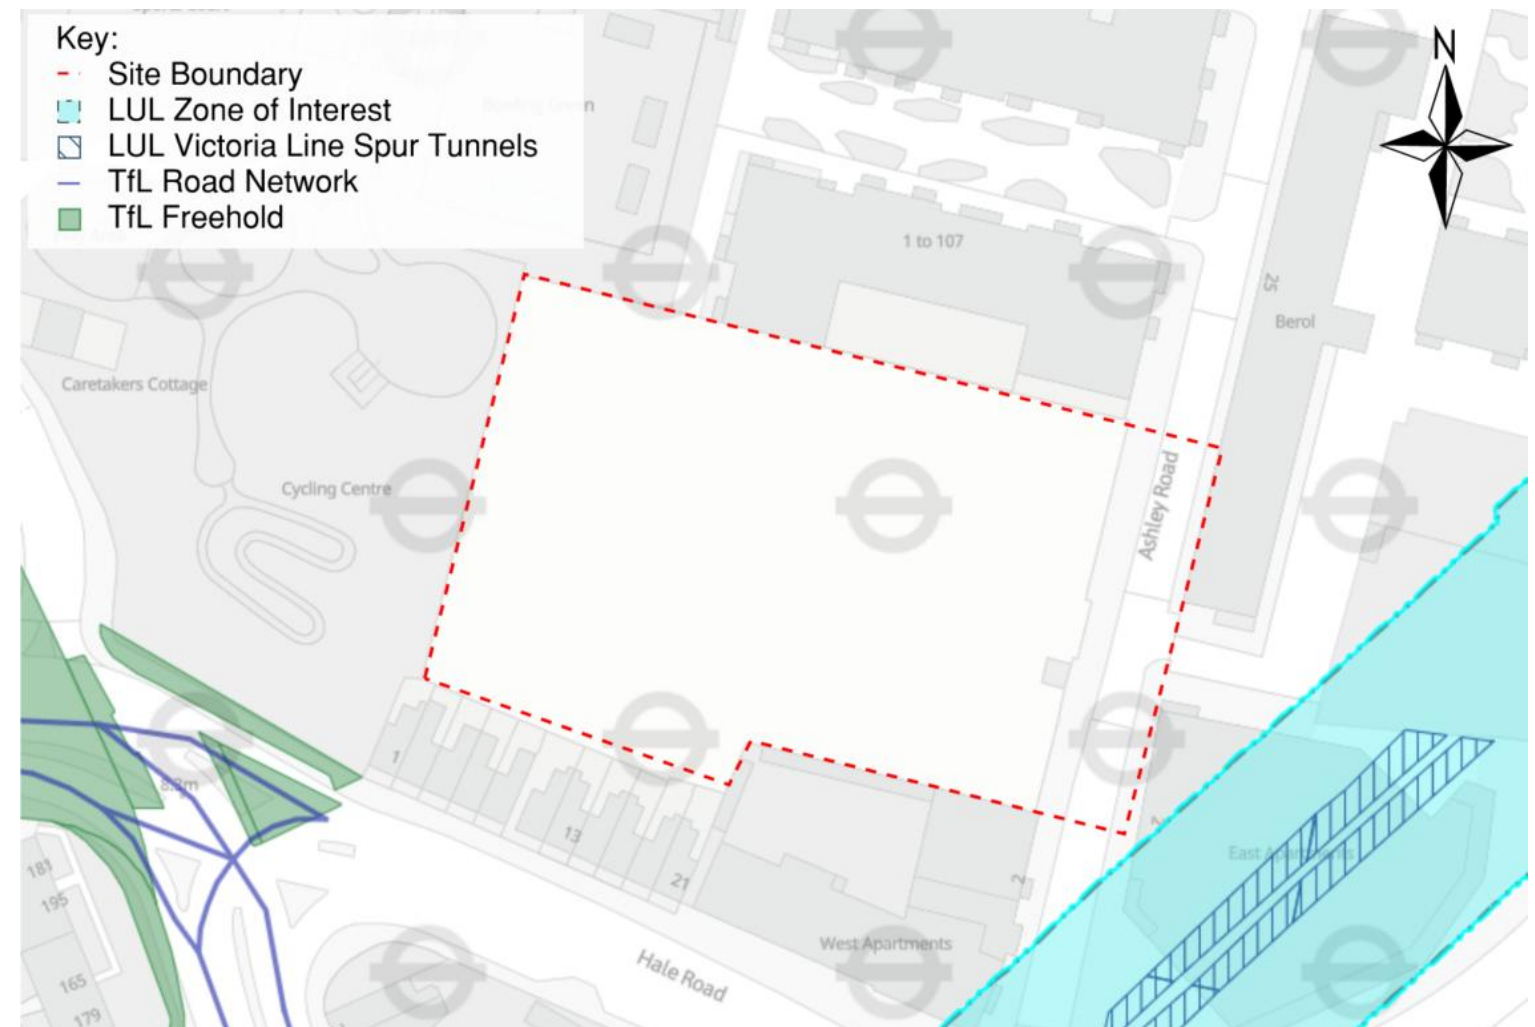
Figure 4: Property Asset Register Public Web Map (Transport for London, Accessed 23/06/2026)

The London Underground Victoria Line Spur tunnels run beneath Ashley Road East Site and adjacent to Ashley Road West Site. The London Underground Limited (LUL) zone of interest (ZoI) runs adjacent to the south-eastern site boundary (refer to Figure 4).

- Proximity to TfL Infrastructure:**  
 The London Underground Victoria Line Spur tunnels run beneath Ashley Road East Site and adjacent to Ashley Road West Site. The London Underground Limited (LUL) zone of interest runs adjacent to the south-eastern site boundary (refer to Figure 4). The available information indicates approximately 8m cover to the tunnel axis. Proposed excavation and piling works may require further liaison with TfL / London Underground Limited (LUL) and compliance with LUL asset protection requirements.

Given the overlap between the proposed building footprints and the LUL ZoI, careful design development and construction sequencing may be required to prevent adverse impacts on the Victoria Line infrastructure. It is likely that ground movement and damage category assessments will be required to justify that there is no significant impact on the tunnels as a result of the proposed development. To inform these assessments, line and level surveys of the tunnels/tracks are required as well as preliminary construction staging.

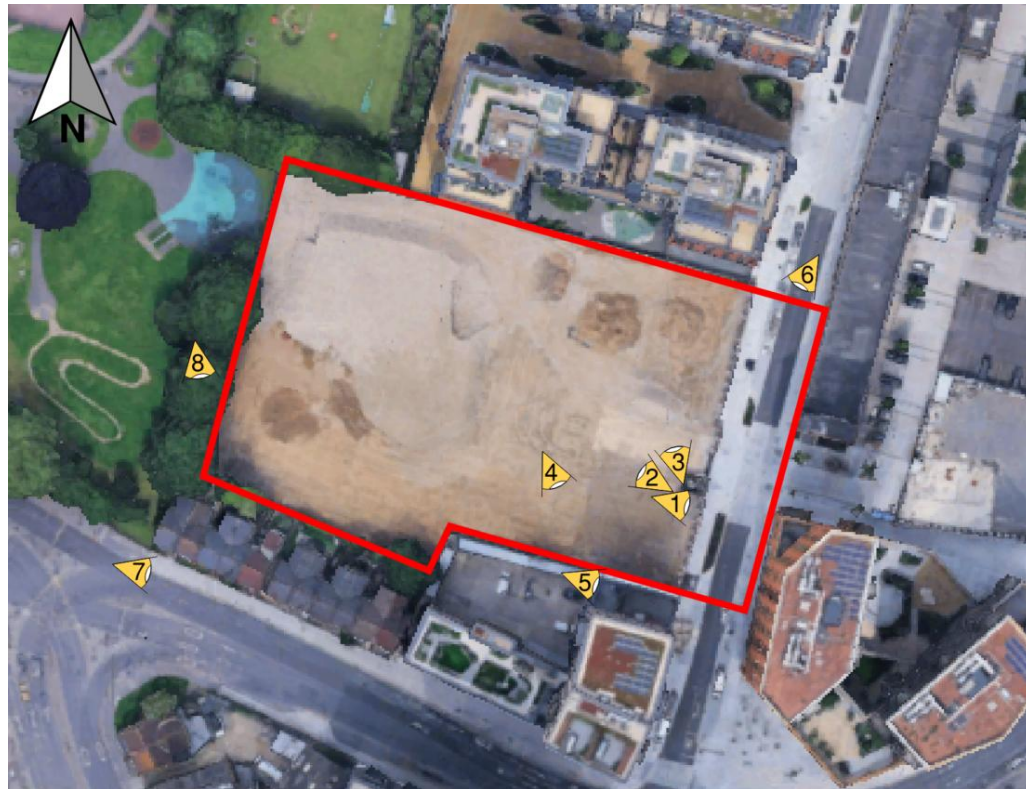
Figure 5: Site Walkover Observation Photos On the 8<sup>th</sup> of July. Observations identified an on-site electrical sub-station (potential contamination), site access constraints, structural and ground conditions, and potential hazards.

**Location** (facing ESE): Site entrance on Ashley Road, inside the gates

**Observation:** Electrical sub-station present

A site walkover was undertaken by Whitby Wood on 8th July 2026. Observations identified the potential sources of contamination; the electrical sub-station at the site entrance and demolition stockpiles. These findings suggest the possible presence of hydrocarbons, oils, heavy metals, asbestos, and other made ground contaminants, which will be considered in the conceptual site model.

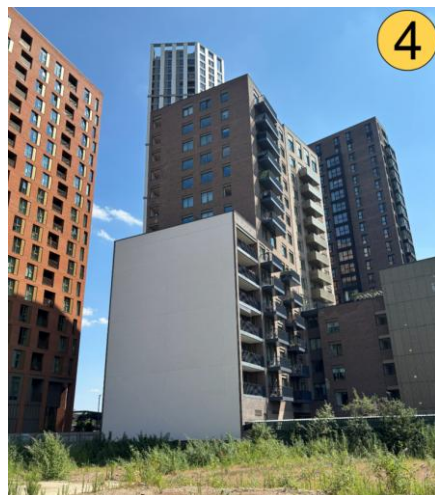
**Location** (facing SE): Ashley Road East apartments

**Observation:** Proximity of Ashley Road East to site

**Relevance:** Potential need for façade retention during works; confirm retention strategy

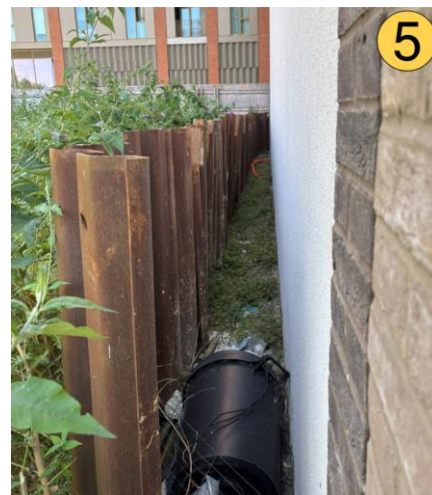
**Location** (facing ESE): Site boundary at Ashley Road East apartments

**Observation:** Presence of sheet pile wall

**Relevance:** Proximity of neighbouring foundations to site; possible below-ground obstruction

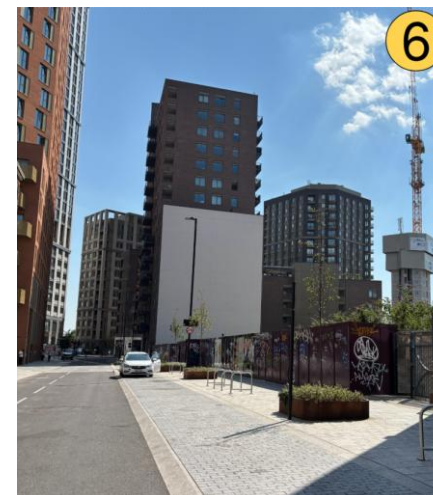
**Location** (facing SW): Ashley Road

**Observation:** Site hoarding on Ashley Road

**Relevance:** Access/plant constraints due to site being located in an urban environment

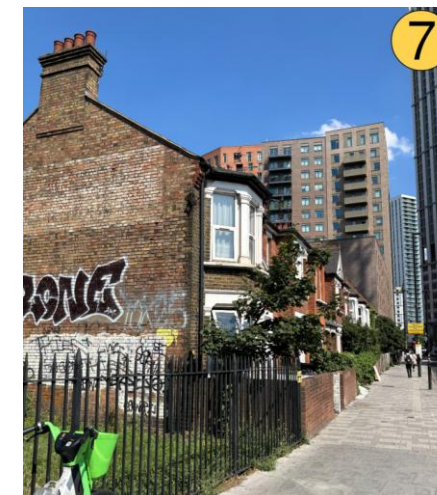
**Location** (facing E): Ashley Road

**Observation:** Row of neighbouring terraced residential units

**Relevance:** Adjacent structure risk; confirm monitoring requirements

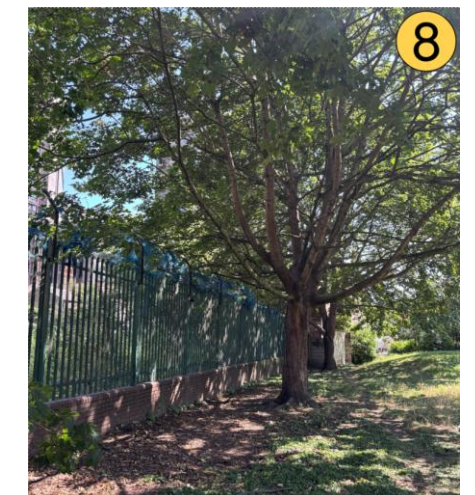
**Location** (facing SSE): Down Lane Park

**Observation:** Trees at Down Lane Park side of site boundary

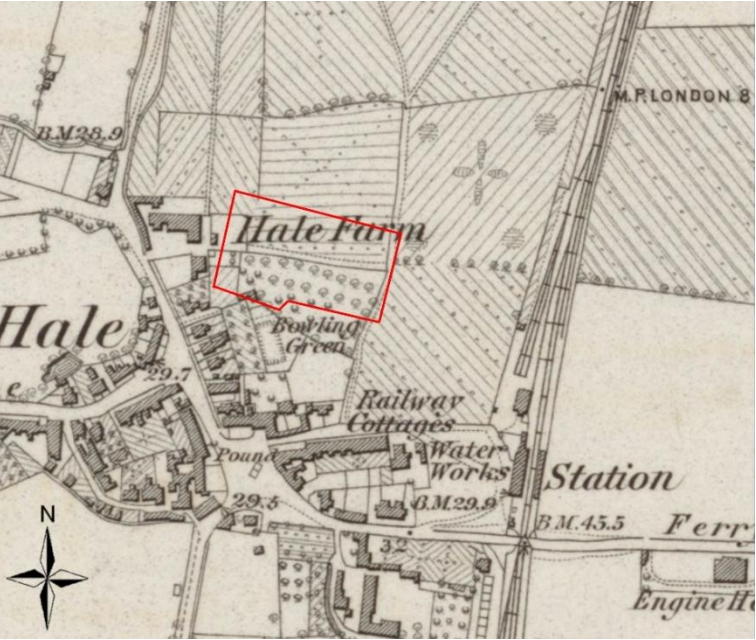
Figure 6: Site History

**1873**

**On-site:** The site appears to have remained predominantly undeveloped (greenfield), with only limited isolated development present.

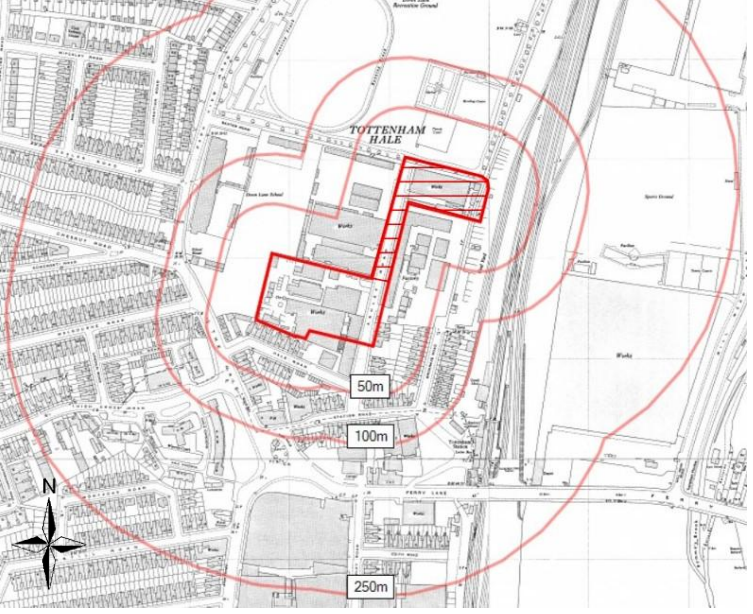
1961-1979

**On-Site:** No significant changes

**Off-Site:** Redevelopment of High Cross Road 100m south-west to the site, including demolition of previous residential buildings and construction of shared housing. Construction of electrical sub-station directly south of the site. Development of rail related works structure 100-250m south-east of site.

**Potential Contamination:** Construction of electrical sub-station likely to introduce higher levels of metal contamination. No significant new industrial source, any new contaminants primarily associated with Made Ground from construction and redevelopment activities, including brick rubble, ash and domestic refuse.

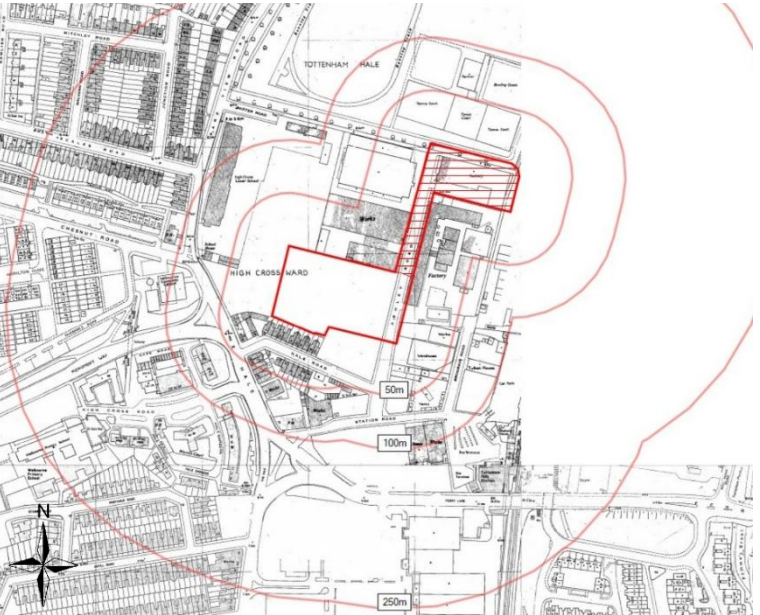
1979-1991

**On-Site:** Complete demolition of ink and varnish factory and any related structures.

**Off-Site:** Demolition of electrical sub-station directly south of site. Demolition and redevelopment of boot and shoe factory, and residential buildings into what is now a retail park 100-250m south of site. Demolition and redevelopment of residential buildings into primary school 250m south-west of site. Redevelopment of junction 100m south of site.

**Potential Contamination:** No significant new industrial source. Any new contaminants primarily associated with Made Ground from demolition, construction, and redevelopment activities, including brick rubble, ash and domestic refuse.

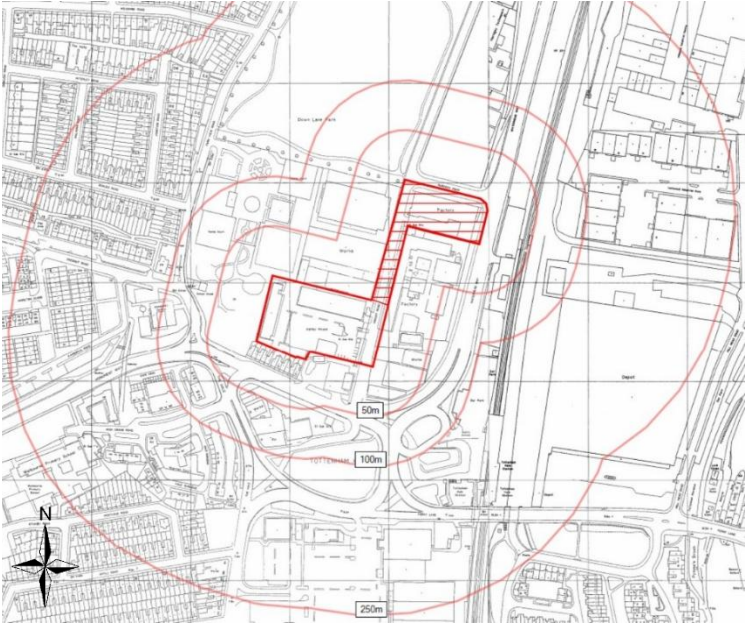
1991-1994

**On-Site:** Construction of Ashley House with two industrial buildings to the north and west of the site boundary, as well as a car park. An electric sub-station is also built on the south boundary of the site.

**Off-Site:** Adjacent to the south-south-east boundary of the site, a petrol station is constructed. Further development of the roads/junctions 100m south of site has taken place. Demolition of school 50-100m north-west of site and extension of Down Lane Park from north to previous location of school and adjacent to west boundary of site. Erection of electrical sub-station 75m south of site. Rail related works structure 100-250m south-east of site identified as the railway depot.

**Potential Contamination:** Construction of petrol station and erection of electrical sub-stations introduce increased risk of metals, hydrocarbon, fuel and combustion residue. Further contribution of contaminants associated with Made Ground (brick rubble, ash, and domestic refuse) from demolition, construction, and redevelopment works.

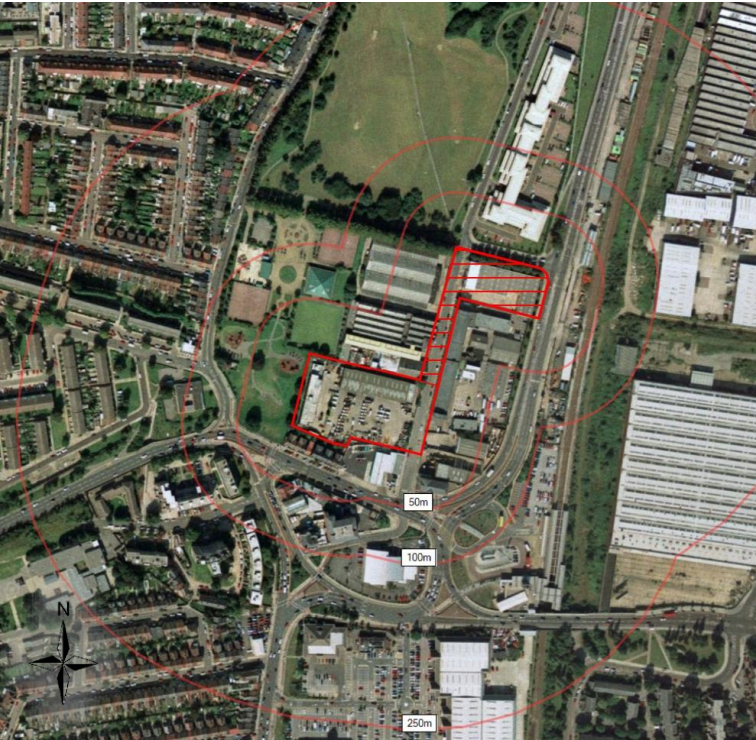
**1999**

**On-Site:** No significant changes observed.

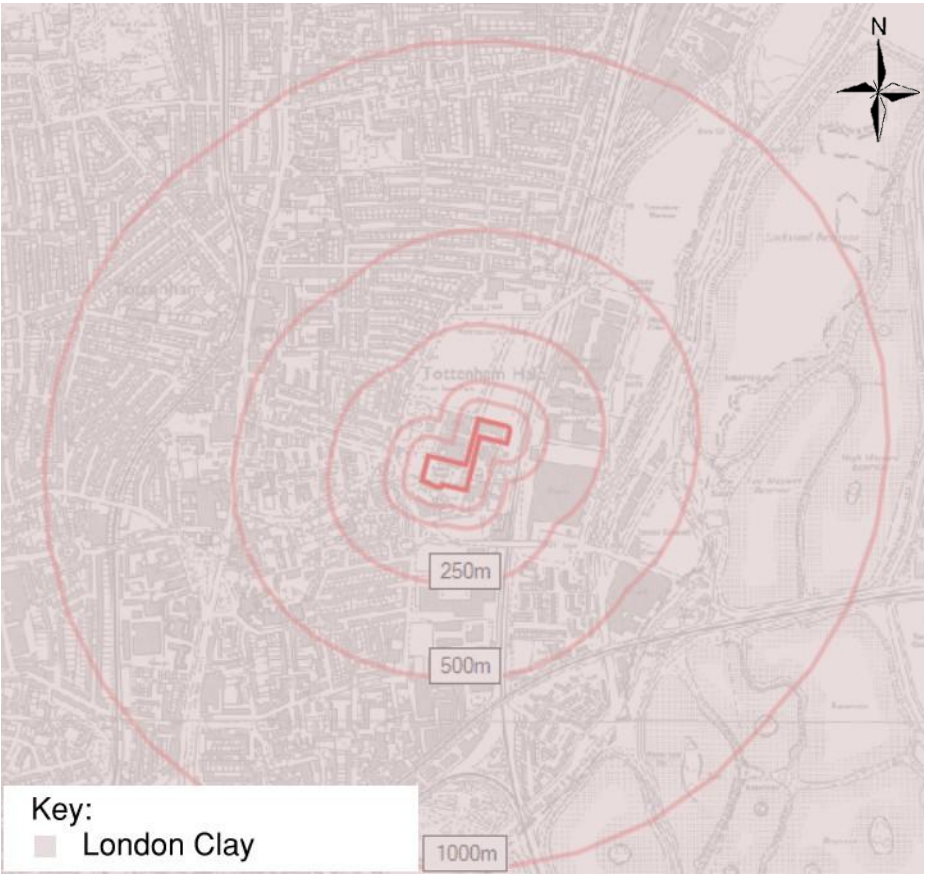
Figure 8: Bedrock Geology (BGS, Accessed 19/02/2026)

The BGS Map in Figure 7 indicates that the superficial geology immediately beneath the site comprises Enfield Silt, Alluvium, and Kempton Park Gravel. Figure 8 shows the mapped bedrock beneath the site as London Clay. No other bedrock strata are recorded directly below superficial deposits within a 1000m radius of the site. London Clay is anticipated to be underlain by the Lambeth Group, Thanet Sands and Chalk Formation.

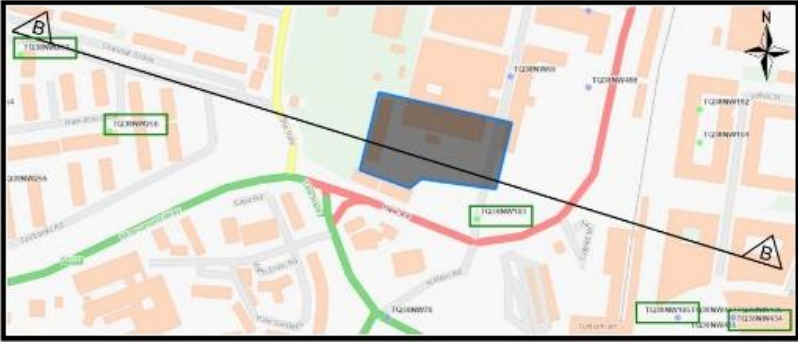
Figure 11: Geological Section B-B

The geological cross-section derived from historical borehole logs from BGS are presented in Figure 10 and Figure 11.

- Key:
- Made Ground
  - Enfield Silt Member
  - Kempton Park Gravel Member
  - London Clay
  - Lambeth Group
  - Approximate LUL tunnel location
  - LUL Zone of Interest

It should be noted that all BGS boreholes are located outside the site boundary, and ground levels were not available for some boreholes. Consequently, sections AA and B-B, shown in Figure 10 and Figure 11, represent an indicative geological sequence only.

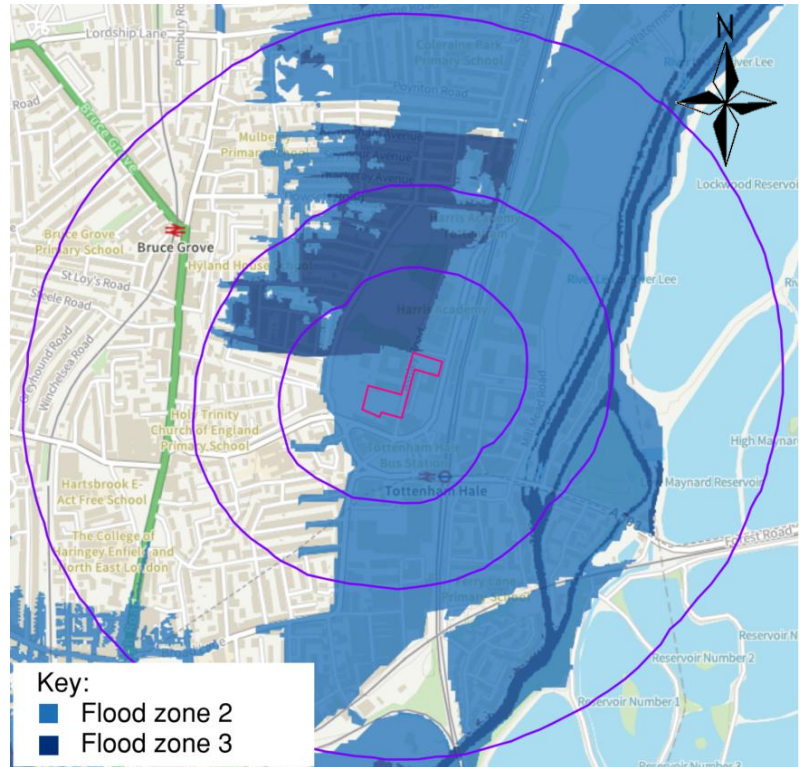
Figure 15: Flood Map (for Planning, Environmental Agency, Accessed 18/06/2026)

According to the Environment Agency's Flood Map for Planning, the site is situated within Flood Zone 2, as shown in Figure 15, indicating a medium risk of flooding from rivers or the sea. The site is reported to be protected by spatial flood defences on the River Lea. Therefore, the risk of flooding from rivers or seas is deemed residual in the event of defence breach.

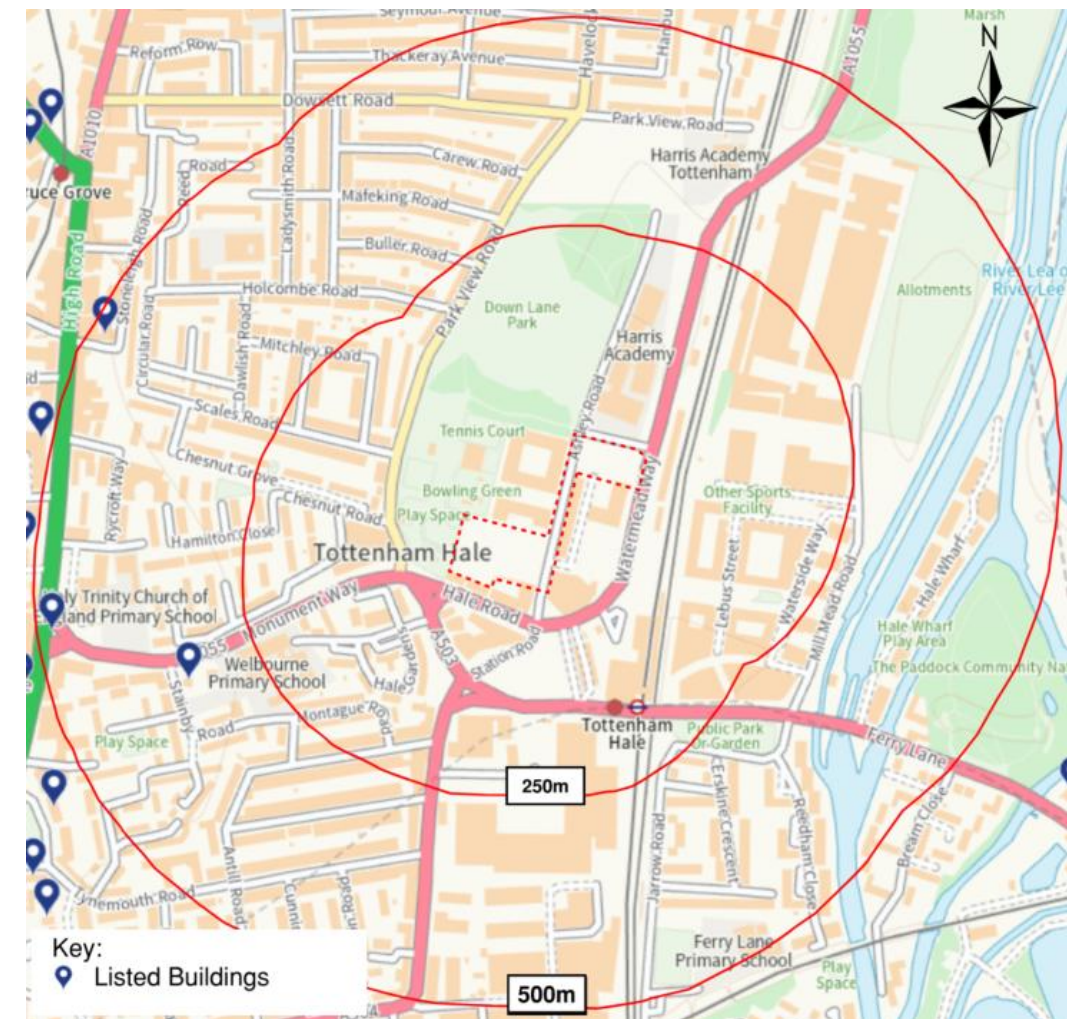
Figure 17: Map indicating nearby Listed Structures (Historic England, Accessed 22/06/2026)

There are no listed structures on site. The closest Grade II listed buildings are located within a 300-500m radius west of site, as shown in Figure 17. These structures are listed as 2 Monument Way, List Entry Number: 1079226; Tottenham High Cross, List Entry Number: 1188856; and The Beehive Public House, List Entry Number: 1393614. These listed buildings are not anticipated to be a key geotechnical constraint based on distance, but heritage/structural constraints should be confirmed by the relevant consultants.
