Northern wall test areas

Project no: 192  
Project name: SOUTHWOOD LANE  
Drawing title: Lower Ground Floor Render Strip Out  
Photos 2  
Drawing no: 192-DET-203  
Date: 07/08/2026

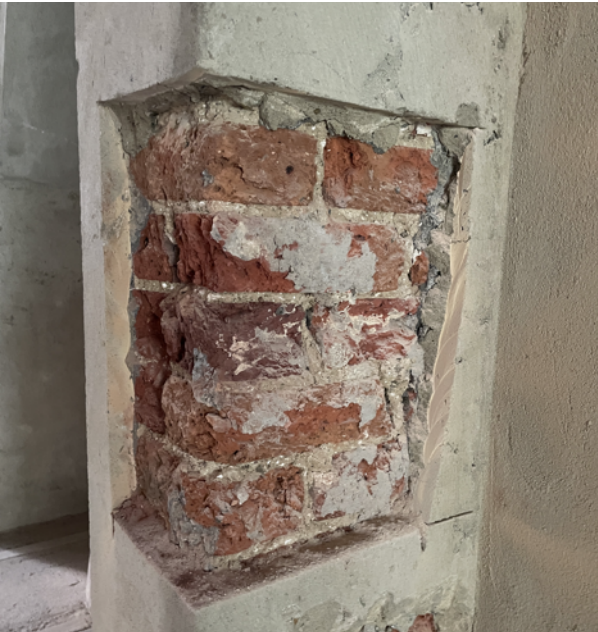
N1 - Chimneybreast corner trial area to northern wall with extensive damage. Almost all the brick faces are coming away. Bricks remain stable, but render removal over corner is more difficult and thin pier is venerable. Render to remain in place.

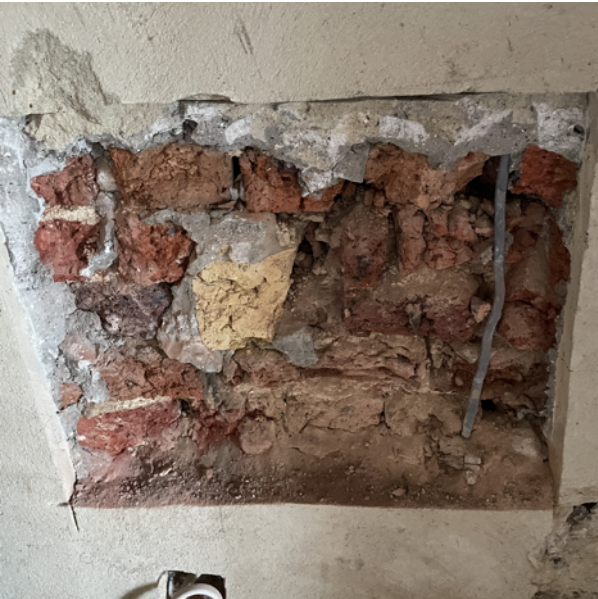
N4 - Chimney back trial area to northern wall with extensive damage. Brick faces are coming away bricks are crumbling with large chunks falling away. Render to remain in place over chimneybreasts.

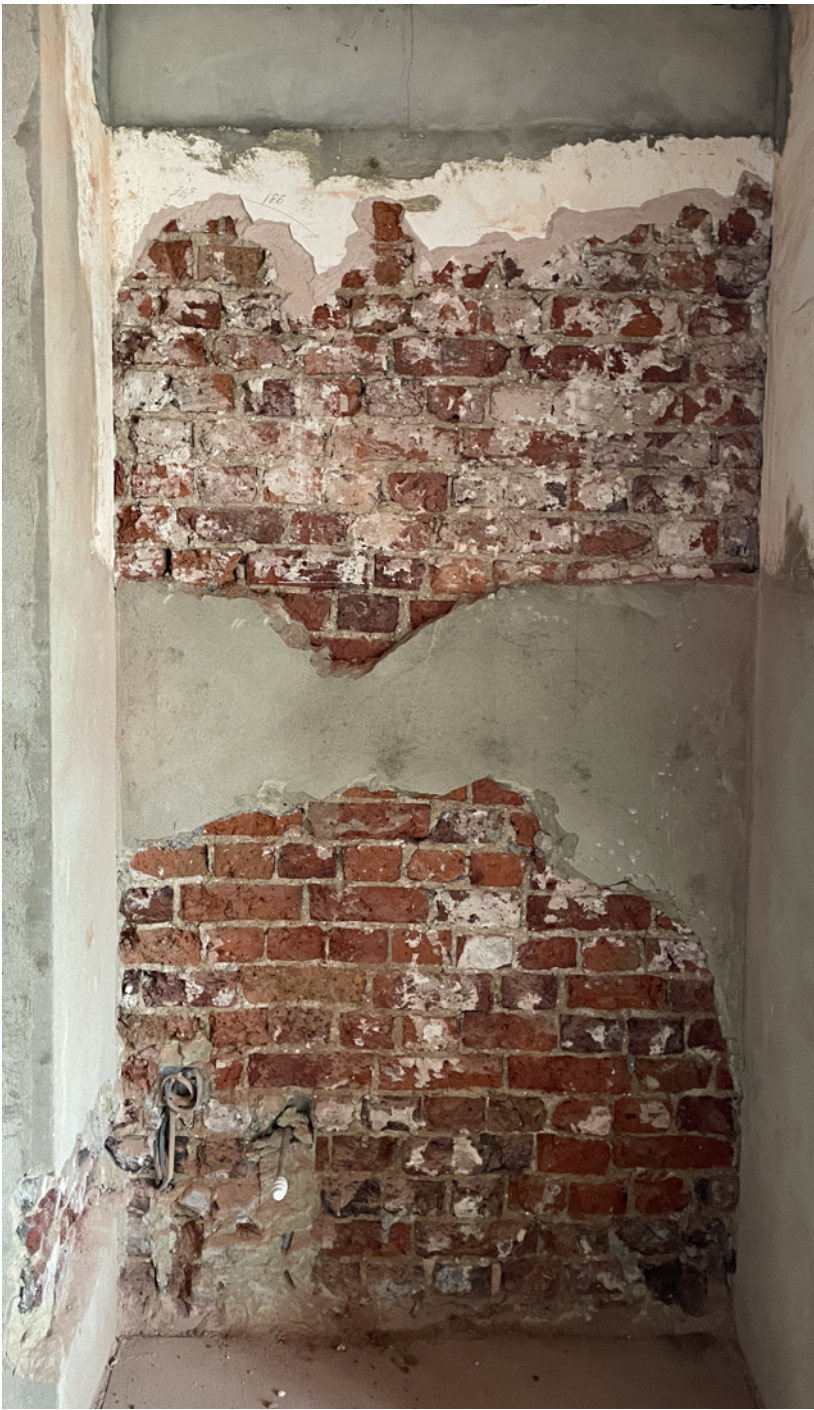
N5 - Trial areas to northern wall with varying damage. Upper render removes more easily with little damage to brick. At lower levels more damage is present with brick faces coming away, but the bricks remain stable. Render removal to continue carefully. Where removal causes more extensive damage localised areas of render will be retained
