Client: YMCA London City and North

Project: YLCAN – Crouch End

Ref: DA22141-00

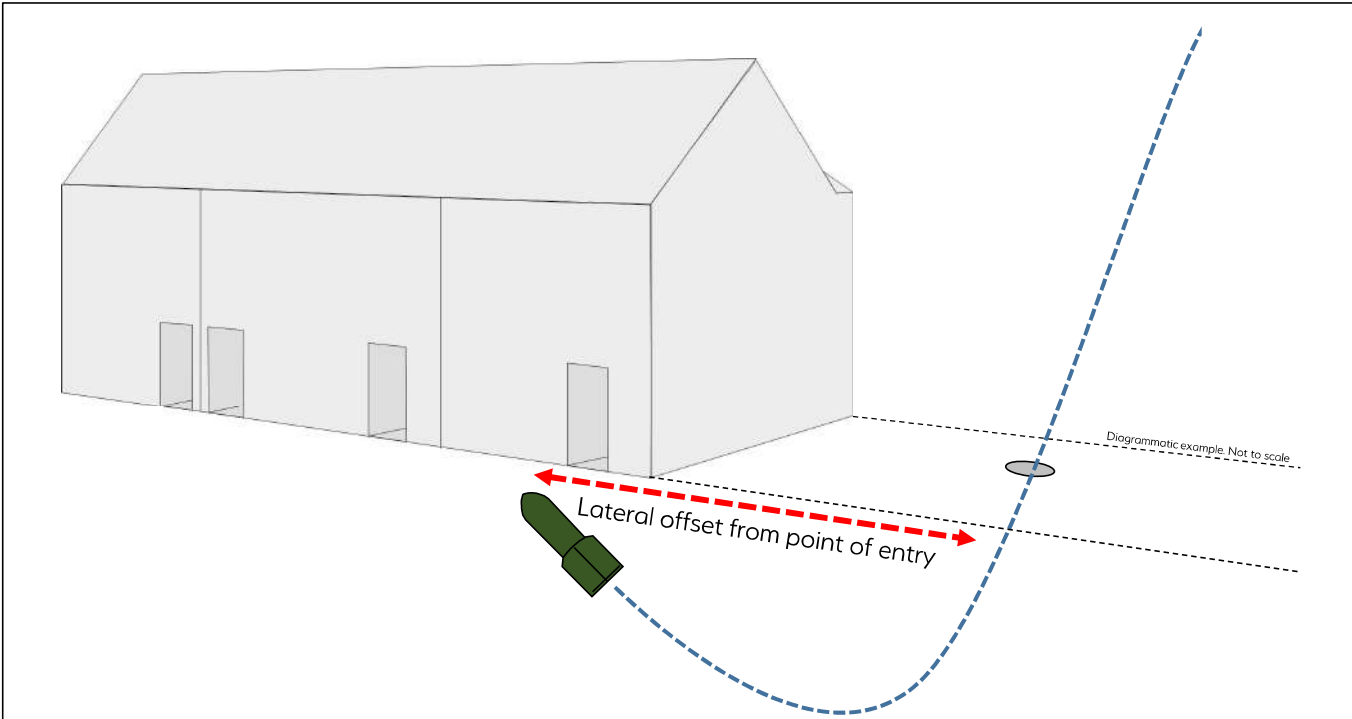
**Top:** J-curve Effect - Due to angle of entry, unexploded bombs would often end their trajectory at a lateral offset from point of entry, often ending up beneath adjacent extant structures/sites.

The photograph **above** shows a 250kg unexploded bomb found in Bermondsey in 2015, pointing upwards, demonstrating 'J-curve'.

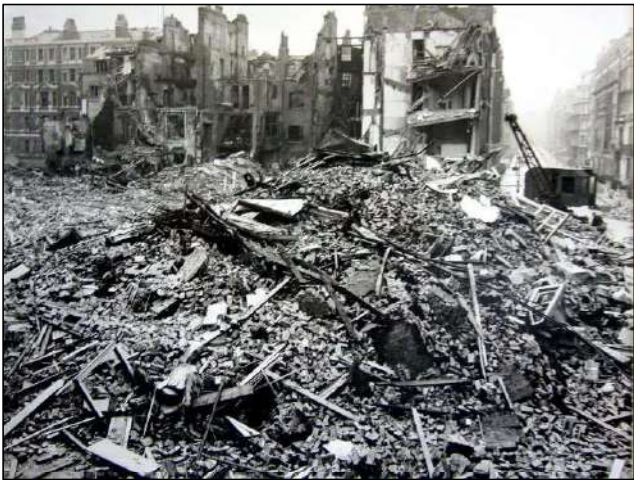
One of the most common scenarios for UXO going unnoticed was when a UXB fell into a 'bomb site' (such as the area shown **Top Left**), the entry hole of the bomb obscured by any debris and rubble present. Note that the entry hole of a 50kg UXB could be as little as 20cm in diameter (**Left**).

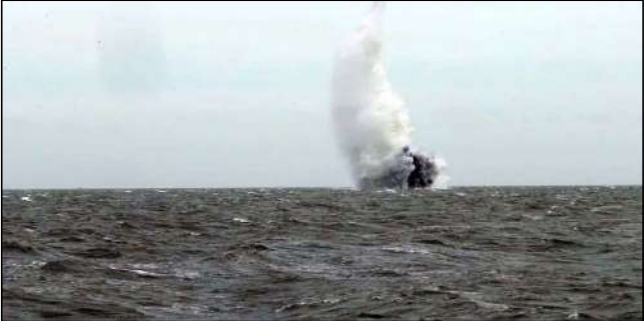
WW2 bomb found near London City Airport blown up

An unexploded World War Two bomb found near London City Airport has been detonated.

The 500kg device was discovered at the King George V Dock on Sunday during planned work at the airport.

The 1.5m-long German bomb - which was found in a bed of silt, 15m underwater - was carefully removed from the Thames and placed in a secure location a mile away from the coast of Essex.

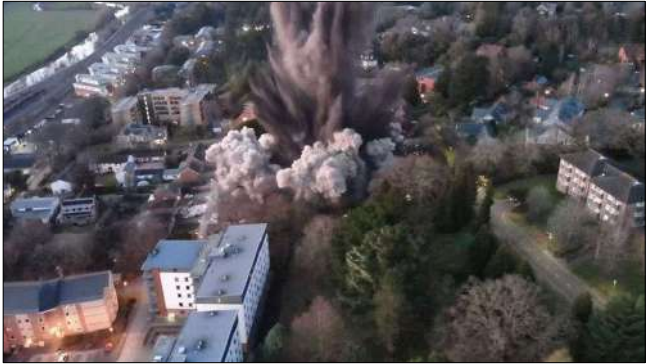
Exeter WW2 bomb is detonated after homes evacuated

More than 2,600 households and 12 university halls of residence were cleared before the 2,200lb (1,000kg) device was destroyed on Saturday.

Police said the blast left a crater about the size of a double-decker bus.

Police have reported large pieces of metal debris hitting buildings and said some properties in the 100m (330ft) exclusion zone had sustained "structural damage".

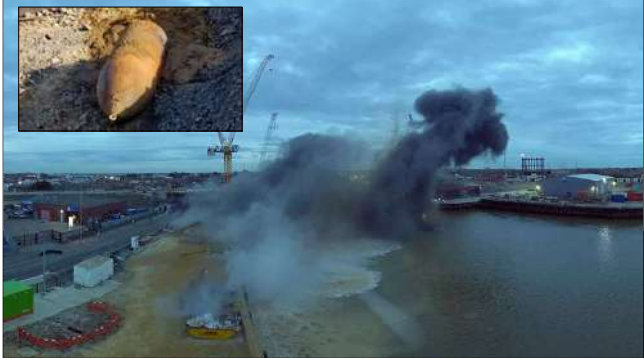
Great Yarmouth: Huge blast after unplanned WW2 bomb detonation

A World War Two bomb found in Great Yarmouth has detonated while work was being done to defuse it, causing a huge blast that was heard for miles.

Army specialists were attempting to disarm it when there was an unplanned detonation at about 17:00 GMT.

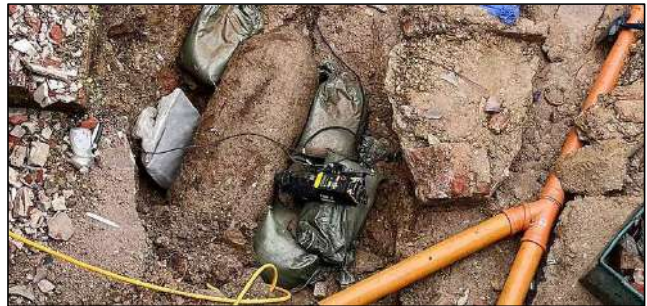
Plymouth unexploded WW2 bomb: Thousands of people displaced

A 500kg (1,102lb) German World War Two bomb that forced the evacuation of thousands of people in Plymouth has been detonated at sea.

The unexploded device was found in a garden on St Michael Avenue on Tuesday, sparking four days of disruption.

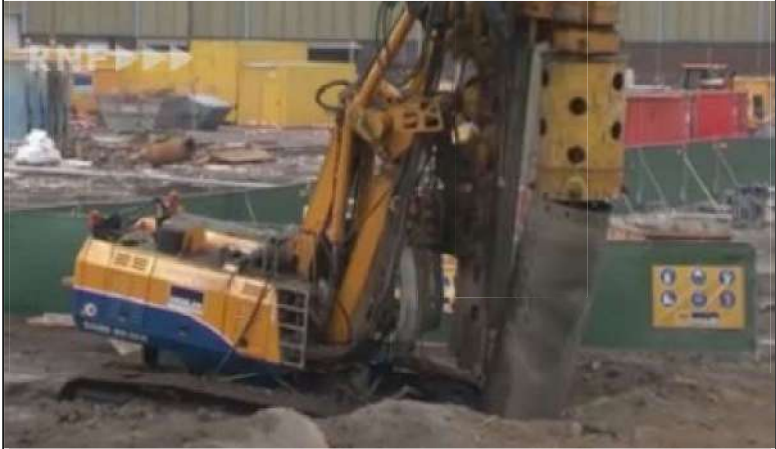
BASF has confirmed that an explosive device, most likely a World War II-era bomb, caused the blast that left one person injured Tuesday at a plant construction site in Germany.

The explosion was reported at BASF's Ludwigshafen toluene diisocyanate (TDI) plant, which recently broke ground for a 300,000 metric tons per year TDI production plant and other construction to expand its facilities.

"Cause of the detonation was an explosive device, presumably a bomb deriving from the Second World War. The device detonated when grounding work was done. No details on [a] delay [are] available. At the moment, the exact circumstances of the incident are [being] evaluated."

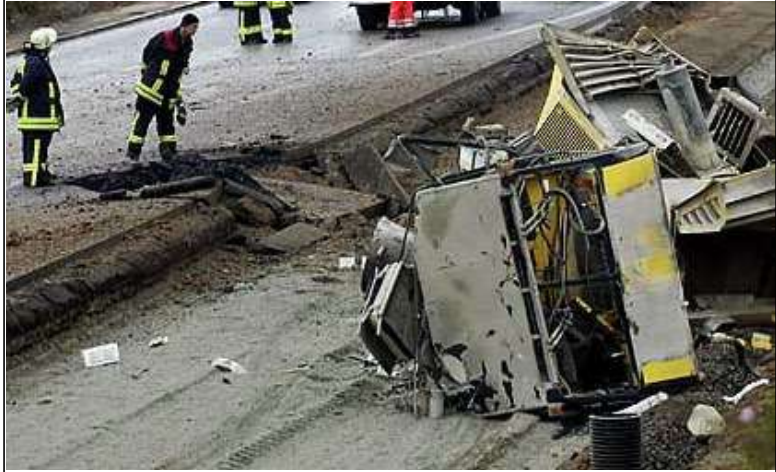
**World War II Bomb Explodes on German Motorway**

A highway construction worker in Germany accidentally struck an unexploded World War II bomb, causing an explosion which killed him and wrecked several passing cars.

A World War II bomb has exploded during construction work on a German highway, killing one worker and injuring several motorists who were driving past, police said.

The worker had been cutting through the road surface near the south-western town of Aschaffenburg when his machine struck the bomb and triggered it. Police said they weren't sure yet what type of bomb it was. "The explosion seems to have been too small for it to have been an aircraft bomb," a police spokesman said.

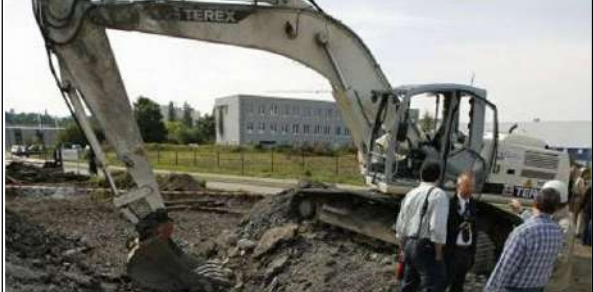
**WWII bomb injures 17 at Hattingen construction site**

**Seventeen people were injured on Friday when a construction crew unwittingly detonated a buried World War II-era bomb in Hattingen.**

An excavator apparently drove over a 250-kilogramme (550 pound) American bomb, damaging surrounding buildings. Most of the injured suffered auditory trauma from the blast, and the excavator operator suffered injuries to his hands, police in the German state of North Rhine-Westphalia said.

"The hole was astoundingly small for such a large bomb full of so many explosives," Armin Gebhard, head of the Arnsberg department for military ordnance removal, told The Local. "But of course it damaged all the surrounding buildings too. We are really happy it wasn't worse."

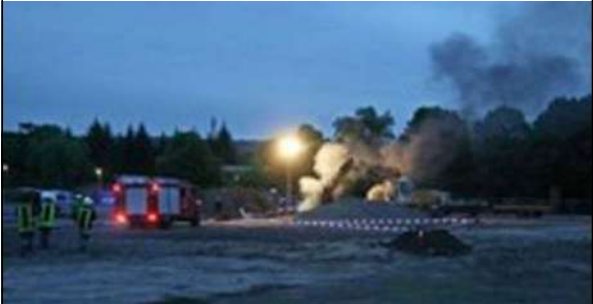
**World War II bomb kills three in Germany**

A special commission is investigating the causes of the explosion, while prosecutors are considering whether the team leader should face charges of manslaughter through culpable negligence, the BBC's Oana Lungescu reports from Berlin.

The blast happened an hour before the defusing operation was due to start.

More than 7,000 people were immediately evacuated when the 500kg bomb was found. Several schools, a kindergarten and local companies remain closed.

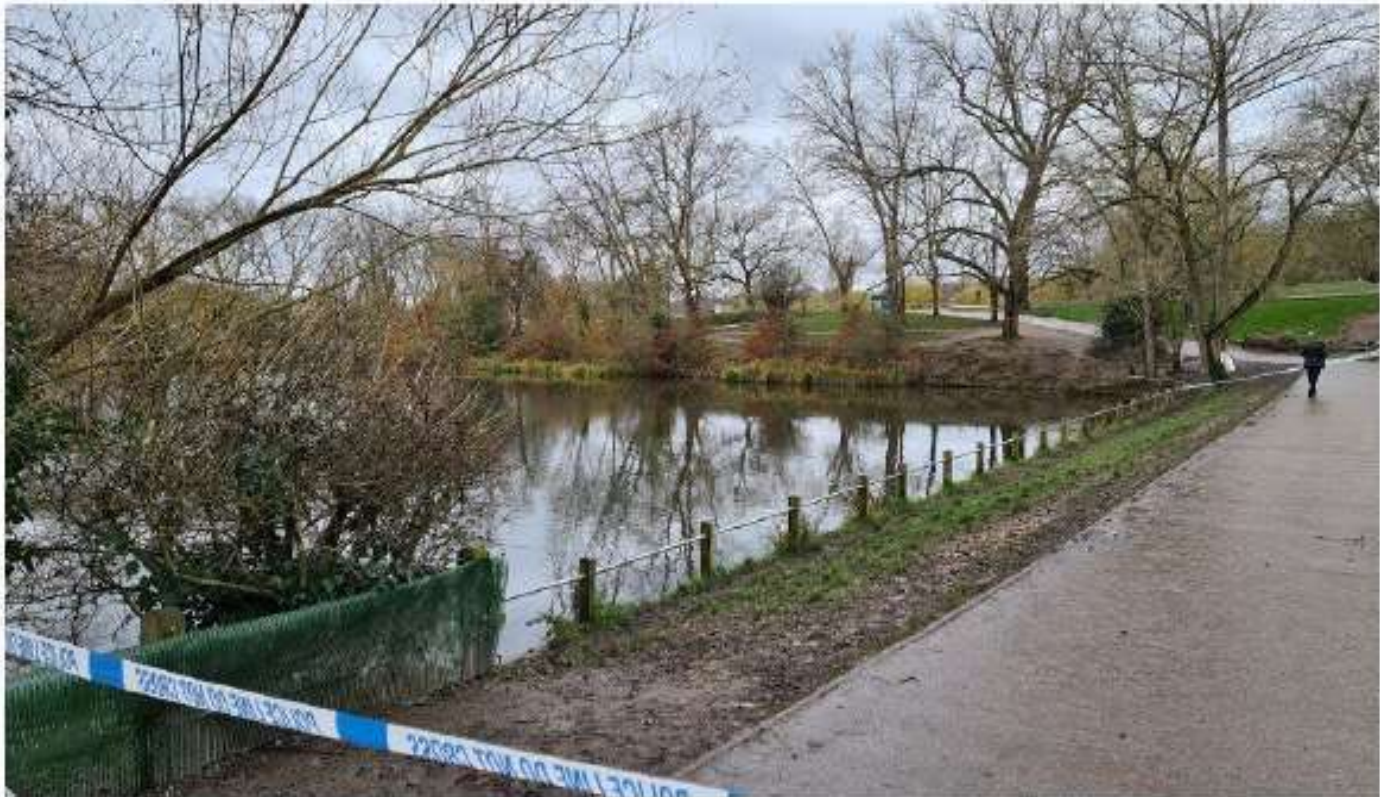
# Unexploded hand grenade found in Hampstead Heath pond

A cordon was put up by police while the bomb was detonated on Saturday lunchtime

PART of Hampstead Heath was sealed off by police on Saturday lunchtime after anglers hooked an unexploded Second World War hand grenade from a Heath pond.

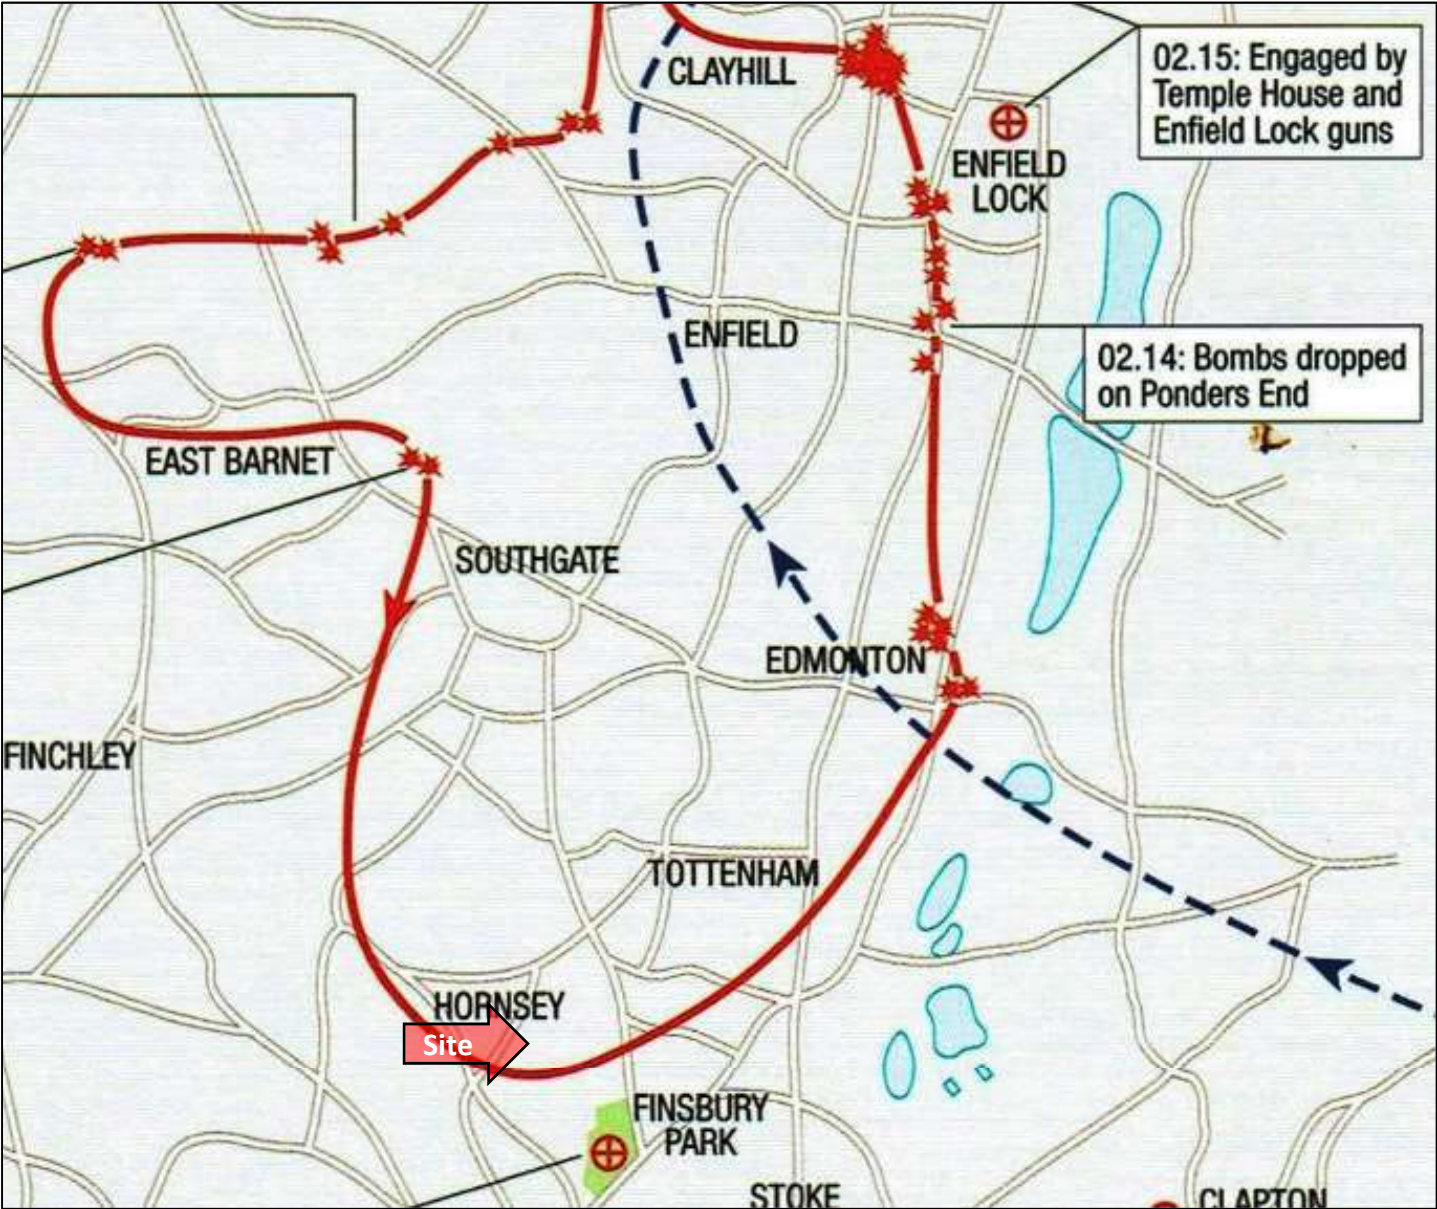
A zeppelin is recorded to have passed approximately 100m west of the site, though no bomb strikes are indicated nearby.
