## Phase I Desk Study

YMCA London City and North, 184 Tottenham Lane, Crouch End, London N8 8SG

On Behalf of Altair Limited

| Report Reference: GWPR7007/DS/April 2026 | | | Status: Final |

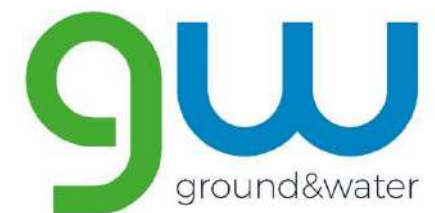
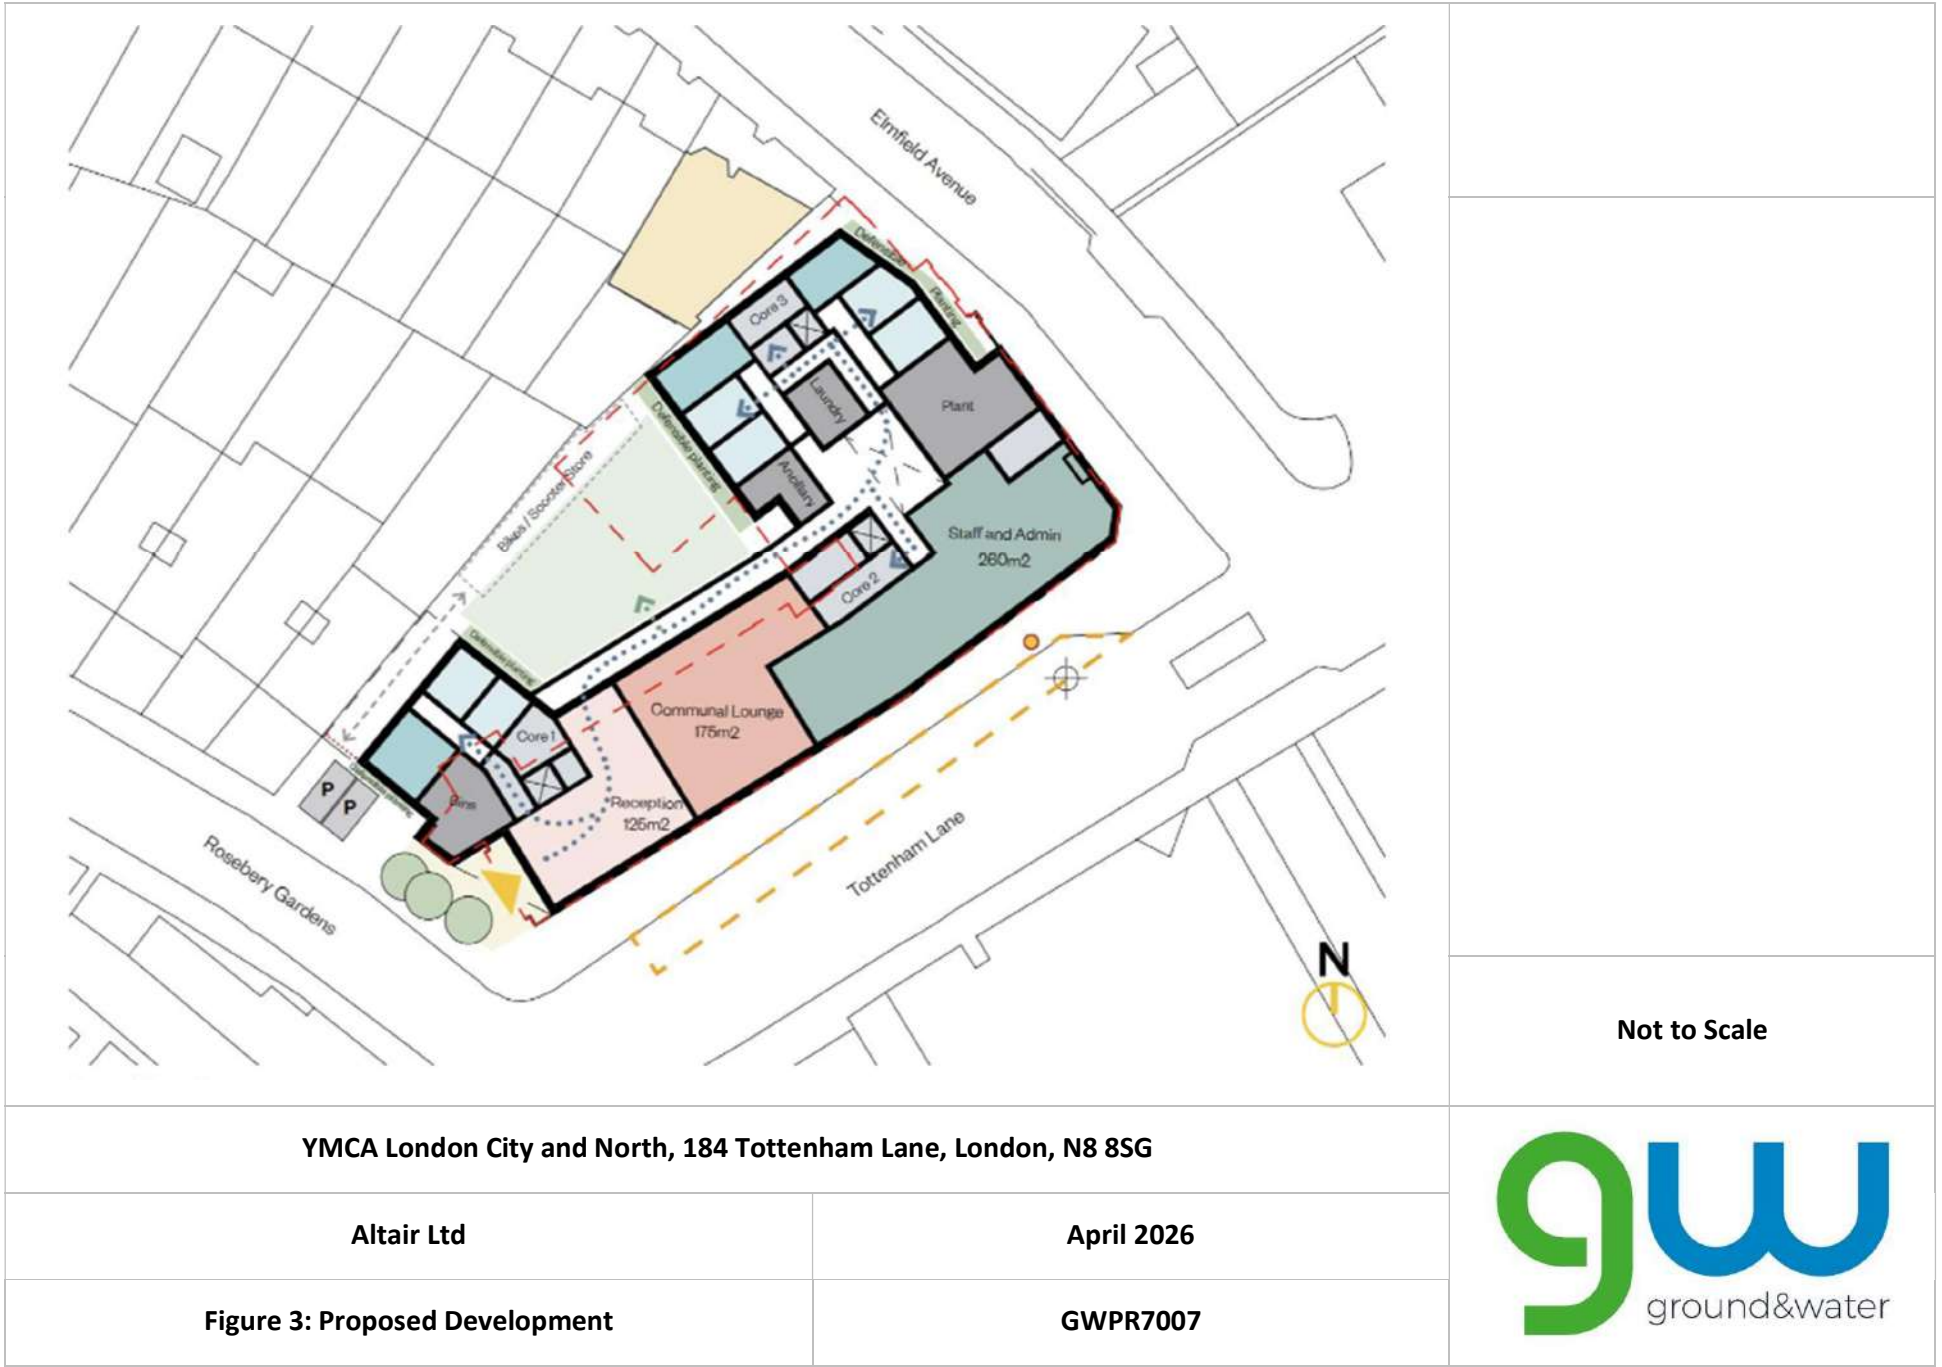
Figure 2: Aerial View of the Site

At the time of reporting, March 2026, the proposed development was understood to comprise the redevelopment of the existing building to deliver approximately 170 bedspaces (from 155 bedspaces) and associated infrastructure. These changes will include alterations to the footprint of the building (part of the northern section the dwelling will be removed and part of the western portion will be extended with new foundations) and adding another storey to the existing 5 storey building. No new soft landscaping areas are proposed. The proposed development plan can be seen within Figure 2.

At the time of reporting, April 2026, the proposed development was understood to comprise the redevelopment of the existing building to deliver approximately 170 bedspaces (from 155 bedspaces) and associated infrastructure. These changes will include increasing the footprint of the building and adding another storey to the existing 5 storey building. The proposed development plan can be seen within Figure 2.

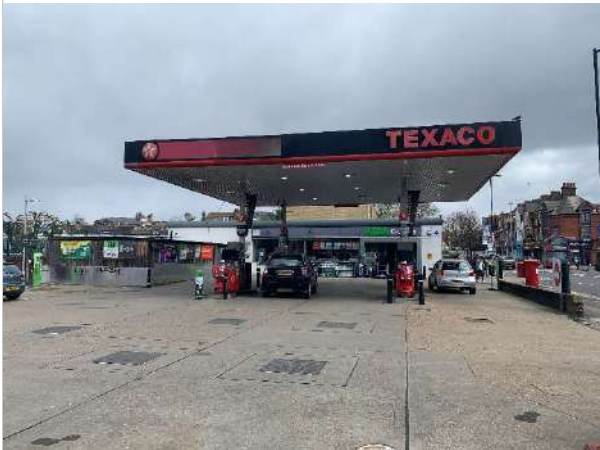
Photograph 9:Petrol station northeast of the site

| Site Description Sheet | |
|---|---|
| <b>Contamination sources off-site</b> | Contamination associated with a petrol station northeast of the site |

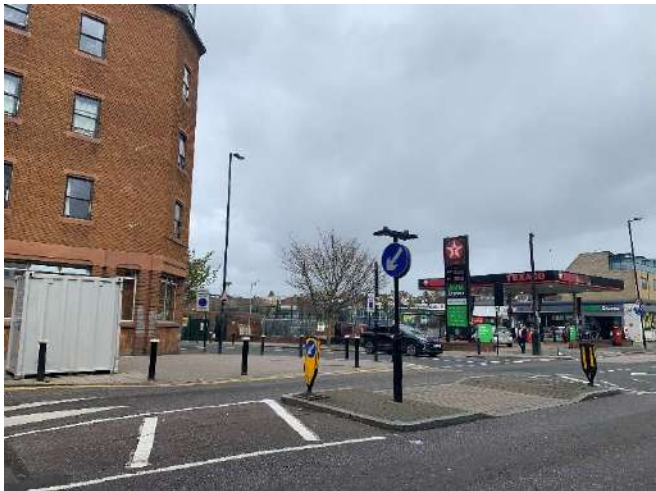
Photograph 10: Looking northeast from the southern side of Tottenham Lane at the site and petrol station
