| DRAWING: | HIGHPOINT II<br>REAR ELEVATION EXTRACT<br>TILED CLADDING |
| PROJECT: | HIGHPOINT |
| STATUS: | PLANNING |
| DRAWING No: | 2545.PL.10.205 |

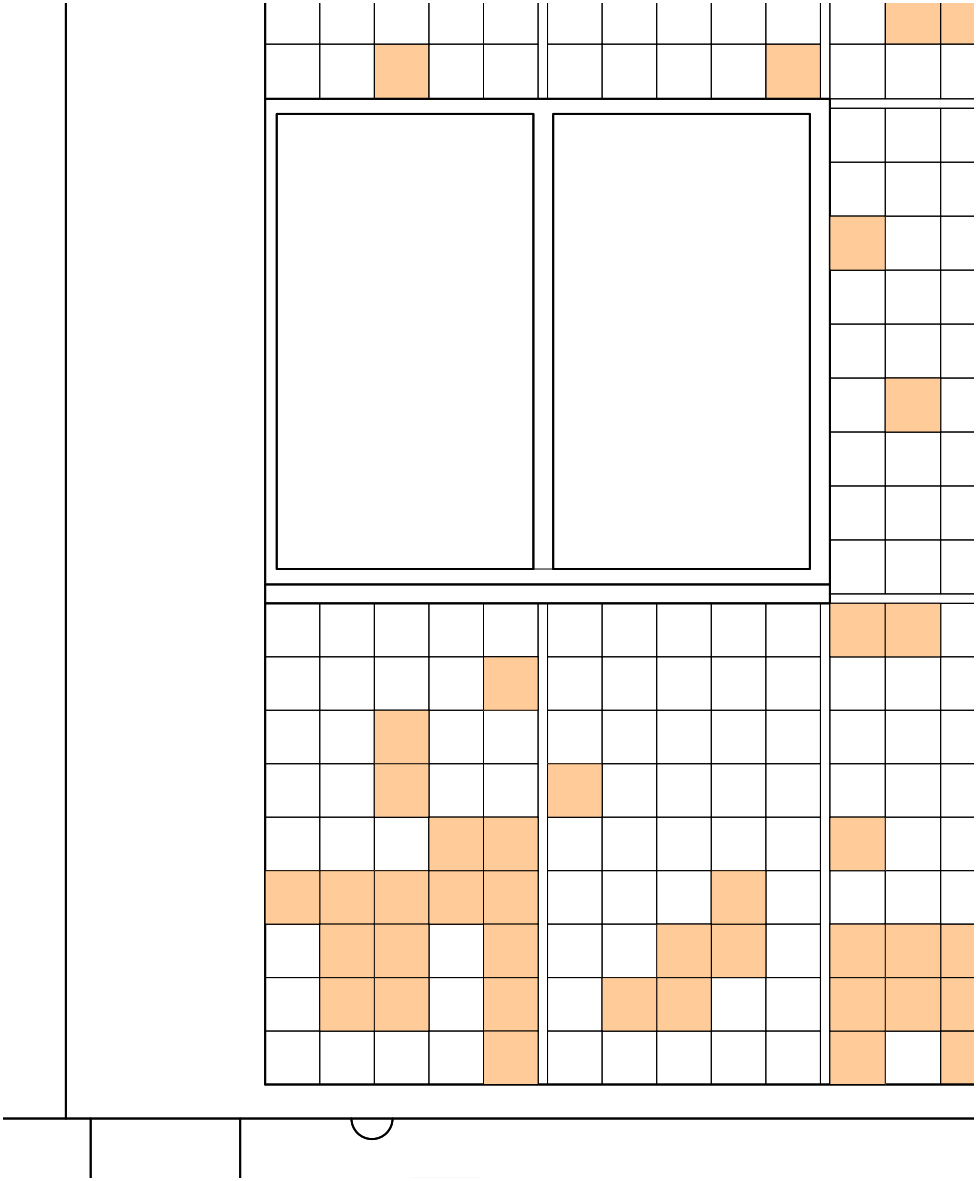
SAMPLE AREA OF HIGHPOINT II - REAR ELEVATION

Drawn area corresponds to area in photo to the right.  
Pink shading indicates tiles that are either damaged or non-original - proposed to be replaced

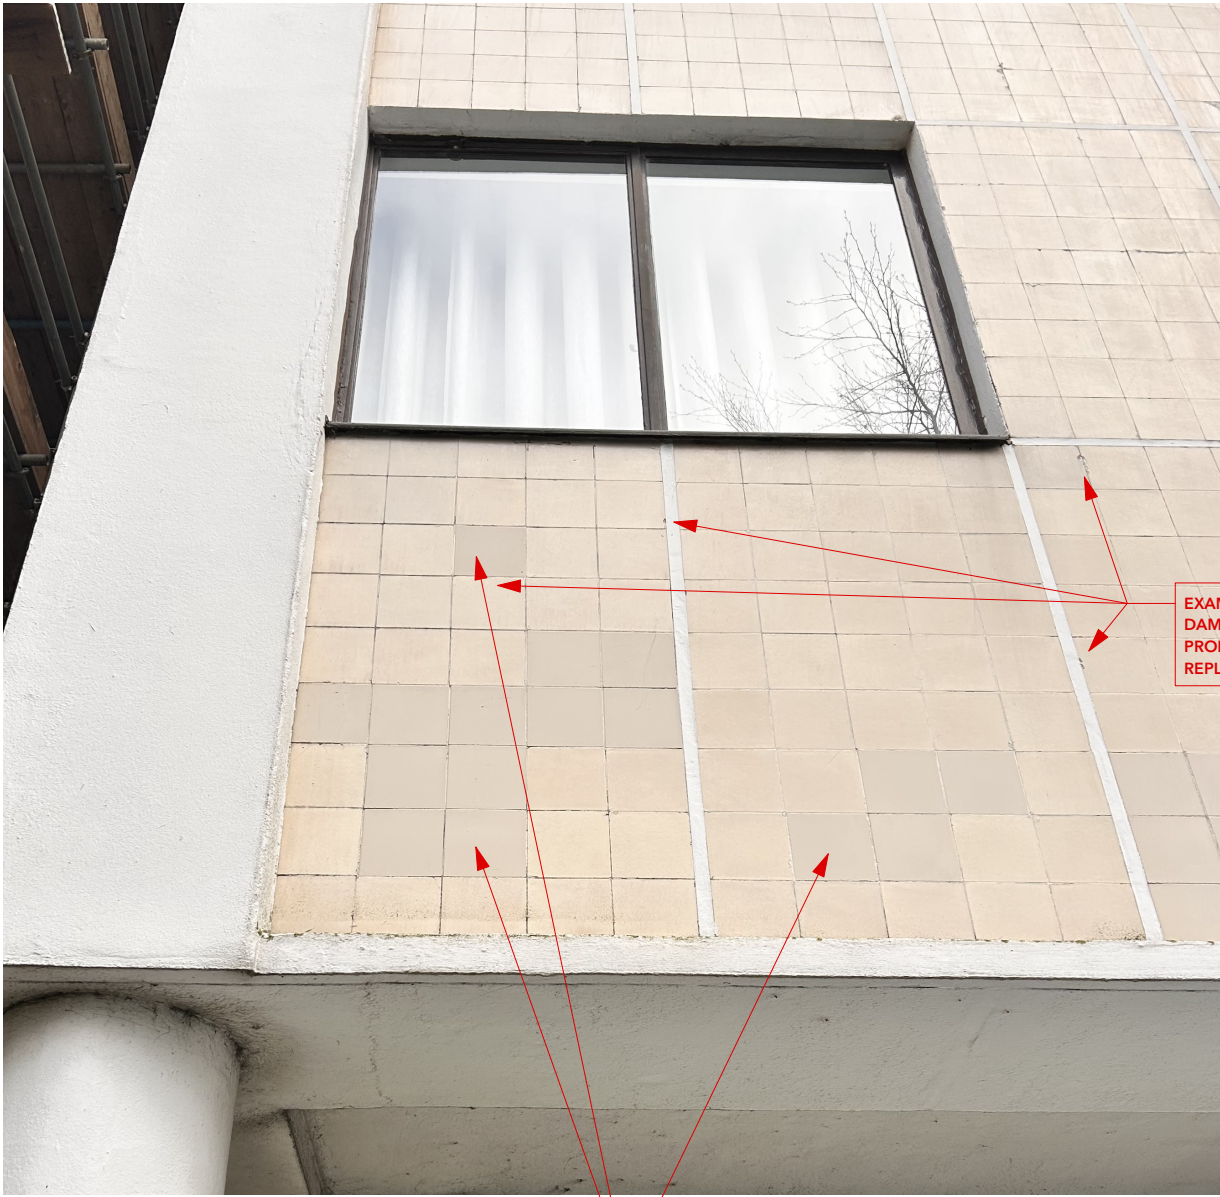
EXAMPLES OF CHIPPED /  
DAMAGED TILES -  
PROPOSED TO BE  
REPLACED

EXAMPLES OF DARKER (NON-ORIGINAL)  
BEIGE TILES - PROPOSED TO BE REPLACED
