## 20. Proposed Risk Mitigation Methodology

This Report has been produced in compliance with the Construction Industry Research and Information Association (CIRIA) C681 guidelines for the writing of Detailed UXO Risk Assessments.

Project: YLCAN – Crouch End

Ref: DA22141-00

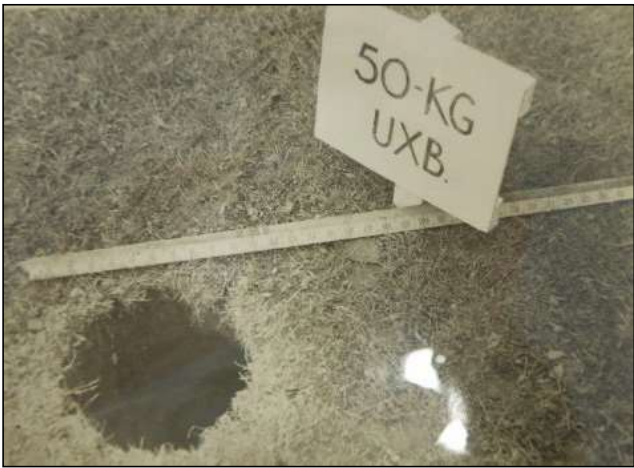
One of the most common scenarios for UXO going unnoticed was when a UXB fell into a 'bomb site' (such as the area shown **Top Left**), the entry hole of the bomb obscured by any debris and rubble present. Note that the entry hole of a 50kg UXB could be as little as 20cm in diameter (**Left**).

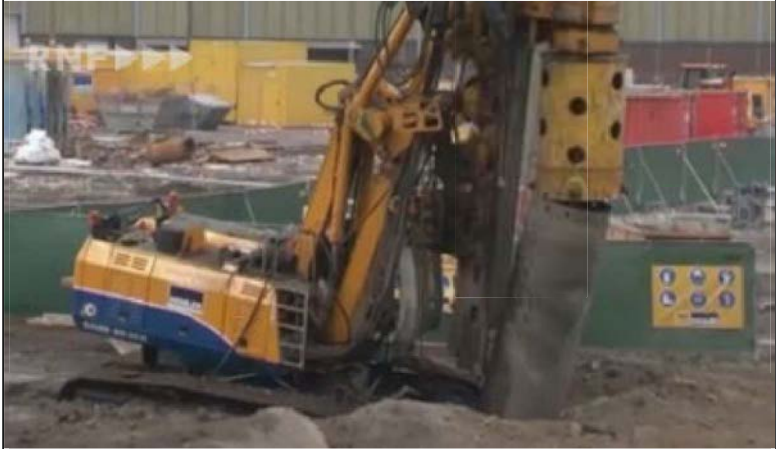
BASF has confirmed that an explosive device, most likely a World War II-era bomb, caused the blast that left one person injured Tuesday at a plant construction site in Germany.

The explosion was reported at BASF's Ludwigshafen toluene diisocyanate (TDI) plant, which recently broke ground for a 300,000 metric tons per year TDI production plant and other construction to expand its facilities.

"Cause of the detonation was an explosive device, presumably a bomb deriving from the Second World War. The device detonated when grounding work was done. No details on [a] delay [are] available. At the moment, the exact circumstances of the incident are [being] evaluated."

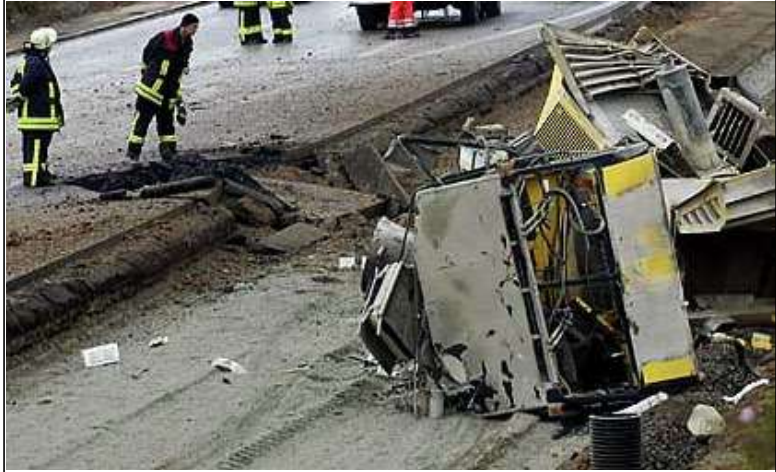
A highway construction worker in Germany accidentally struck an unexploded World War II bomb, causing an explosion which killed him and wrecked several passing cars.

A World War II bomb has exploded during construction work on a German highway, killing one worker and injuring several motorists who were driving past, police said.

The worker had been cutting through the road surface near the south-western town of Aschaffenburg when his machine struck the bomb and triggered it. Police said they weren't sure yet what type of bomb it was. "The explosion seems to have been too small for it to have been an aircraft bomb," a police spokesman said.

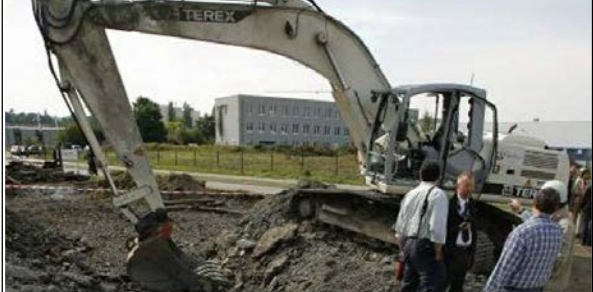
**Seventeen people were injured on Friday when a construction crew unwittingly detonated a buried World War II-era bomb in Hattingen.**

An excavator apparently drove over a 250-kilogramme (550 pound) American bomb, damaging surrounding buildings. Most of the injured suffered auditory trauma from the blast, and the excavator operator suffered injuries to his hands, police in the German state of North Rhine-Westphalia said.

"The hole was astoundingly small for such a large bomb full of so many explosives," Armin Gebhard, head of the Arnsberg department for military ordnance removal, told The Local. "But of course it damaged all the surrounding buildings too. We are really happy it wasn't worse."

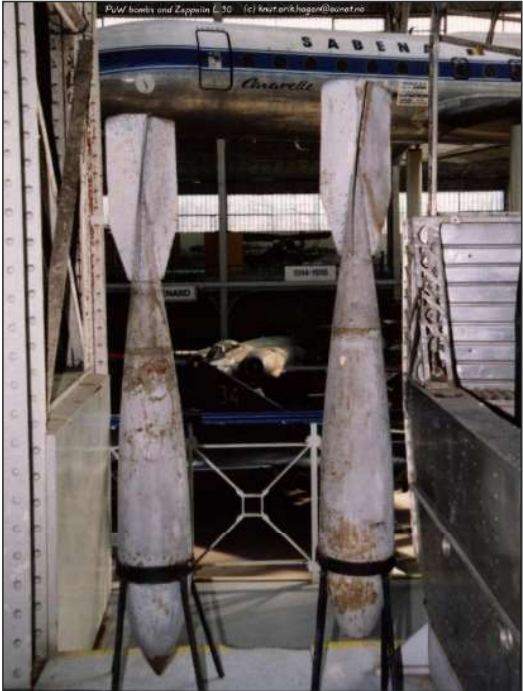
Examples of 50 and 100kg German WWI bombs

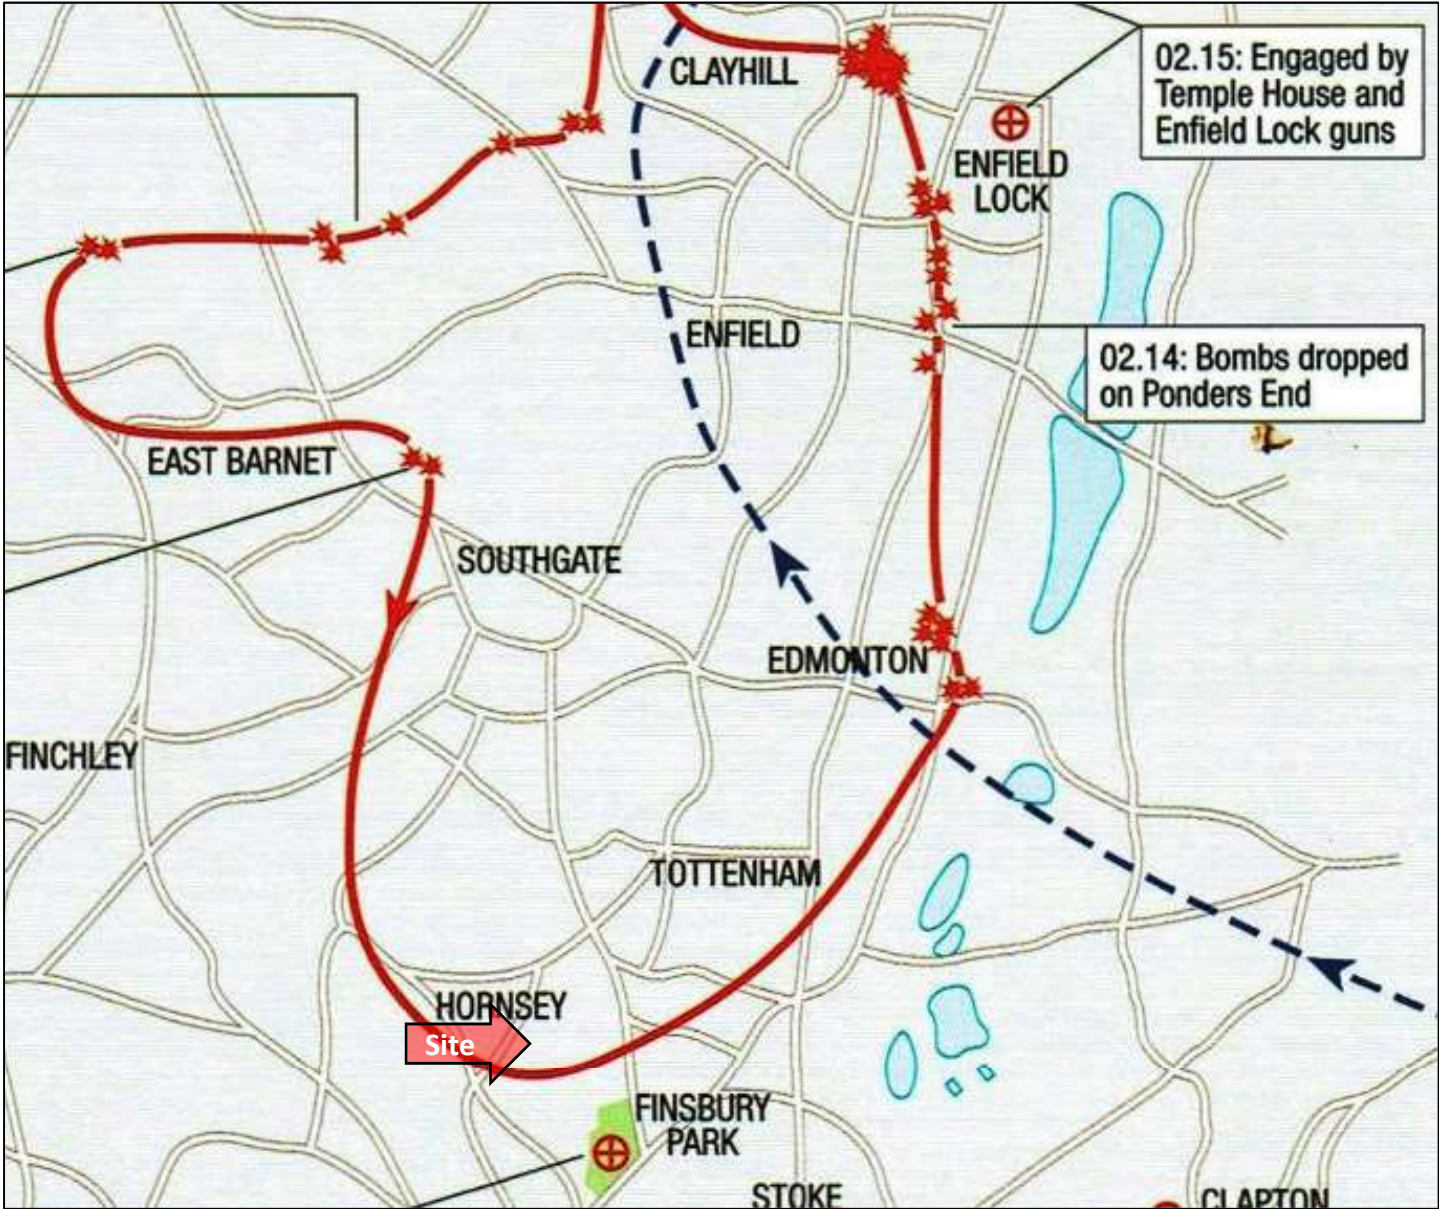
A zeppelin is recorded to have passed approximately 100m west of the site, though no bomb strikes are indicated nearby.

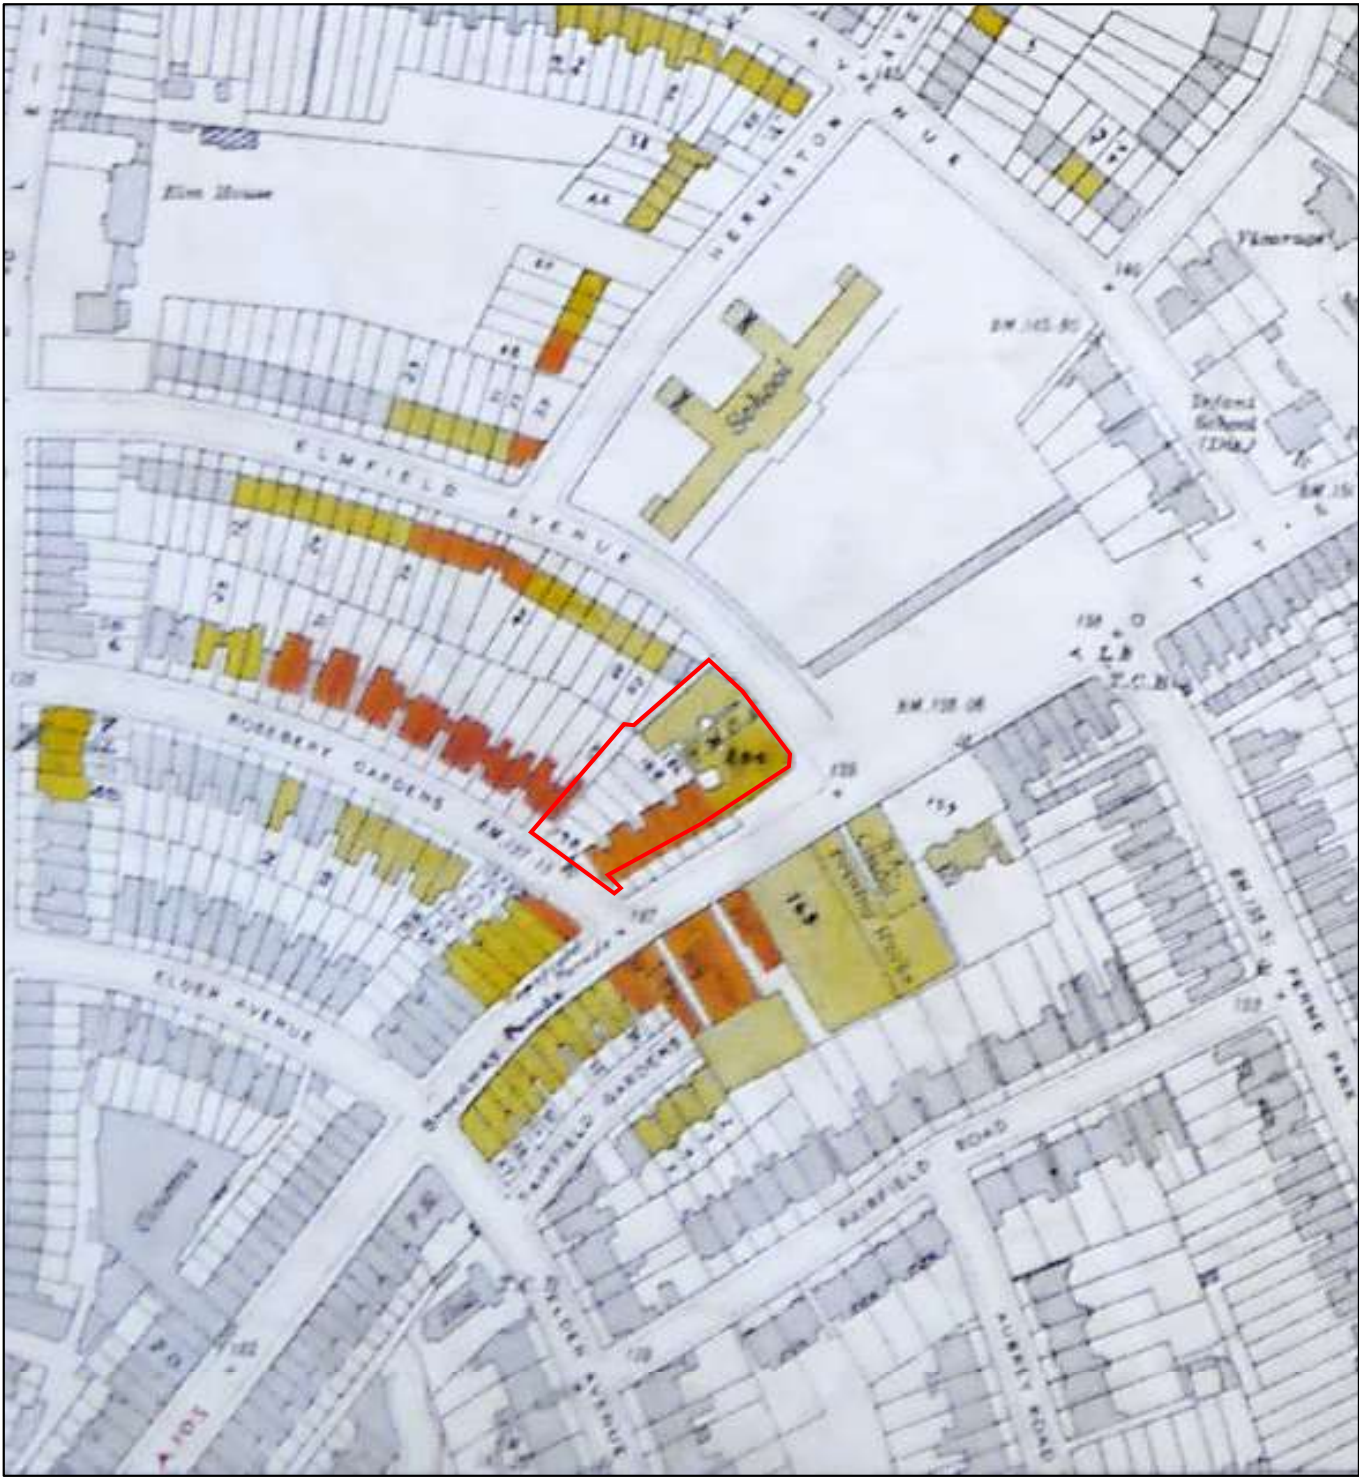
- Category 1 - "Total damage, building to be demolished."
- Category 2 - "Some repairs possible, but could become Cat 1."
- Category 3 - "Border line areas, uncertain whether repairs possible, might have to be demolished."
