**Down Lane Park  
Adjacent to Park View Road & Ashley Road  
Tottenham Hale  
London  
N17 9AU**

## **Geo-Environmental Investigation Report**

**Document Reference: 12230/GEI**

**October 2019**

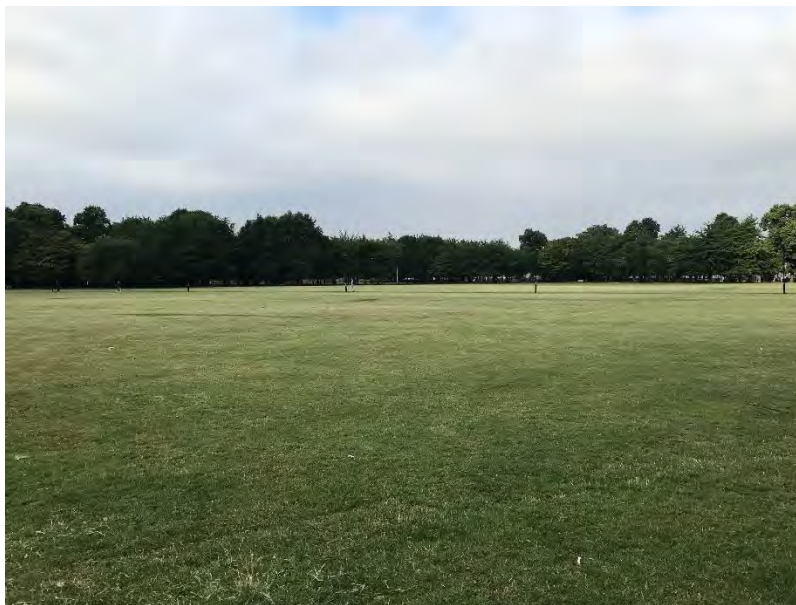
View of park area across northern part of the site

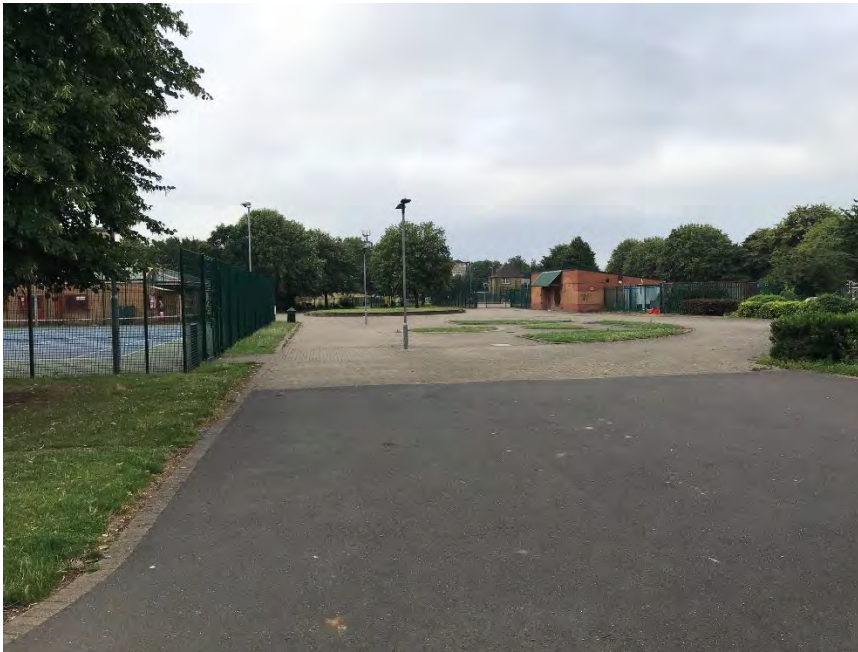
View of southern portion of site with tennis courts in foreground and existing council depot to the right – Looking south

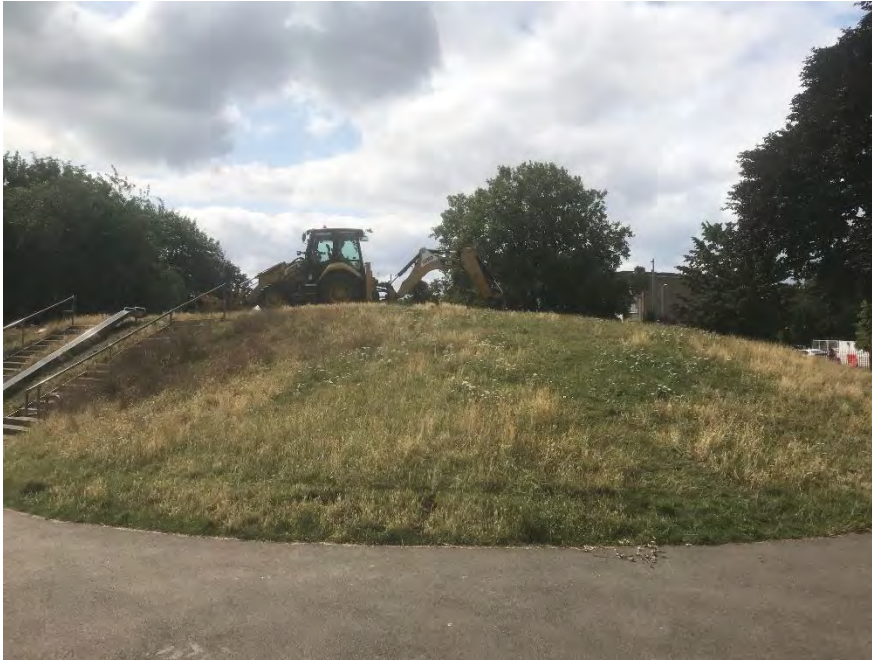
View of existing earth mound within southern part of the site
