# Broadwater Farm Estate

## Mural mosaic

Cutting Line proposal  
Test Trial for removing of tesserae  
Recommendations  
Preventative work  
August 2023

Authored by Paolo Volpi & Ian Devine  
Reviewed by Adrian Attwood ACR

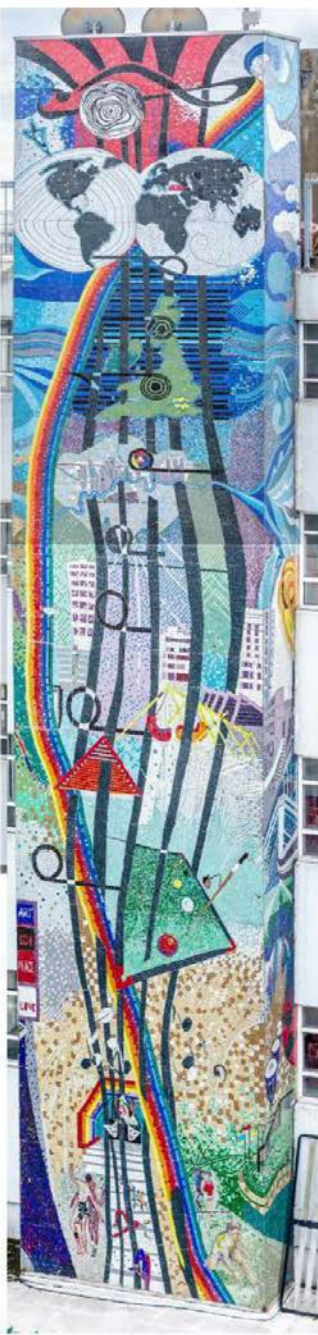
Elevation views  
Scale 1:75@A3

Every marked line (18nr in total + 1 inaccessible because situated between the screed of the mezzanine ceiling) was chosen according to the existing original joints made by the artist during the laying process\*. Unfortunately, while in some cases the laser level followed the existing joints, in other cases it exceeded them.

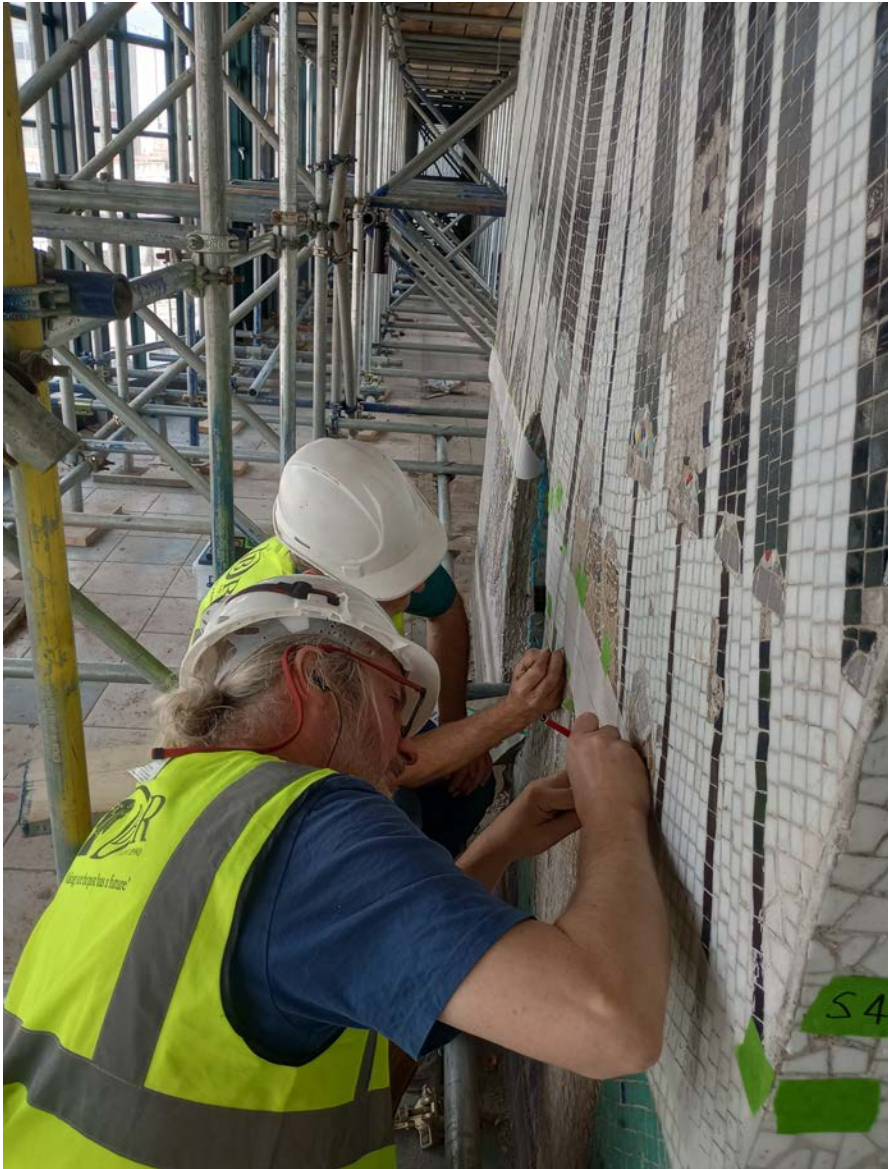
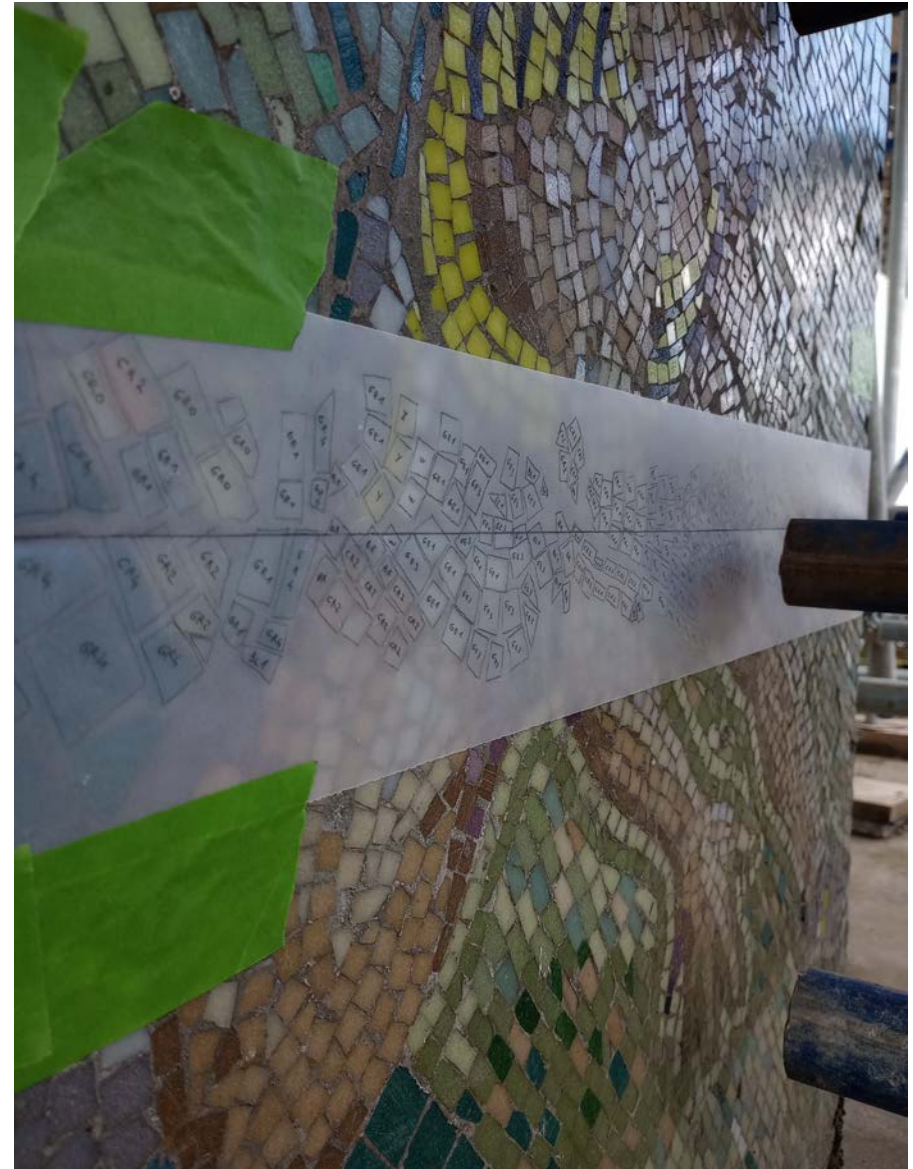
Templates were made using tracing technique, placing strips of tracing paper sheets directly onto the mosaic and, the contour of at least two rows of tesserae above and below the line was traced using a pencil.

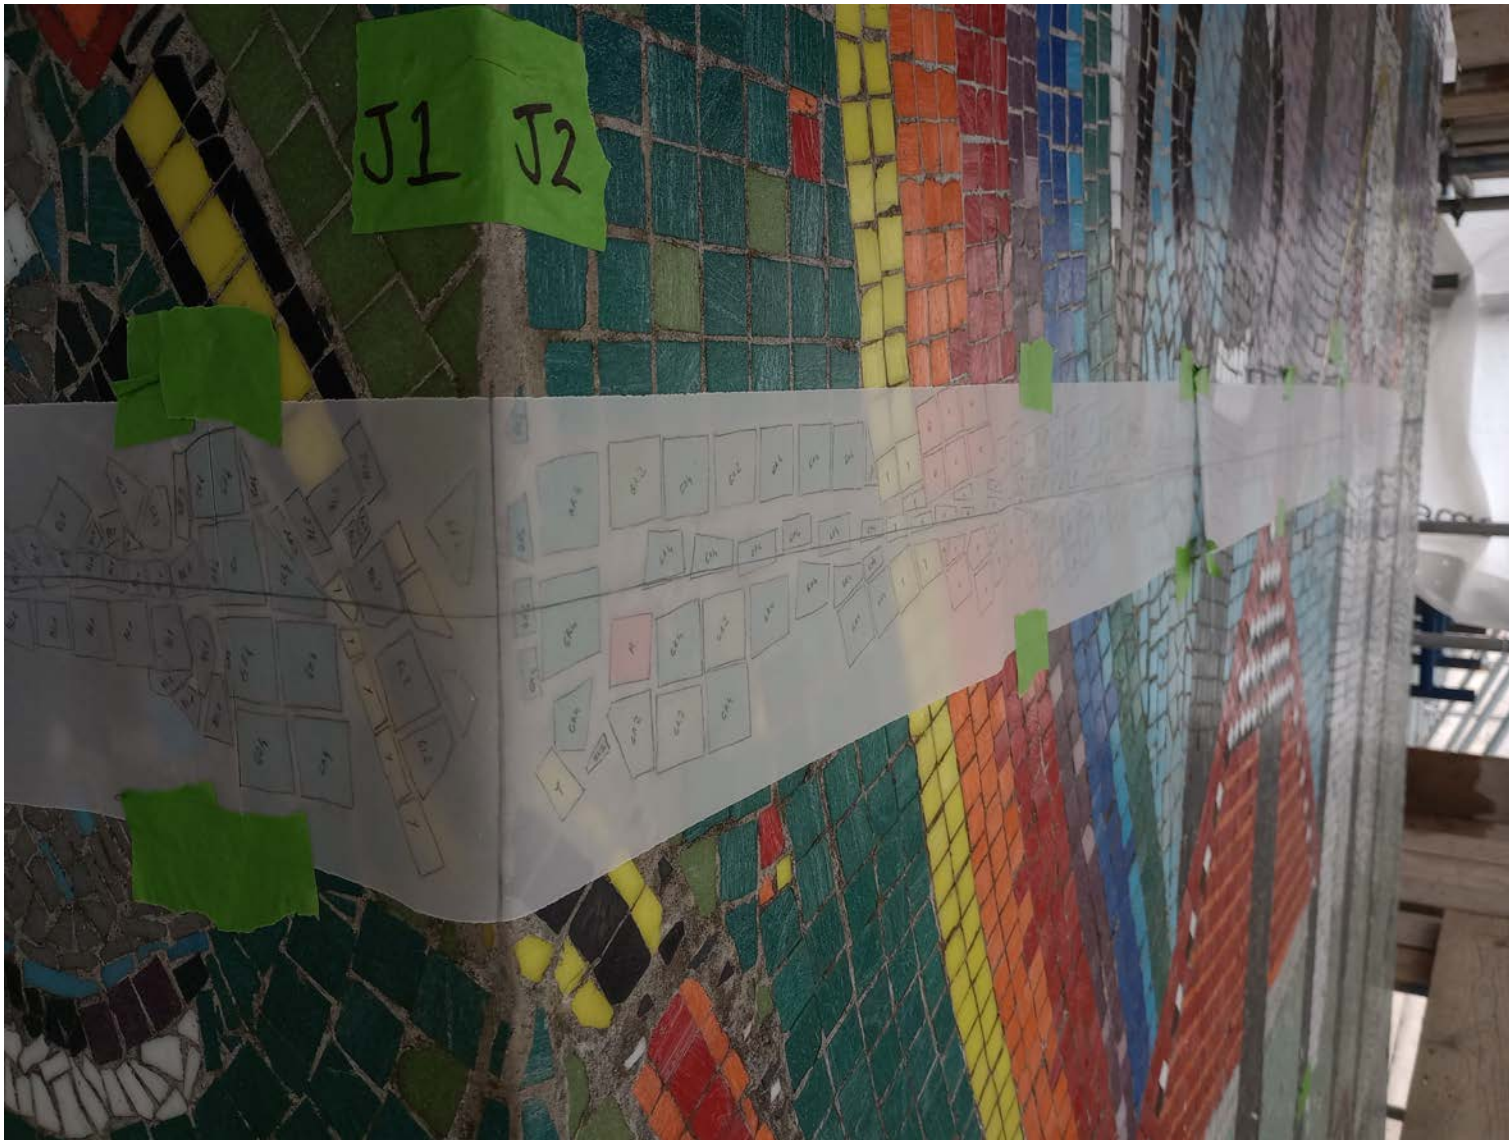
The result was a perfect copy of each tessera, its shape, colour and exact position on the proposed cut line.

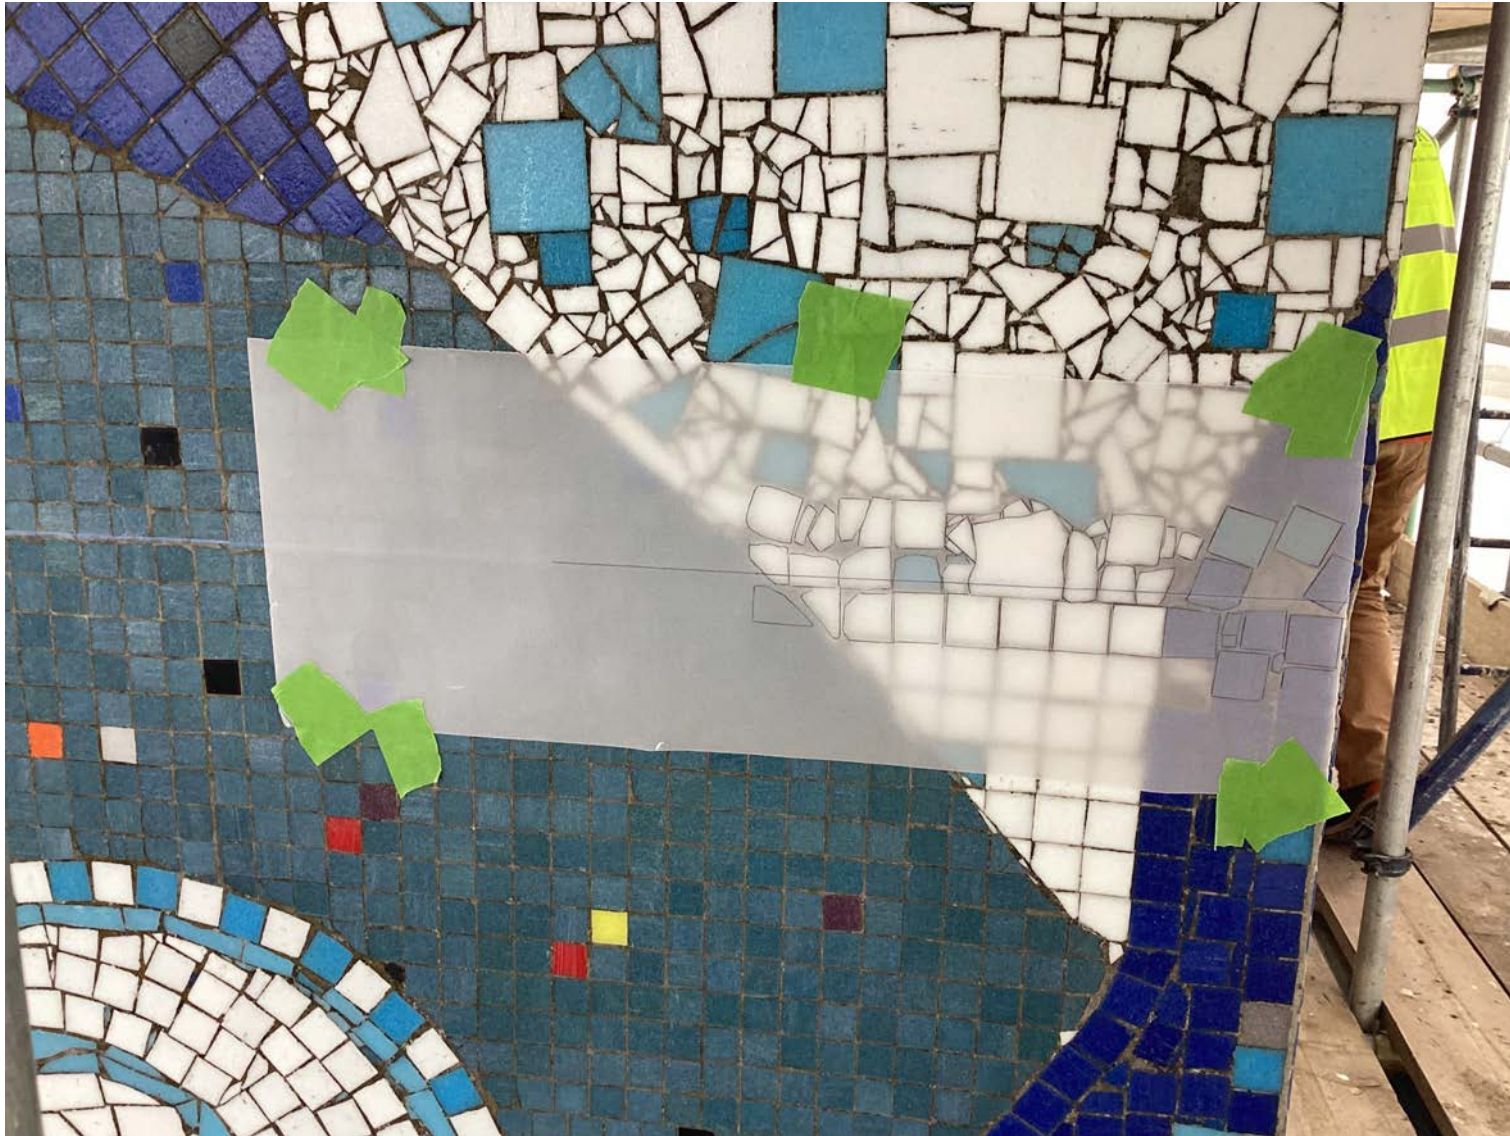
The trial location was on the cut line between panels A1 and B1. The trial area was 300mm x 75mm. This area has irregularly sized and shaped tesserae. The area was photographed and outlines of the tesserae traced before the cutting test commenced.

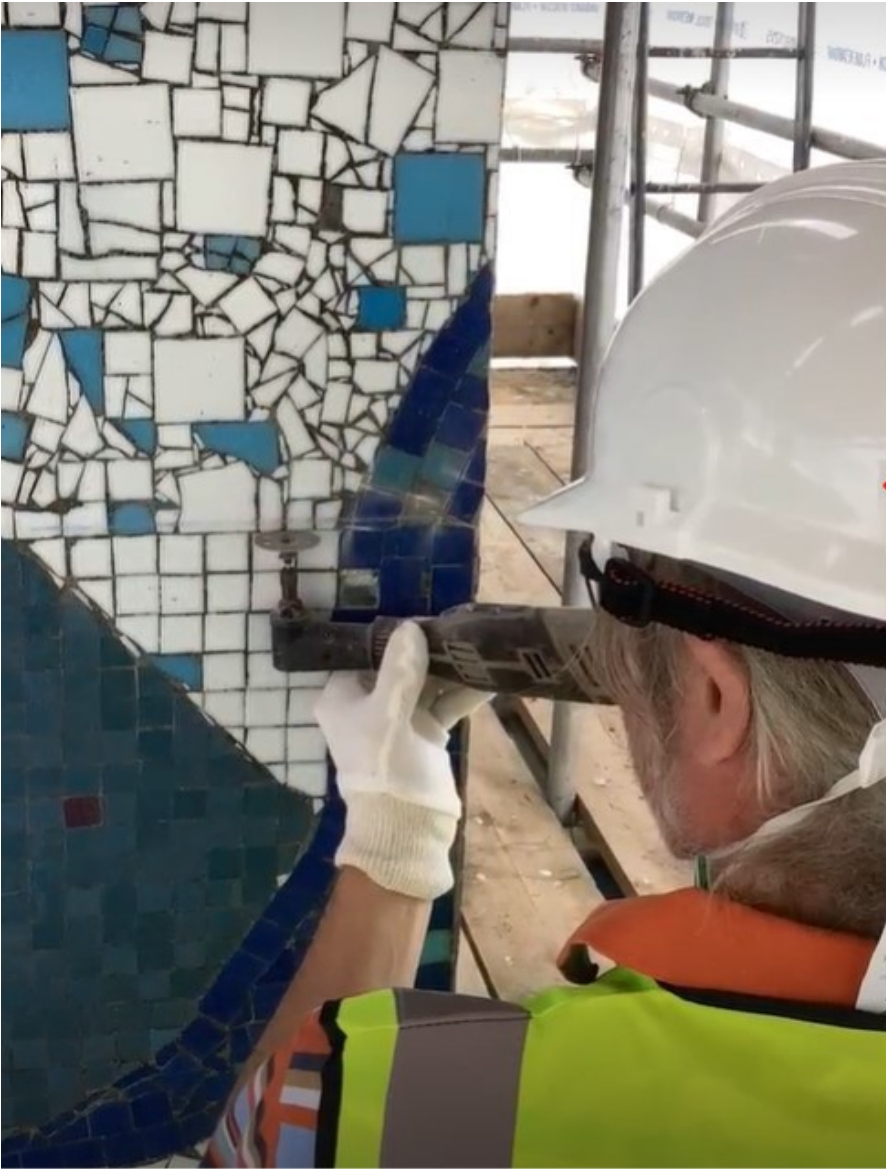
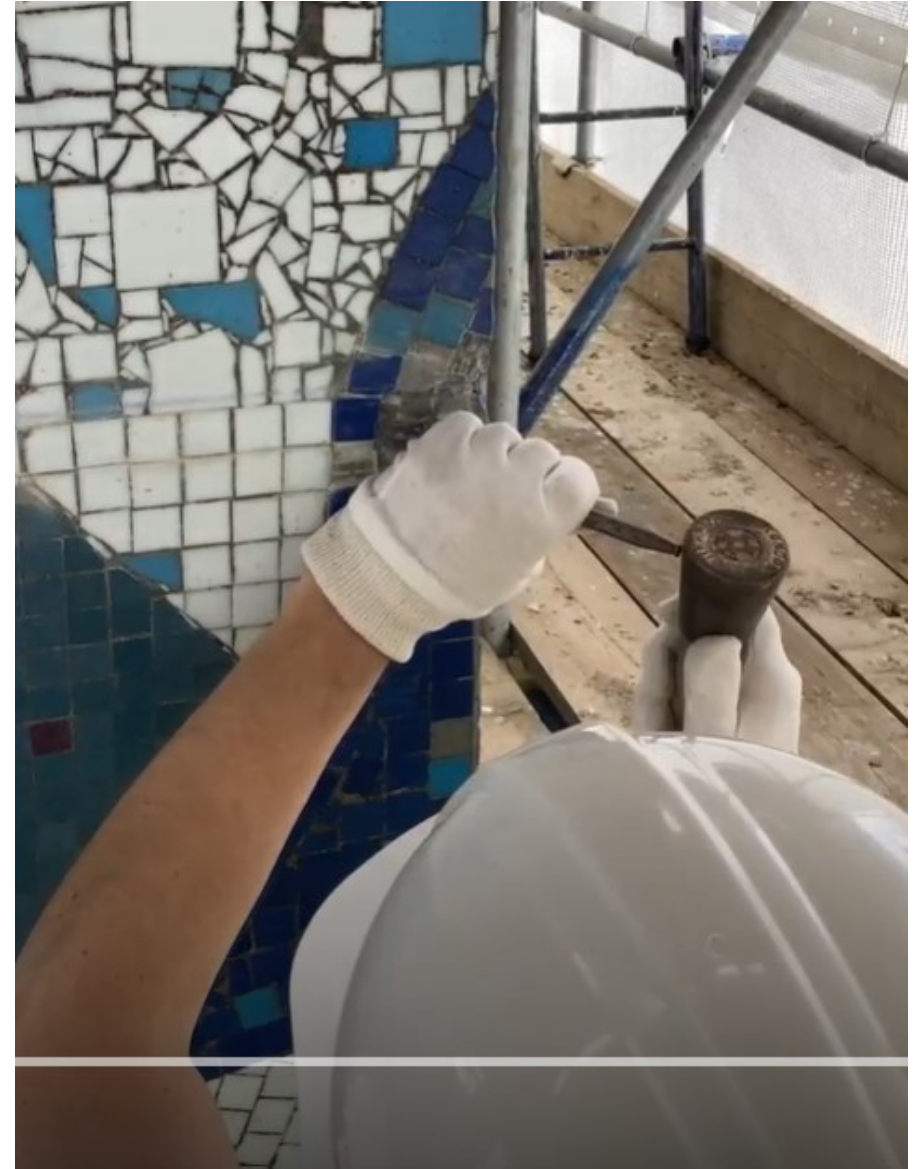
The joints between the tesserae were cut with a Dremmel diamond cutting disc. Then the tesserae were carefully removed with a sharp tungsten chisel and dummy mallet.

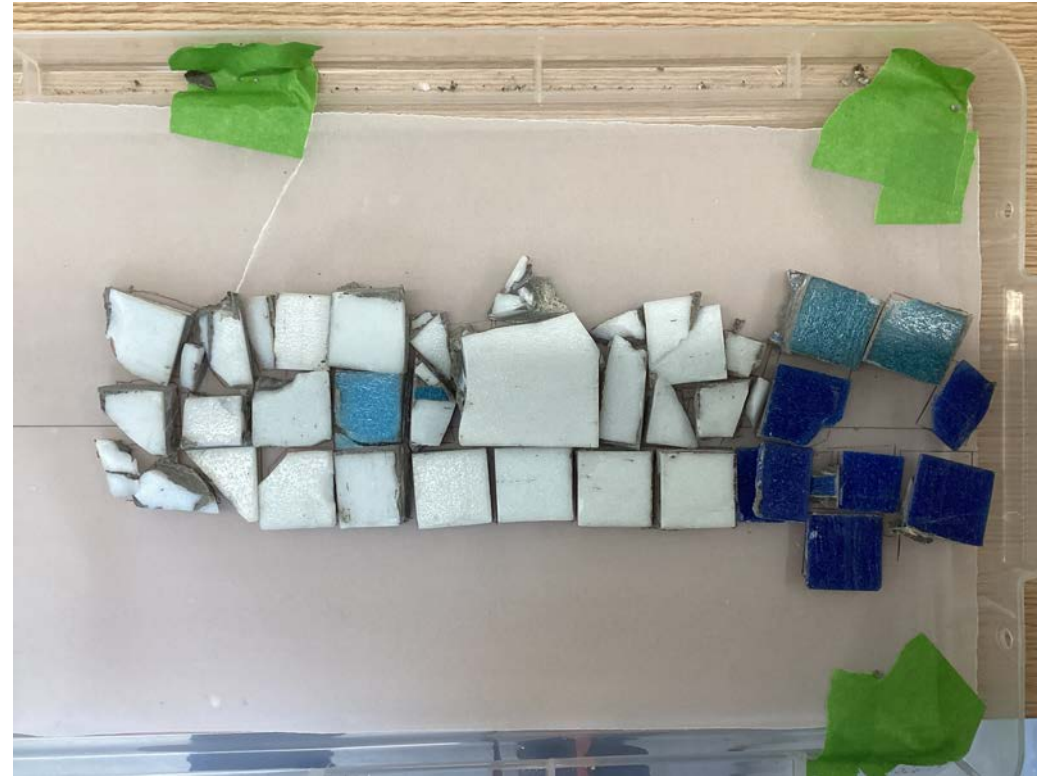
Tesserae were placed and numbered on the template as they were being removed to maintain the original design. Then these were safely stored so that they could be re-used.

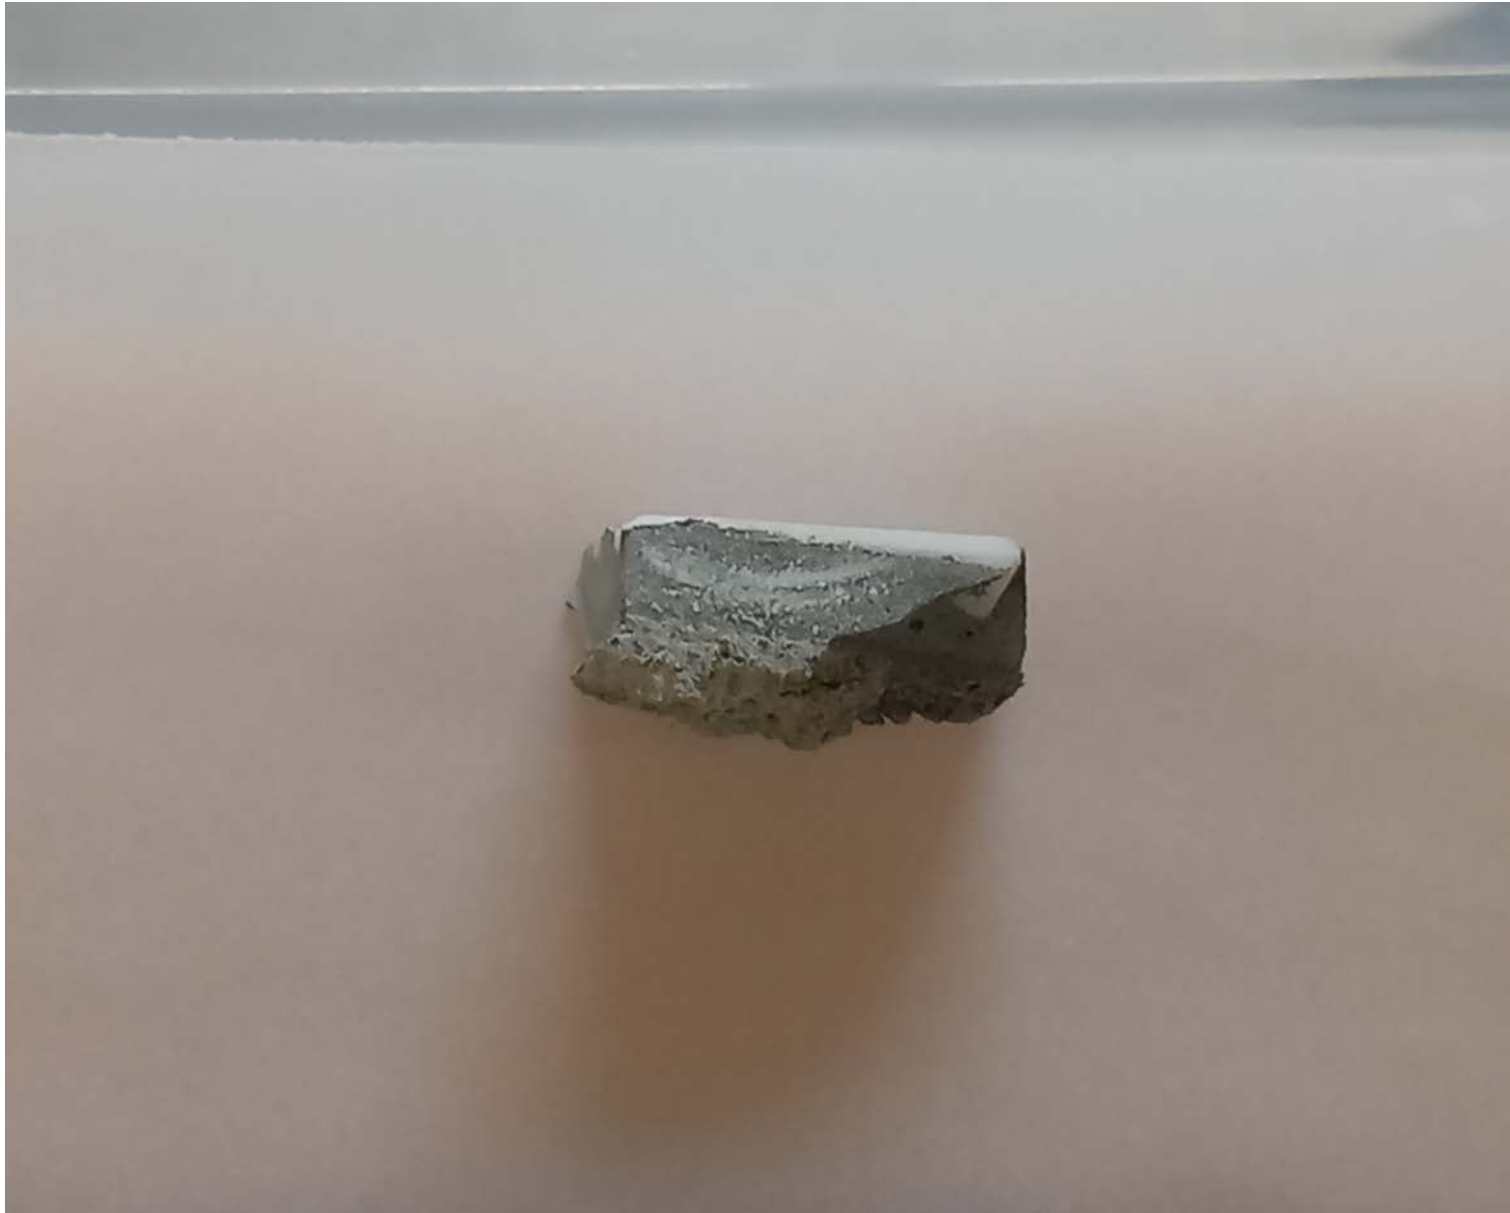
The mosaic, made of modern cement and concrete, might also be modified by adding polymers that would make these materials incredibly strong. Due to the tesserae being well adhered to the cement, several of them fractured during removal. They will need to be<sup>14</sup> additionally worked on so that the bedding material can be removed before they are re-installed.

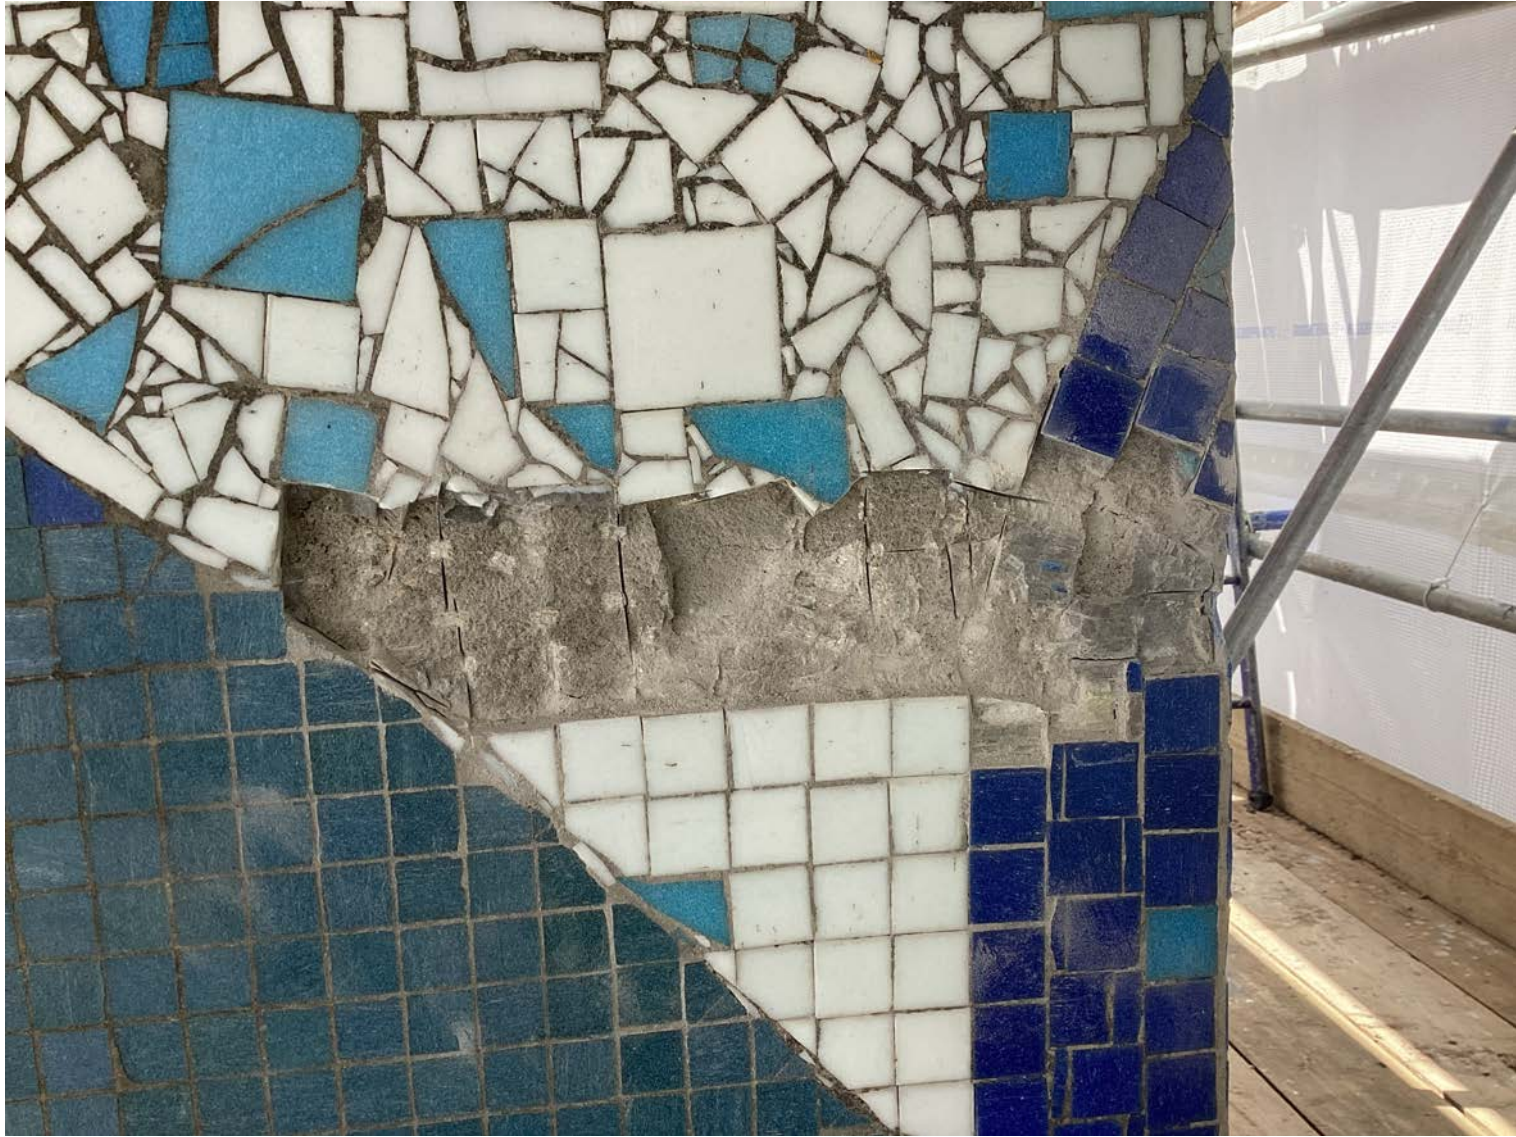
Tesserae were difficult to remove with this method due to the bond between tesserae and bedding material. Being in vitreous paste (glass) and very thin (3mm to 4mm), they are very fragile. These have achieved a very secure bond with the bedding mortar so they can only be removed intact with the bedding material attached. Removing this cement later is likely to result in damage and further loss of tesserae.

The removing of tesserae along the cut lines, that was to enable diamond cutting of the structural concrete, resulted in too much loss of individual tesserae. This method should not be considered as a “first option”.

Cutting through the concrete blocks without removing tesserae along cut lines.

- First cut 50mm of concrete
- Second cut 120/150mm of concrete
- Last final slow and accurate cut through the tesserae approaching the diamond disk half way at the front.

**DBR Conservation** recommends using a diamond disk as thin as possible, possibly not segmented so to not stress the mosaic tesserae during the cutting process.
