**Geo-Site Assessment Report  
Wood Green Social Club  
Wood Green, London  
N22 5NJ**

**ISSUE DATE: July 2023  
REPORT REF: 21206R1 (Issue C)**

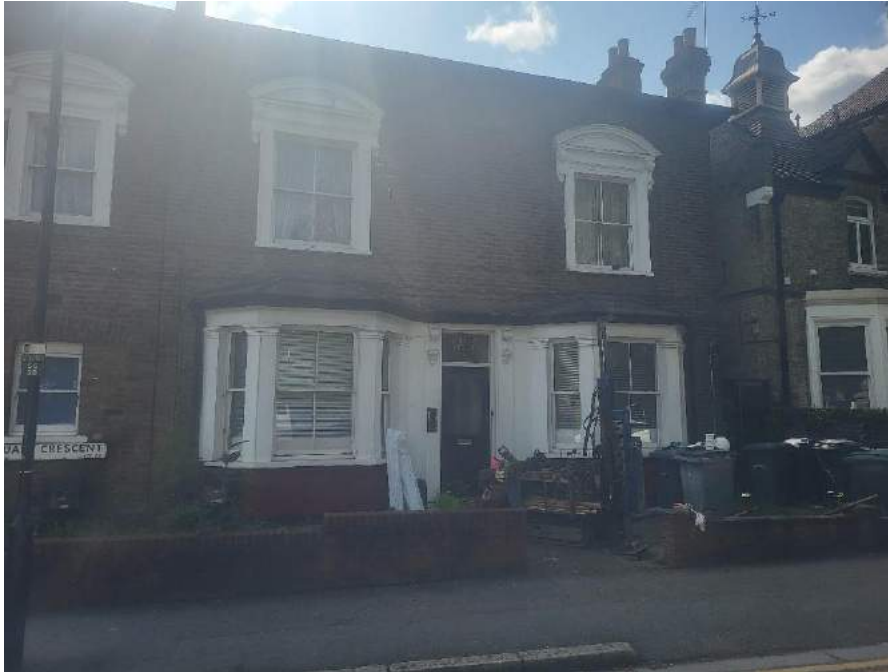
Photo 1 – Detached dwelling (facing south)

The site measures 0.15 hectares with a N to S distance of ~50m and an E to W distance of ~35m comprising a detached brick-built residential dwelling (Photo 1) and Wood Green Social Club (Photo 2) building with hard standing in moderate condition across the site (Photo 3). A drainage system runs at the rear of the site along the eastern border (Photo 4). There were no signs of any surface contamination.
