## Detailed Unexploded Ordnance (UXO) Risk Assessment

| <b>Project Name</b> | St Ann's Hospital |
| <b>Site Address</b> | St Ann's Road, Tottenham, London, N15 3TH |
| <b>Report Reference</b> | DA5244a-00 |

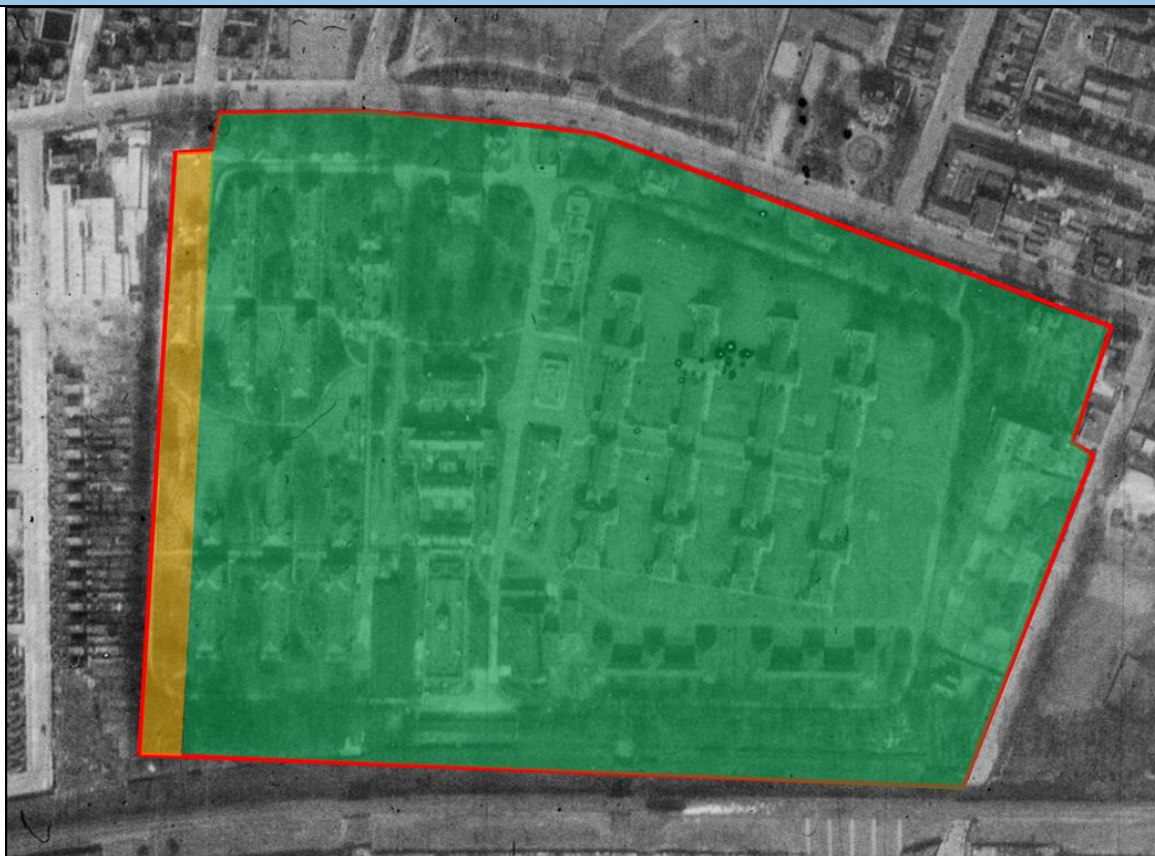
Risk Map

For indicative purposes – not to scale.  
Please note that this assessed risk map may not take into account all post-war redevelopment/excavations on site.

- Based on this criteria 1<sup>st</sup> Line Defence have assessed the majority of the site to be at **Low Risk**, with the far western section of the site at **Medium Risk**. A buffer zone has also been provided to take into account the 'J-curve' effect, whereby a bomb can move laterally underground and come to rest within adjoining ground away from its point of entry.
- There is no evidence that the site formerly had any military occupation or usage that could have led to contamination with items of Allied ordnance, such as LSA and SAA. The conditions in which HAA or LAA projectiles may have fallen unnoticed within the site boundary are however analogous to those regarding aerial delivered ordnance.

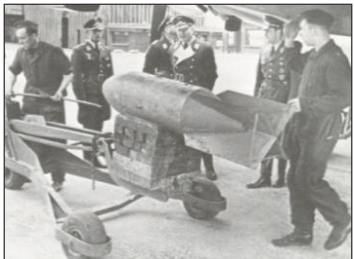
SC 250kg High Explosive Bomb

| Use | Against railway installations, embankments, flyovers, underpasses, large buildings and below-ground installations. |
| Remarks | It could be carried by almost all German bomber aircraft, and was used to notable effect by the Junkers Ju-87 Stuka (Sturzkampfflugzeug or dive-bomber). |

SC250 bomb being loaded onto German bomber

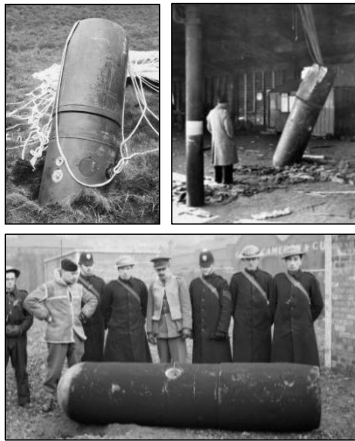
Parachute Mine (Luftmine B / LMB)

| Use | Against civilian, military and industrial targets. Used as blast bombs and designed to detonate above ground level to maximise damage to a wider area. |
| Remarks | Deployed a parachute when dropped in order to control its descent. Had the potential to destroy a whole street of housing in a 100m radius. |

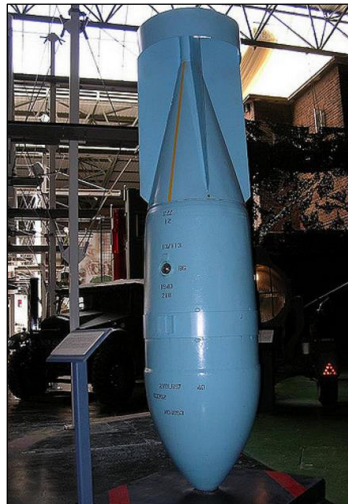
SC 1000kg

| Use | SC type bombs are General Purpose Bombs used primarily for general demolition work. Constructed of parallel walls with comparatively heavy noses. They are usually of three piece welded construction |

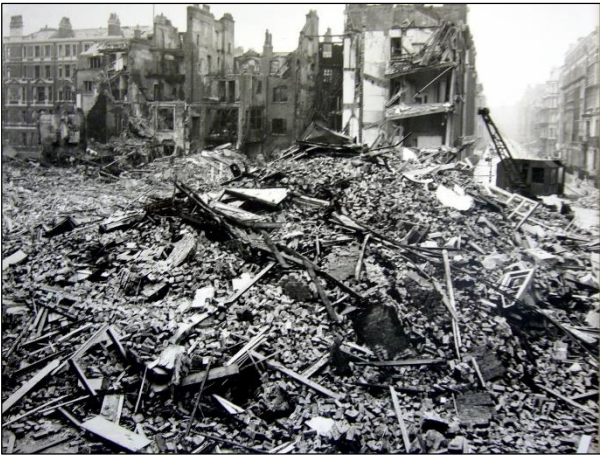
**Top:** J-curve Effect - Due to angle of entry, unexploded bombs would often end their trajectory at a lateral offset from point of entry, often ending up beneath adjacent extant structures/sites.

One of the most common scenarios for the above occurring was where a UXB fell into a 'bomb site' (such as the area shown **Top Left**), the entry hole of the bomb obscured by debris and rubble present. Note that the entry hole of a 50kg UXB could be as little as 20cm in diameter (**Left**).

Photograph **above** shows 250kg bomb found in Bermondsey pointing upwards, demonstrating 'J-curve'

J-curve is the term used to describe the characteristic curve commonly followed by an aerial delivered bomb dropped from height after it penetrates the ground. Typically, as the bomb is slowed by its passage through underlying soils, its trajectory curves towards the surface. Many UXBs are found with their nose cone pointing upwards as a result of this effect. More importantly however is the resulting horizontal offset from the point of entry. This is typically a distance of about one third of the bomb's penetration depth, but can be up to 15m.
