# GEOSHIELD Verification Report

REPORT NUMBER: 004

PROJECT: Blocks D3 & D4. Clarendon Road.

AREA SURVEYED: Retaining wall.

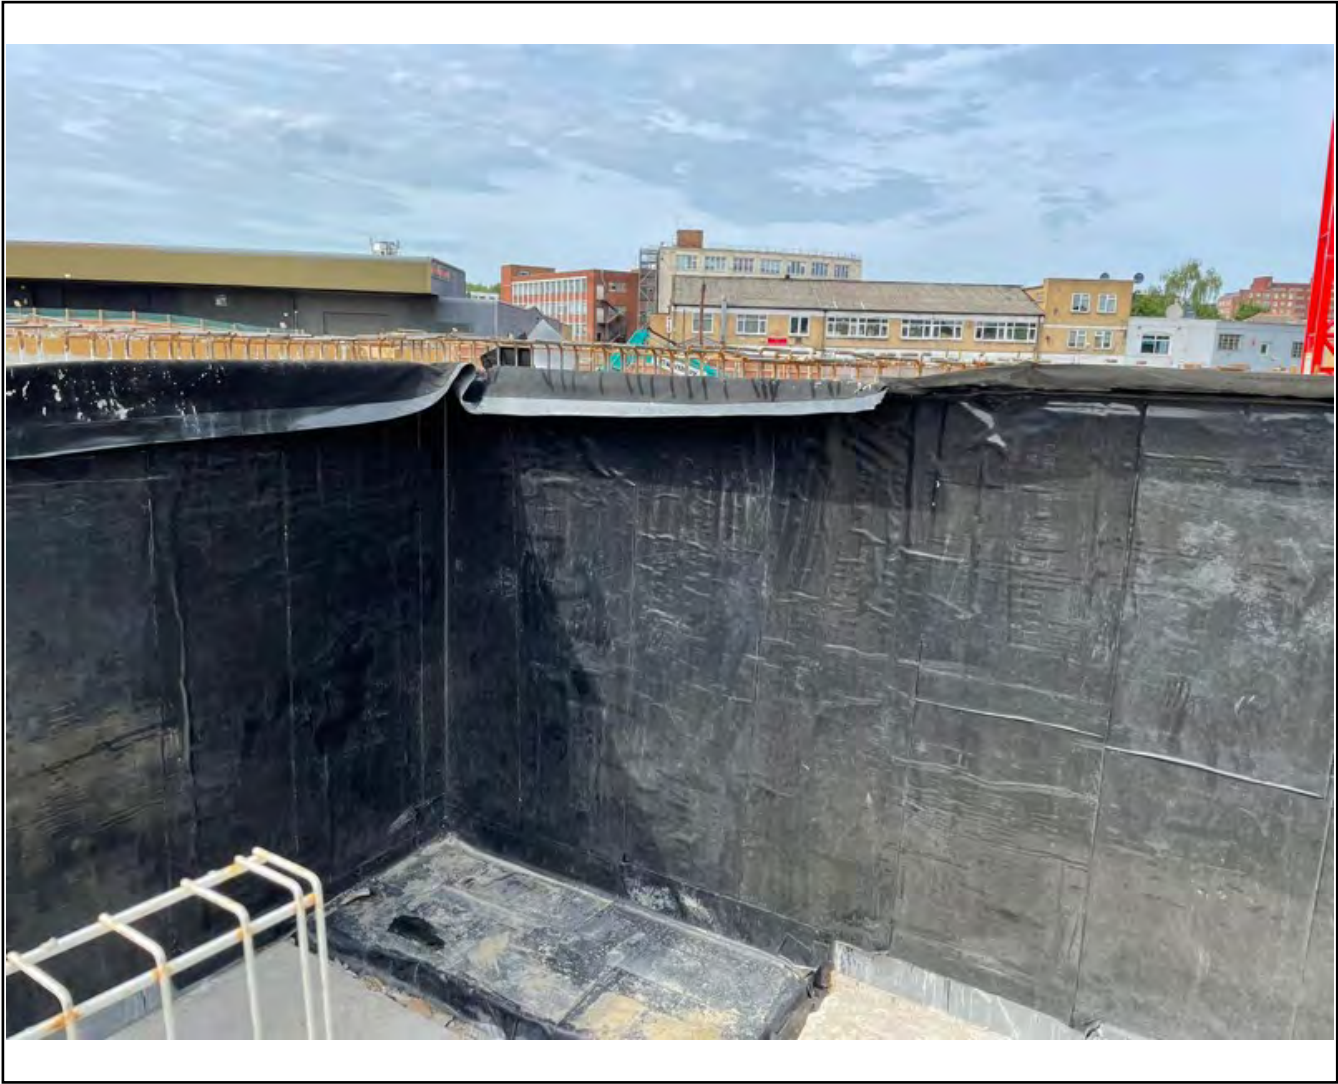
Block D3 - Retaining wall.

Overview photograph of the area verified during this visit.

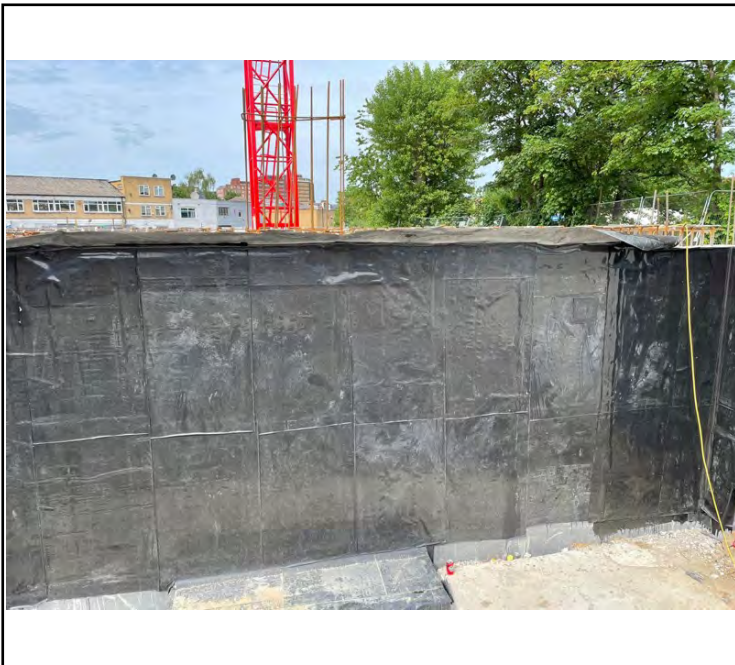
LOCATION/GRID LINE: Block D3 - Retaining wall

The retaining wall within block D3 has been primed with Pudlo self seal primer and left to cure prior to the Pudlo ultra seal application. The installation has been carried out in accordance to manufactures specification. The photograph below on the left displays...

...a section of the completed retaining wall. The photograph above on the right shows evidence of the Pudlo self seal primer.

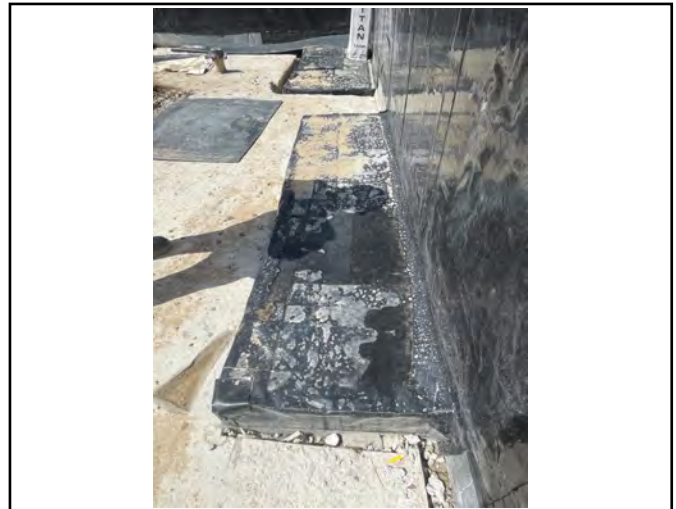
LOCATION/GRID LINE: Block D3 - Retaining wall

The photograph below on the right shows the installers have carried out the install in close connection to the design detail. A continuous strip of Pudlo ultra plus membrane has been linked to the top of the retaining wall so sufficient overlaps can be achieved...

The photograph above on the right shows the Pudlo ultra seal has been returned onto the existing Pudlo ultra plus membrane. This has created continuity of ground gas protection throughout the higher and lower levels throughout the block.

A good standard of works carried out by the specialist installers from SWC.

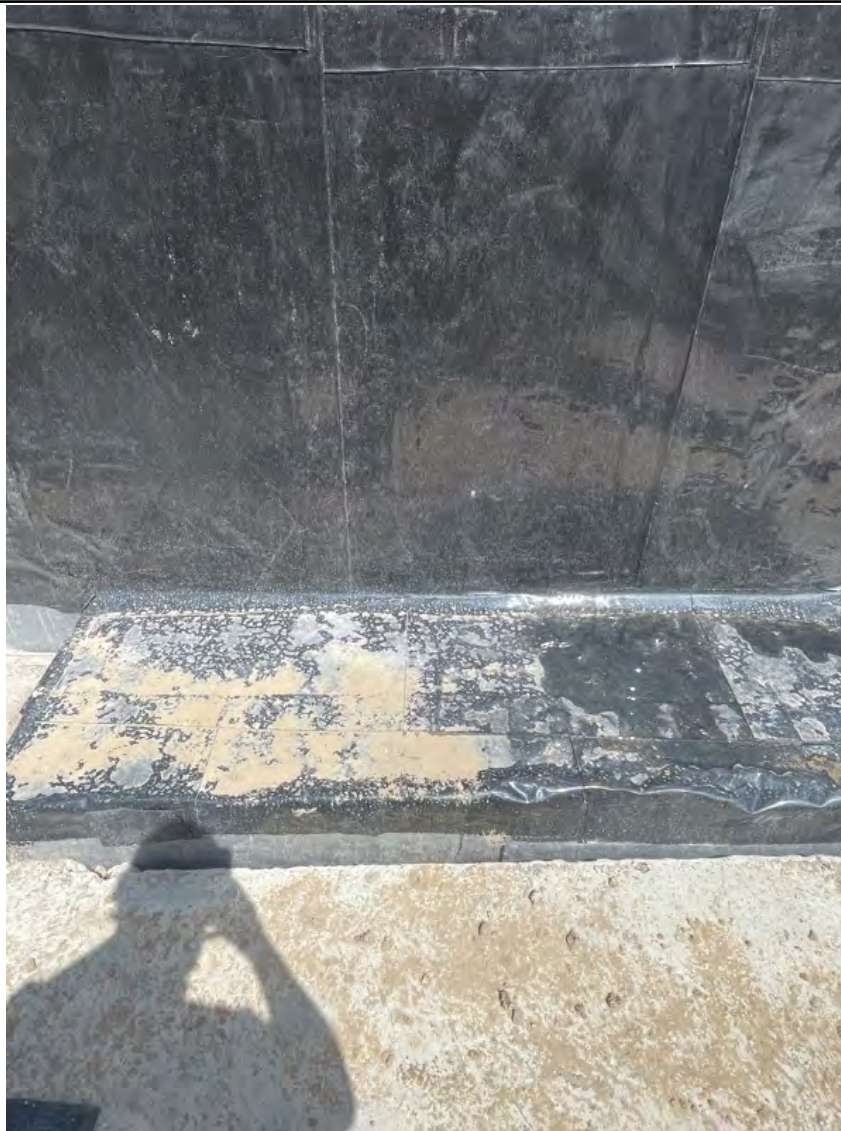
The above photograph displays further evidence of the Pudlo ultra seal returned onto the exposed Pudlo ultra plus membrane from the adjacent slab which was verified and tested on a previous visit.

Verified in accordance with CIRIA 735.

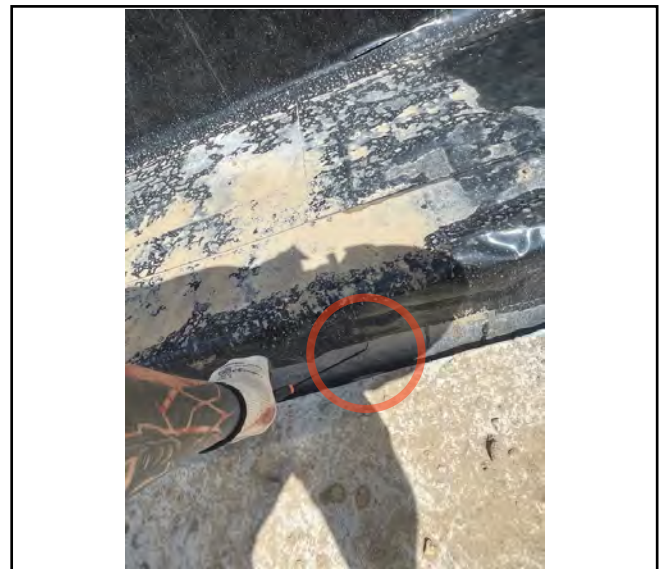
LOCATION/GRID LINE: Block D3 - Retaining wall

The photograph on the right displays the pick&probe test being conducted upon the return onto the Pudlo ultra +. No faults identified. Verified in accordance with CIRIA 735
