22011 69 Cromwell Avenue, N6 5HS  
December 2023 Basement Impact Assessment (BIA)

22011-MHA-ZZ-ZZ-RP-S-001

## Non-Technical Summary

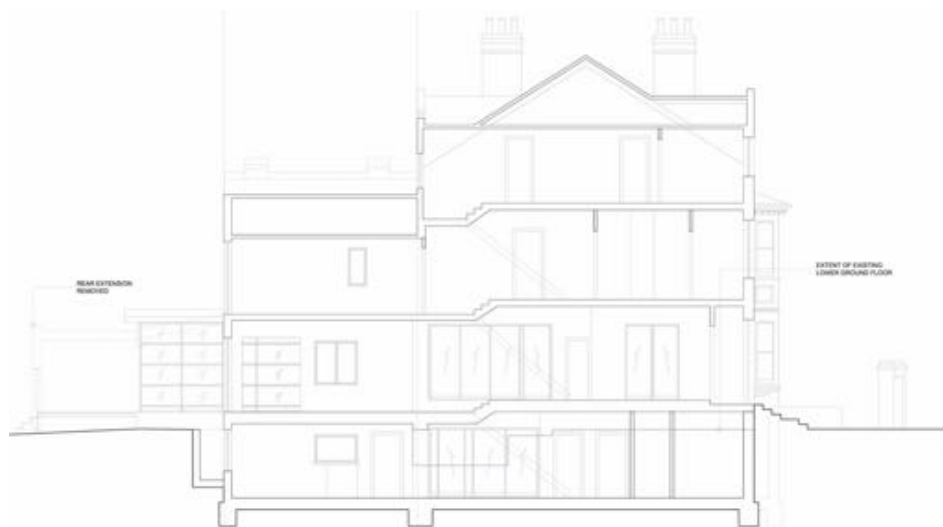
It is proposed that a full-storey basement be provided under the footprint of majority of the existing property and part of the new extension, as shown on the indicative section below (superseded drawing, refer to Edencoast Ltd's latest).

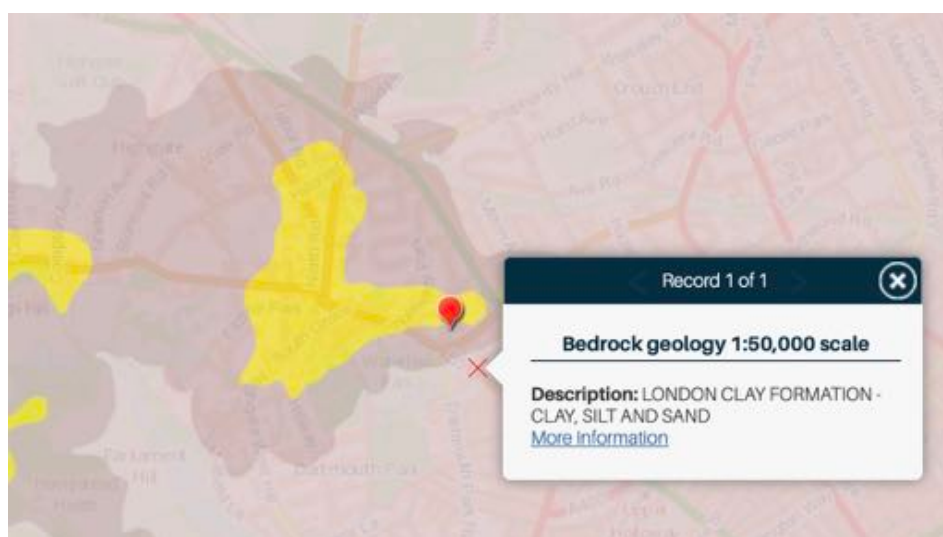
Only bedrock without any superficial deposits shown on the maps. Site is on the boundary between recorded bands.

British Geological Survey (BGS) maps (see Appendix C) indicate the site to be located along the boundary of the Claygate Member (clay, silt & sand) and the Bagshot Formation (sand).
