**Supplementary Site  
Investigation & Risk  
Assessment Report**

**Project Name:** Kerswell Close

**Location:** Tottenham, London, N15 5HT

**Project ID:** J15567

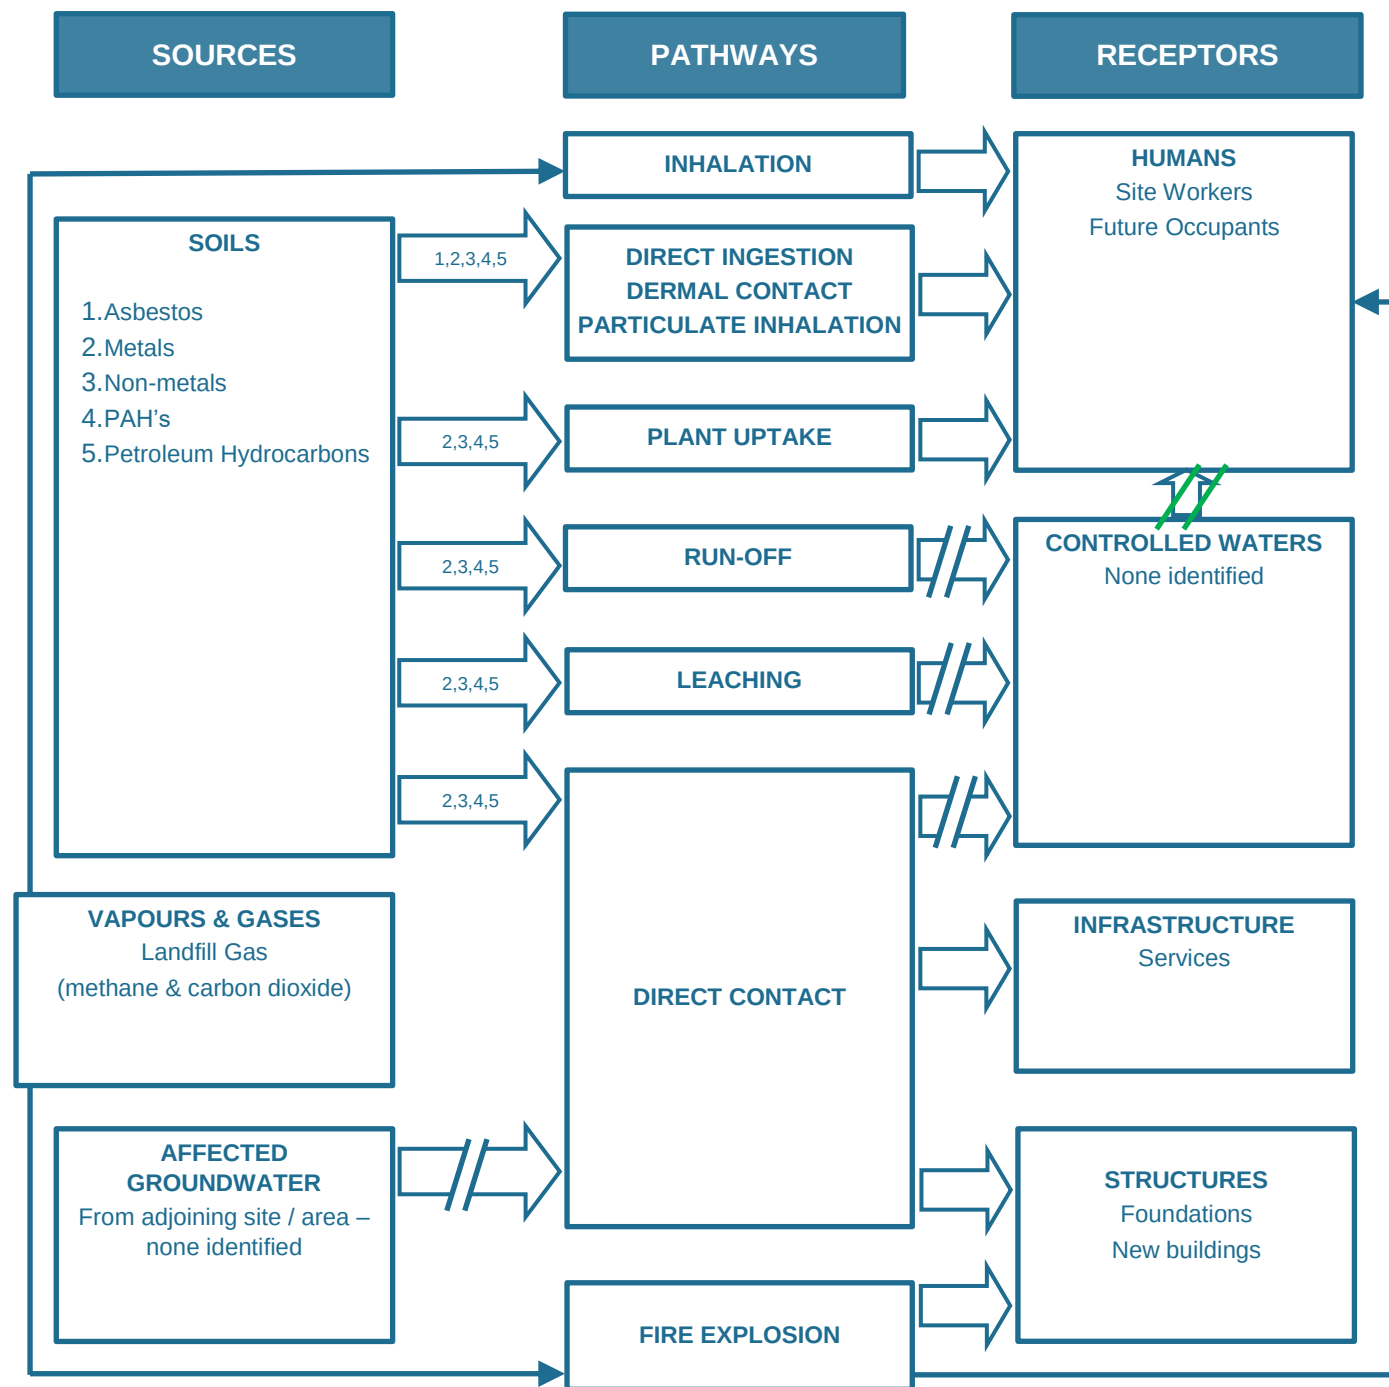
The following diagram shows the potential pollutant linkages identified for the site and summarises the preliminary conceptual model:

// Denotes potential pollutant linkage not complete.

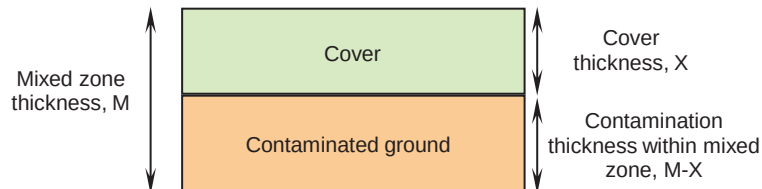
## Model adopted for calculations :

Contaminant : Benzo(a)pyrene (PAH)

On the basis of the concentrations of Lead a capping layer of 300mm thickness would be required. However, the concentrations of PAH found would require a 380mm depth of capping. Alternatively, a 300mm capping layer, with a deter-to-dig membrane could be provided. Calculation sheets for the depth of the capping layers are given in Appendix C.

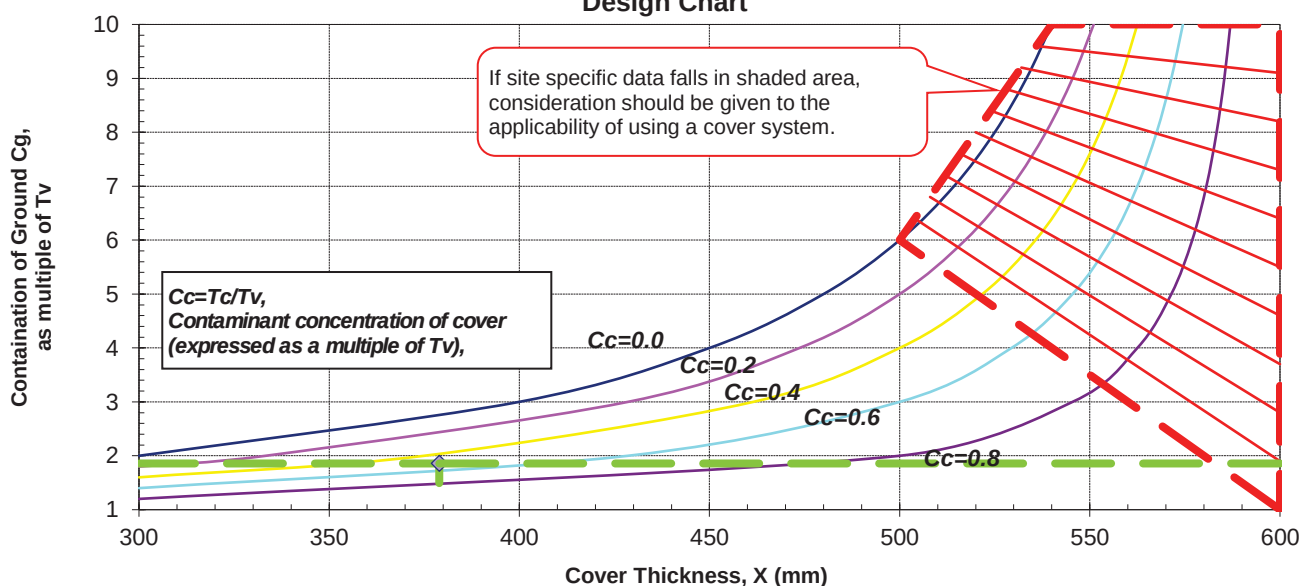
## Design Chart

**The required thickness of cover MUST be redesigned once the details of the cover are known.**

1. This calculation MUST be revised, based on the details of the soil to be imported.
2. The clean cover has not been imported to site yet, therefore a value of  $C_c = 0.5$  is assumed in above calculations.
3. The contaminant concentrations in the imported soil must not exceed the target guideline value adopted above.
4. To revise the calculation the design chart shown above could be used.

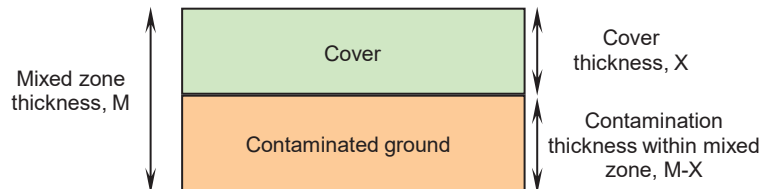
### Model adopted for calculations :

Contaminant : Lead (Pb)

**Minimum Thickness of Clean Cover Recommended : 300 mm**

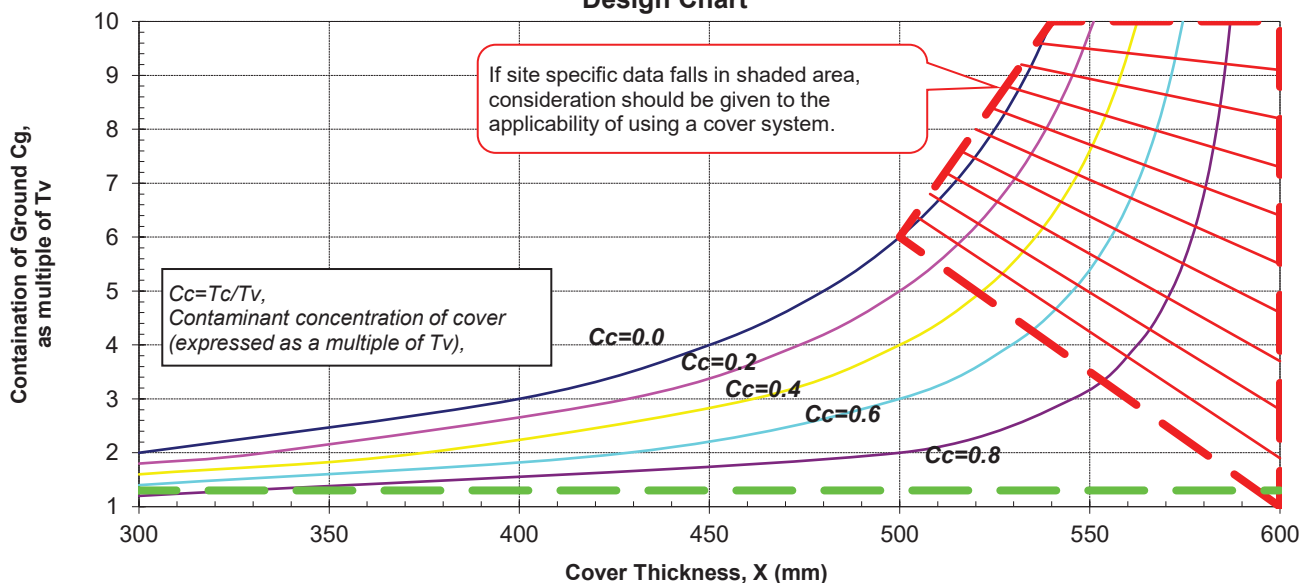
### Design Chart

**The required thickness of cover MUST be redesigned once the details of the cover are known.**

1. This calculation MUST be revised, based on the details of the soil to be imported.
2. The clean cover has not been imported to site yet, therefore a value of  $C_c = 0.5$  is assumed in above calculations.
3. The contaminant concentrations in the imported soil must not exceed the target guideline value adopted above.
4. To revise the calculation the design chart shown above could be used.

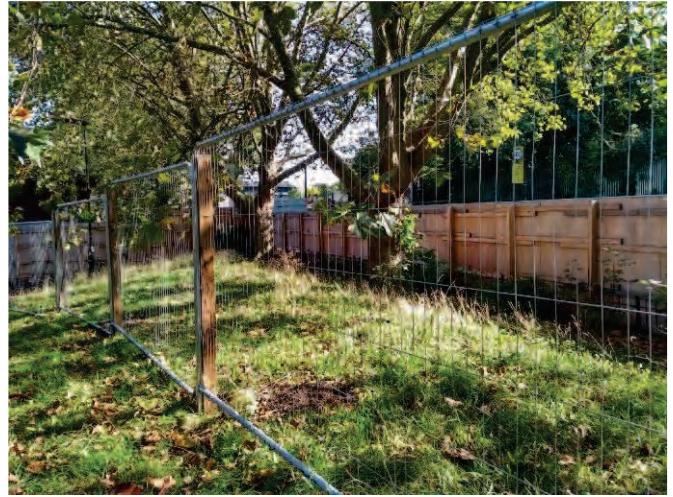
Plate 8: Tree Root Protection Area on the southeast of the site.

Around 50% of the site comprises soft landscaping, predominantly on the south of the site (comprising the soil mounds), with two small grass covered areas on the north of the site. There are a number of semi-mature trees across the top of the soil mounds. Species include Horse Chestnut, Sycamore and Ash. It is understood that some of these trees are the subject of Tree Protection Orders (TPO's), with fencing having been erected to prevent access and potential damage to the tree roots, during the redevelopment works.

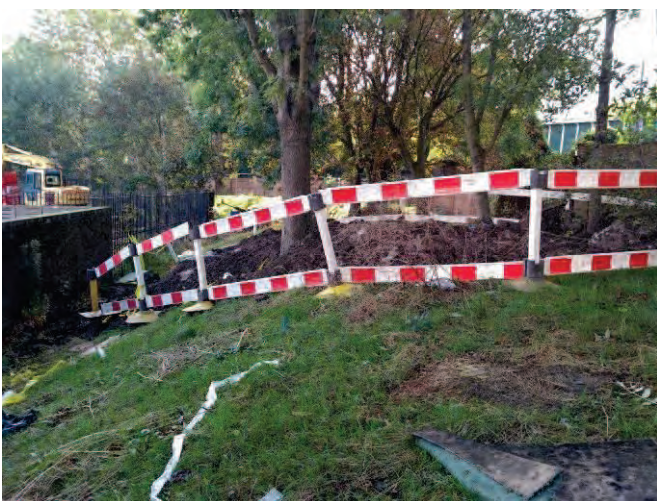
Plate 11: Area on the southwest of the site where the gas main has been repaired.

It was also planned to include the monitoring well on the southwest of the site (BH02 previously installed by Land Science) in the monitoring program. However, this location had been lost due to works undertaken to repair the leaking gas main. Due to access constraints (the site topography, spoil resulting from the repair of the gas main and the location of the gas main itself, a new monitoring well could not be constructed in this area of the site.

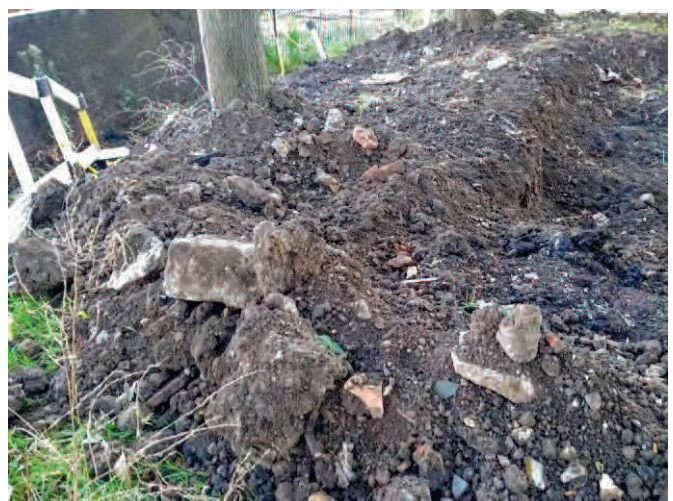
Plate 12: Made Ground/spoil from the repair of the gas main.

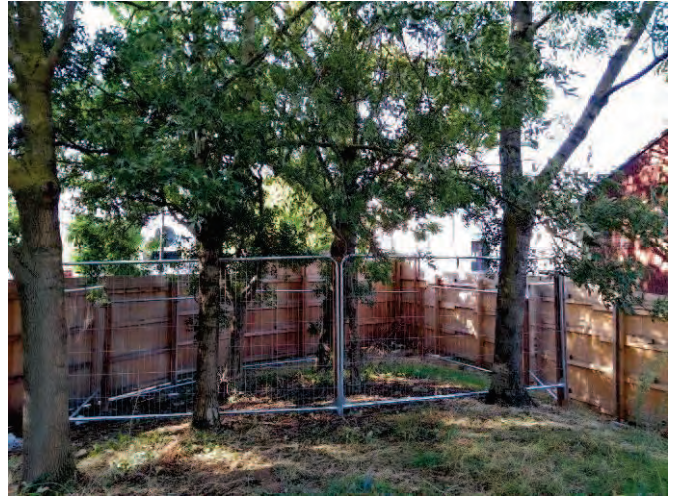
Plate 14: Tree Protection Area on the southwest corner of the site.

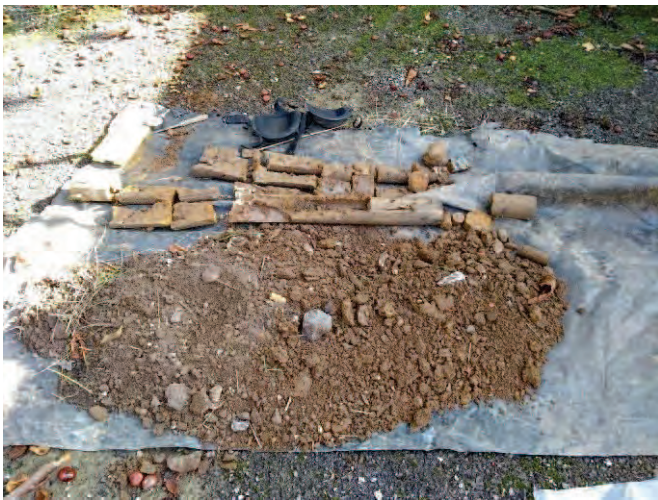
Plate 15: Arisings from WLS01.

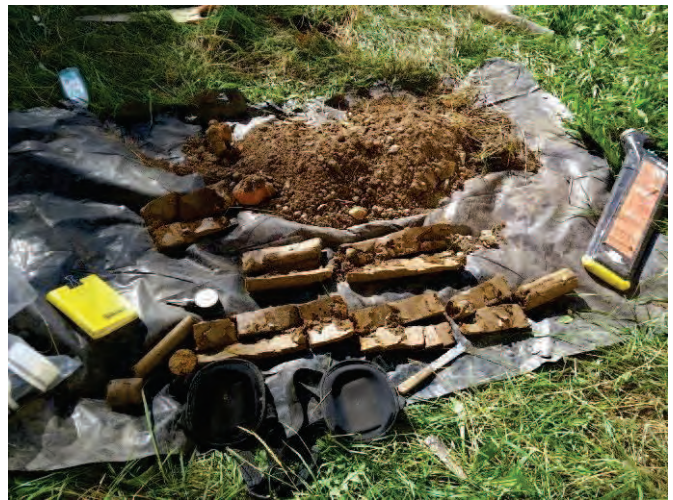
Plate 16: Arisings from WLS03.

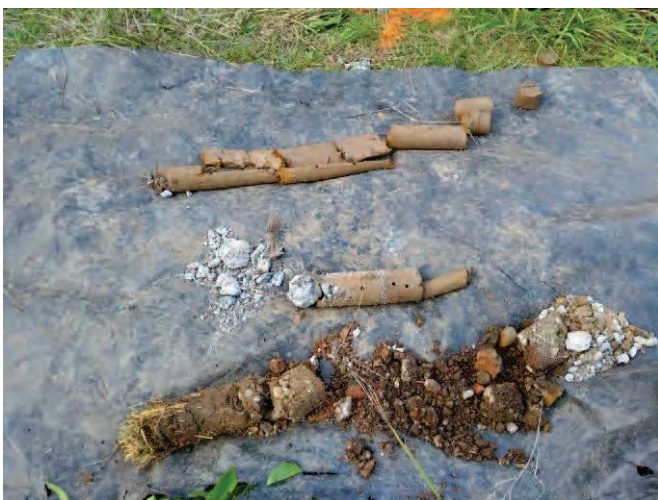
Plate 17: Arisings from WLS04.

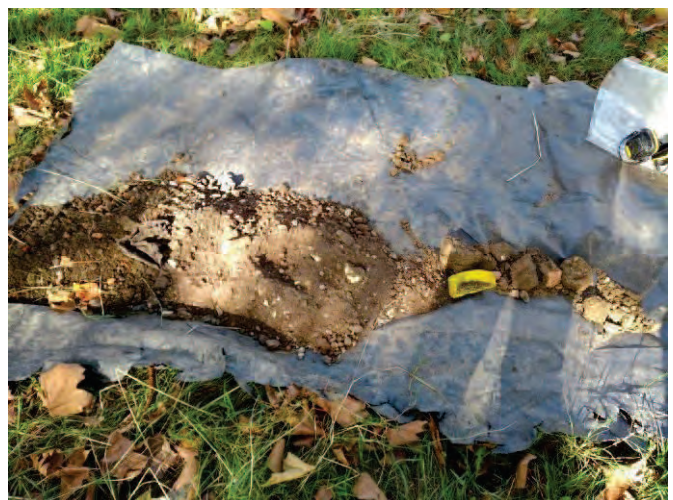
| Sample<br>(Location &<br>Depth) | Soil type | Presence & ID | Asbestos<br>Quantification %<br>(if required) |
|---|---|---|---|
| HA01<br>0.0-0.6m | Made Ground | Loose fibres of Chrysotile (white) asbestos | <0.001* |

Plate 18: Arisings from HA01.
