# TECHNICAL NOTE

Block D3 Verification Report

This document and its contents have been prepared and are intended solely as information for St William Homes LLP and use in relation to the Block D3 soft landscaping areas in Phase 3 of the former Hornsey Gasworks at Mary Neuner Road, Hornsey, N22 6UG.

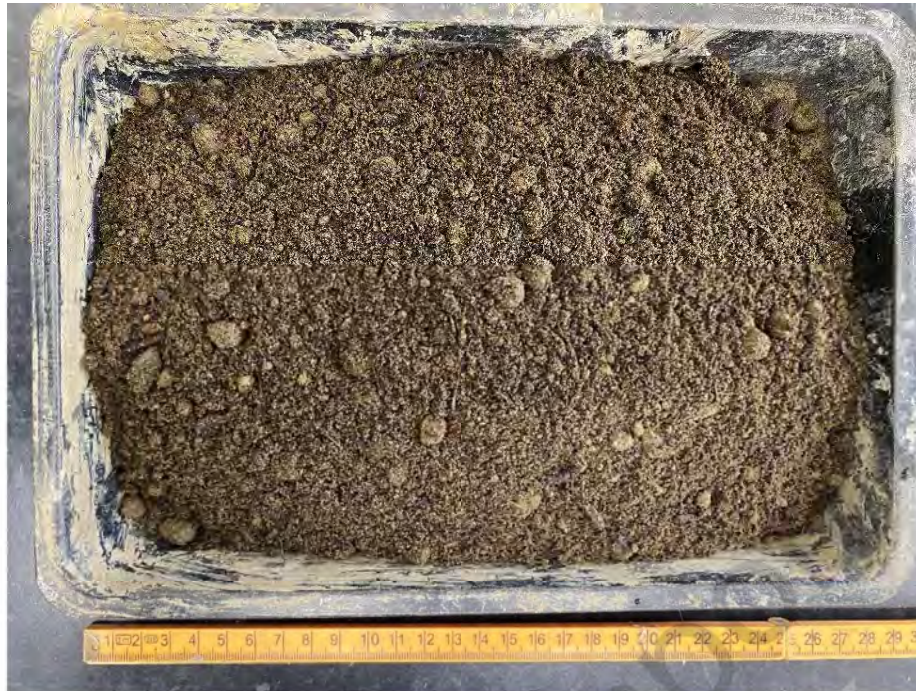
*Plate 1: Charlton Topsoil Sample*

The sample was described as a very dark brown (Munsell Colour 10YR 2/2), slightly moist, friable, very slightly calcareous SANDY LOAM with a weakly developed, very fine to fine granular and subangular blocky structure\*. The sample was moderately stony and contained a moderate proportion of organic fines and occasional woody fragments. No unusual odours, deleterious materials, roots or rhizomes of pernicious weeds were observed.

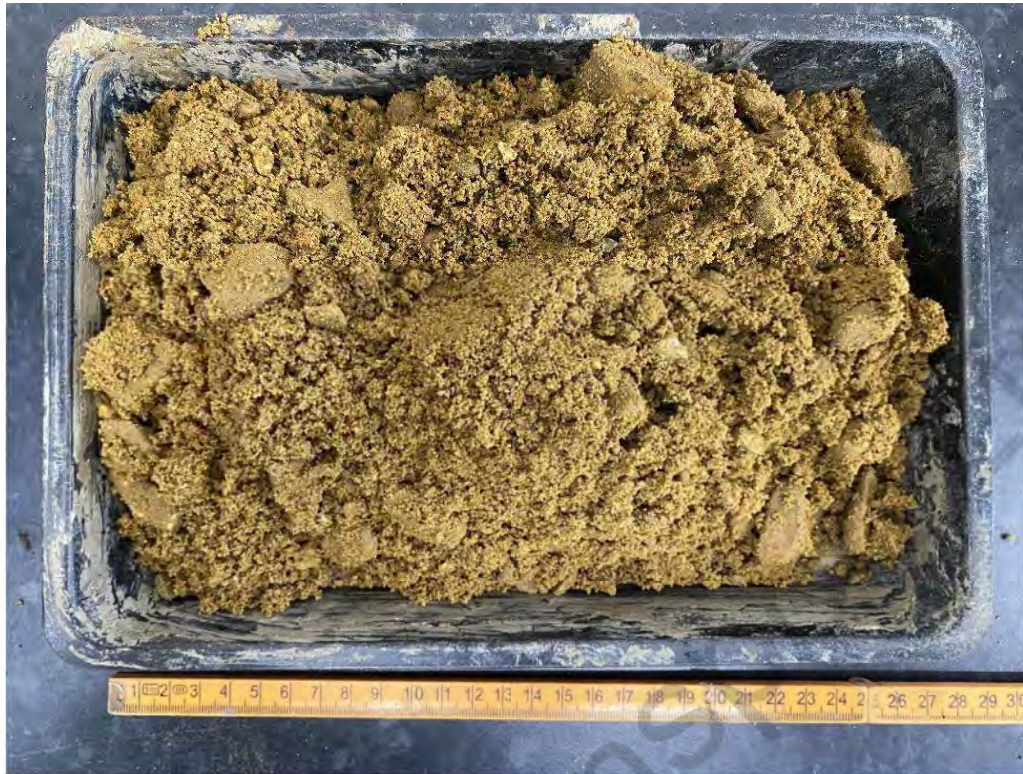
*Plate 1: Wennington Subsoil Sample*

The sample was described as a yellowish brown (Munsell Colour 10YR 5/8), moist, friable, very slightly calcareous SAND with a single grain structure. The sample was moderately stony, comprising stones up to 30mm in size, and no unusual odours, deleterious materials, roots or rhizomes of pernicious weeds were observed.

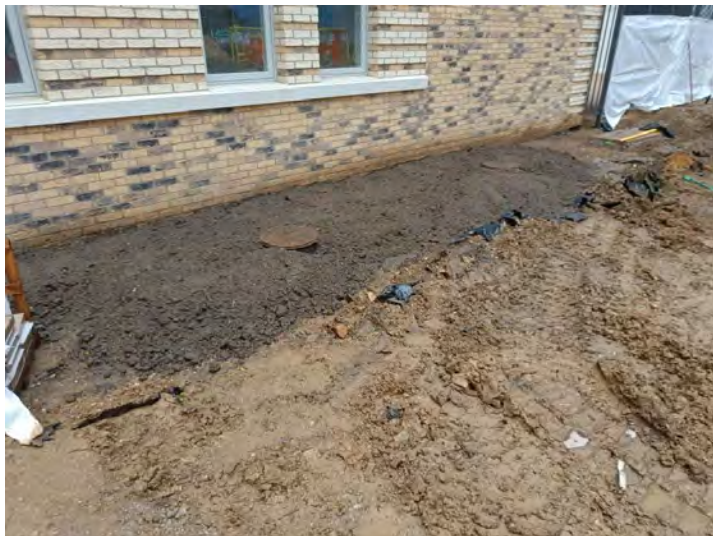
| <b>Photo No.</b><br>1 | <b>Date:</b><br>24/10/23 | |

| <b>Description:</b><br><br>Installation of top soil<br>in Zone 1 block D3. | | |

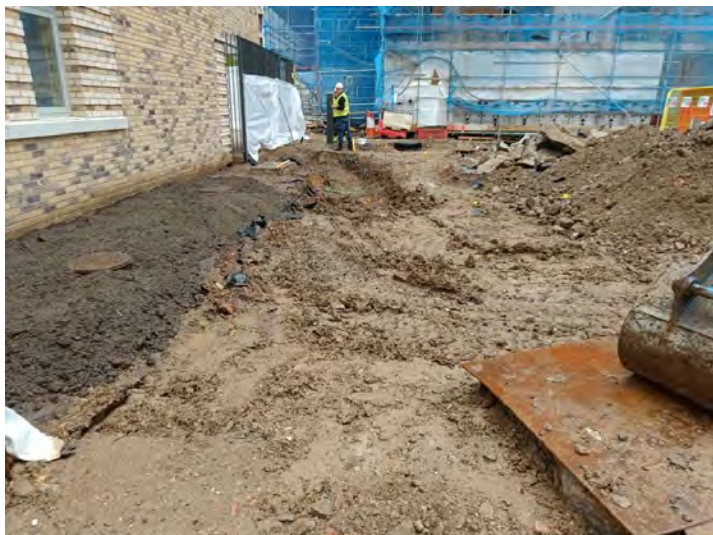
| <b>Photo No.</b><br>2 | <b>Date:</b><br>24/10/23 |

| <b>Description:</b><br><br>Placed top soil sub soil<br>Zone 1 and area<br>awaiting installation. | |

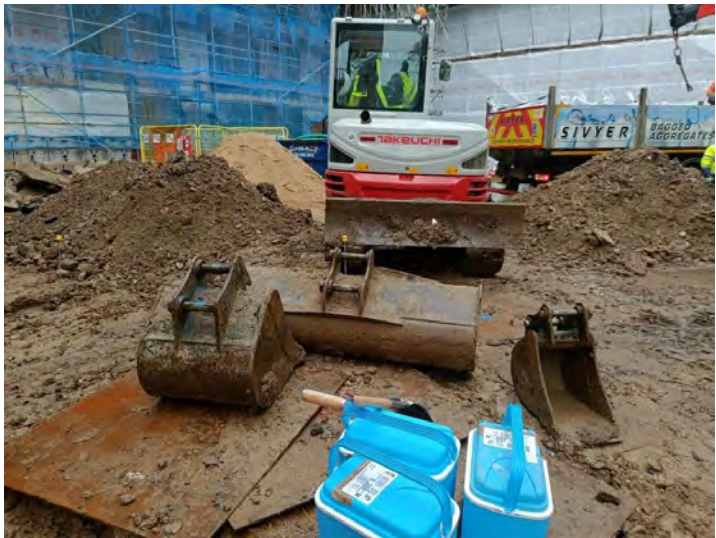
| <b>Photo No.</b><br>3 | <b>Date:</b><br>24/10/23 |

**Description:**  
D3 Zone 2 still in work.

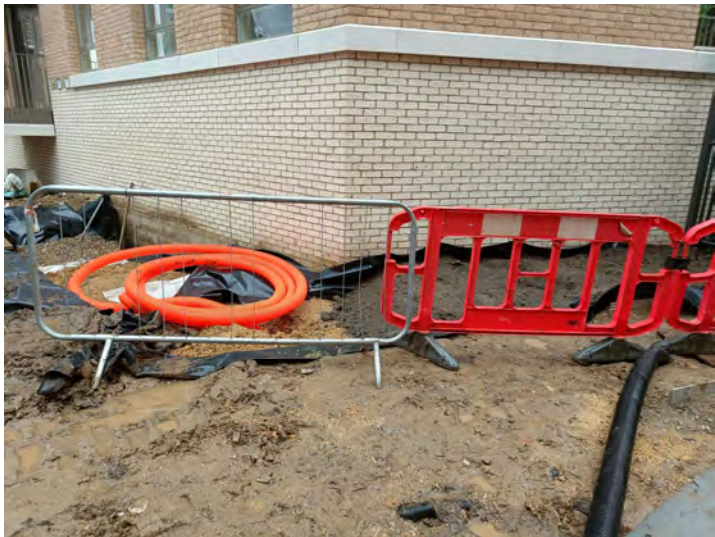
| <b>Photo No.</b><br>4 | <b>Date:</b><br>24/10/23 |

**Description:**  
D3 Zone 3 work in progress top soil and sub soil installed right of photo. White Marker Layer present left of photo under sub soil. Shingle under lay present left of photo.

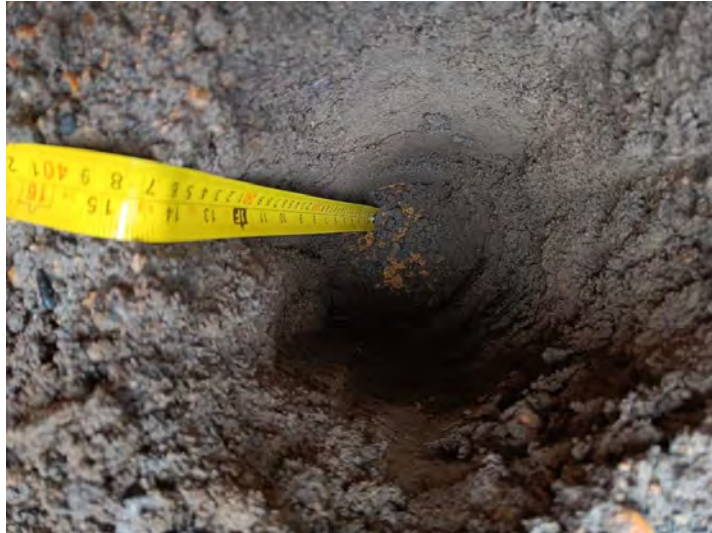
| <b>Photo No.</b><br>5 | <b>Date:</b><br>24/10/23 |

| <b>Description:</b><br><br>D3 Zone 1 HTP1 top<br>soil thickness. | |

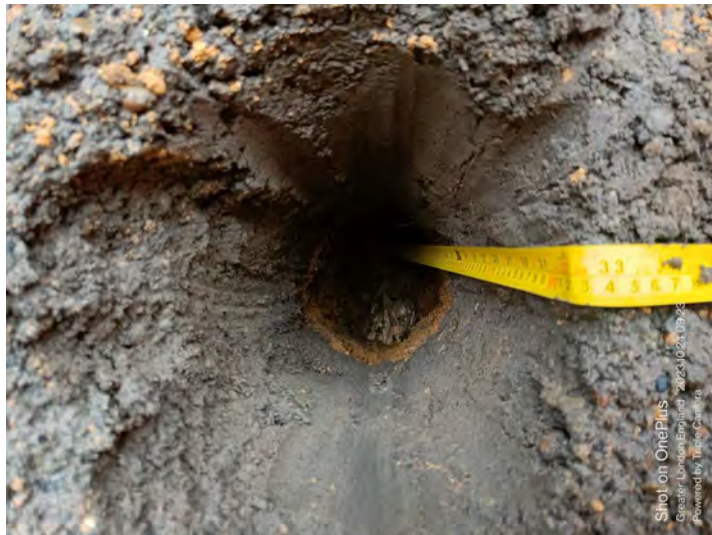
| <b>Photo No.</b><br>6 | <b>Date:</b><br>24/10/23 |

| <b>Description:</b><br><br>Zone 1 HTP1<br>membrane proven. | |

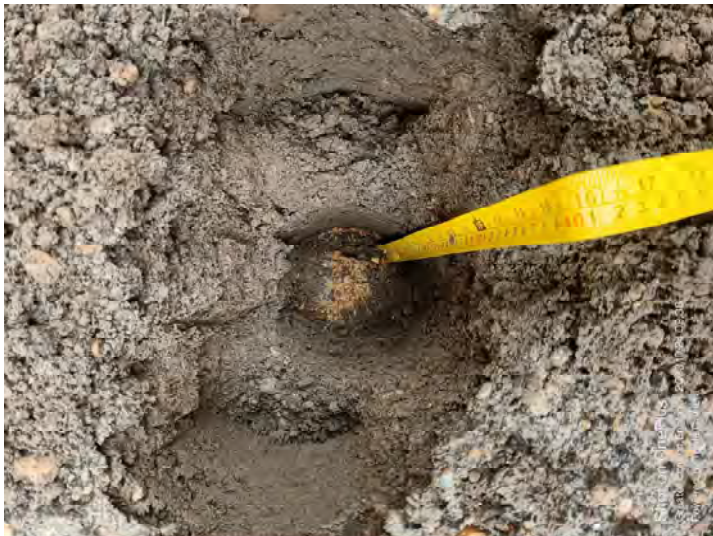
| <b>Photo No.</b><br>7 | <b>Date:</b><br>24/10/23 |

| <b>Description:</b><br><br>D3 HTP2 Zone 3 to sub soil. | |

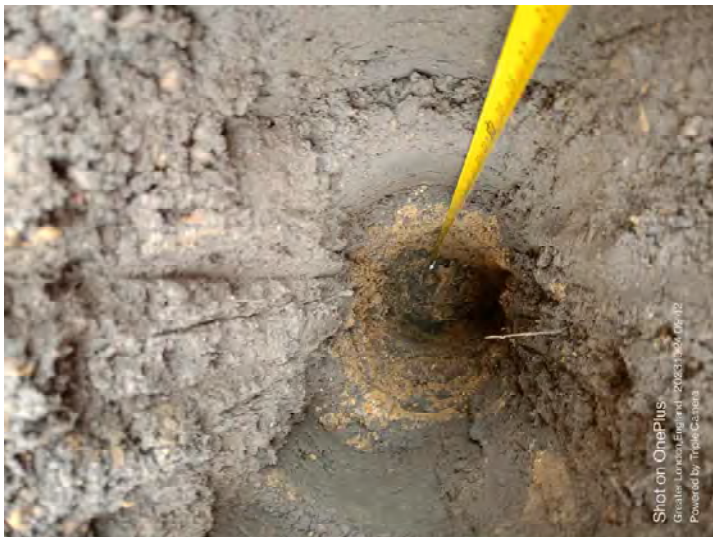
| <b>Photo No.</b><br>8 | <b>Date:</b><br>24/10/23 |

| <b>Description:</b><br><br>D3 HTP2 membrane proven under sub soil. | |

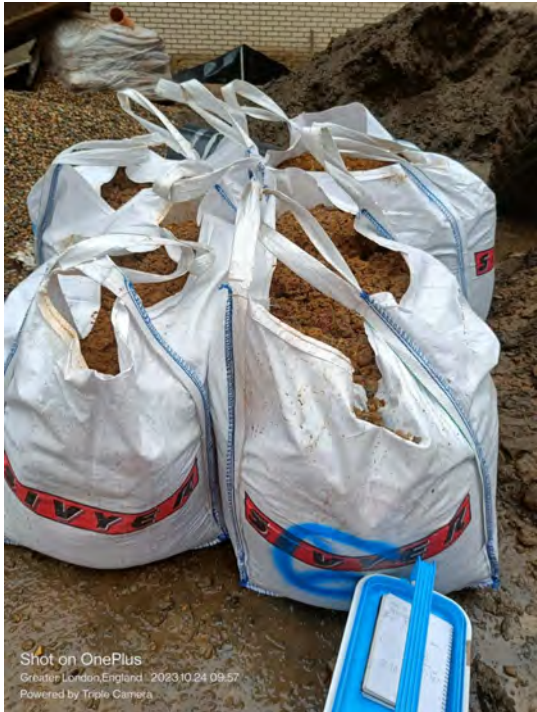
| Photo No.<br>9 | Date:<br>24/10/23 | |

| Description:<br><br>Sub soil for Block D3<br>Zone 2, 4,5 and 6. | | |

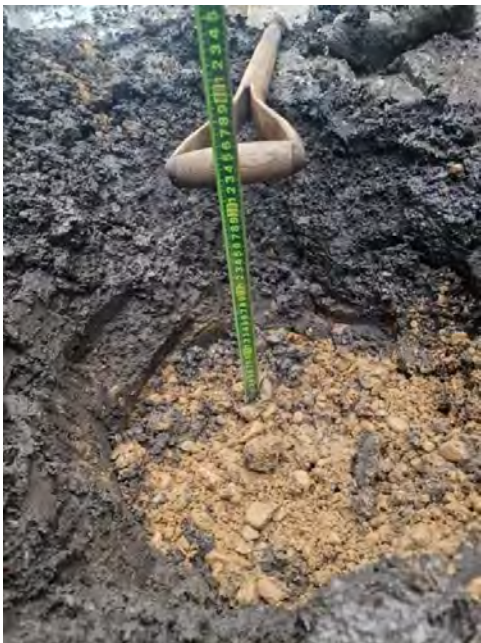
| Photo No. | Date: | |
|---|---|---|
| 2 | 12/12/23 | |

| Photo No. | Date: | |
|---|---|---|
| <b>Description:</b><br><br>Zone 1 depth to sub soil. | | |

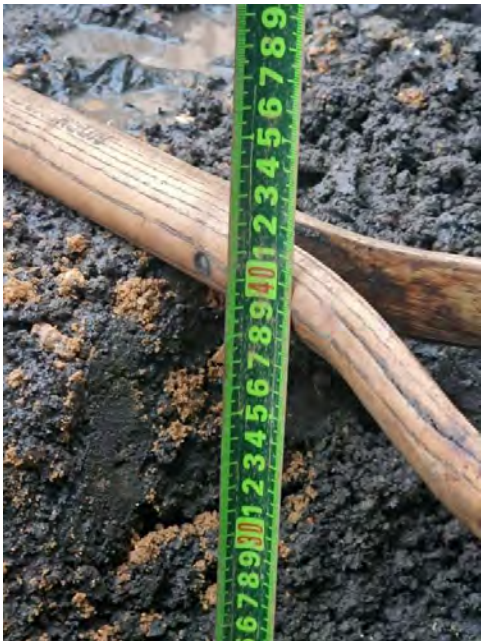
| Photo No.<br>3 | Date:<br>12/12/23 | |

| Description:<br><br>Zone 1 depth to sub soil. | | |

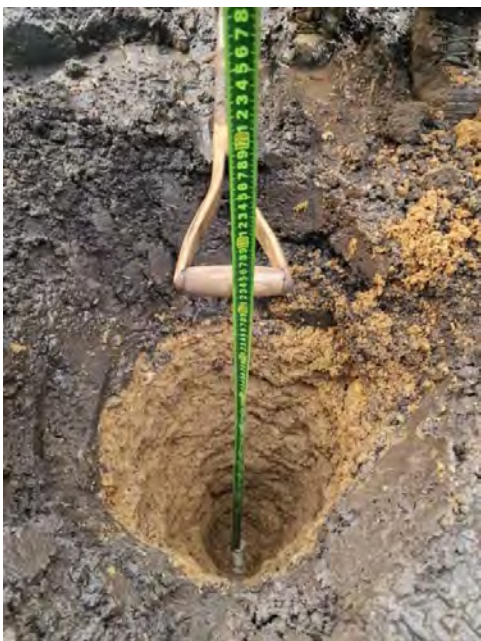
| Photo No.<br>4 | Date:<br>12/12/23 | |

| Description:<br><br>Zone 1 membrane proven under sub soil. | | |

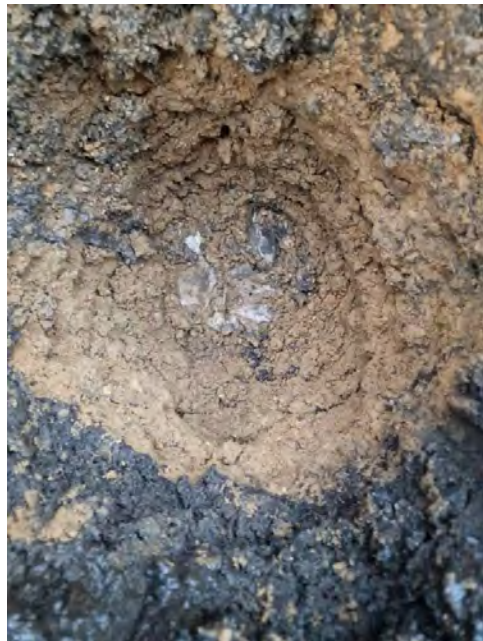
| <b>Photo No.</b><br>5 | <b>Date:</b><br>12/12/23 |

| <b>Description:</b><br><br>Zone 1 membrane<br>proven under sub soil. | |

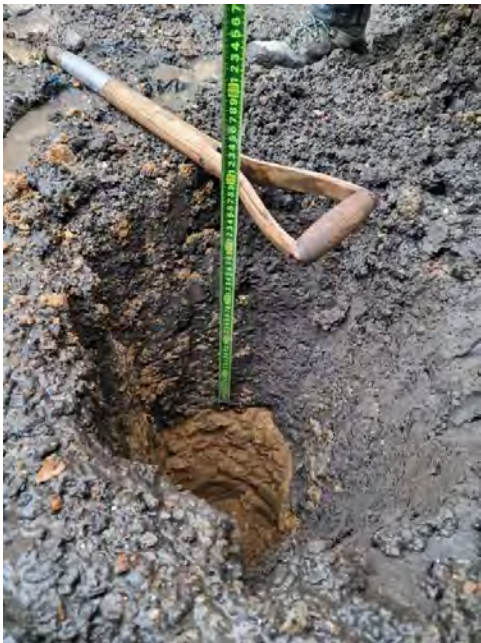
| <b>Photo No.</b><br>7 | <b>Date:</b><br>12/12/23 | |

| <b>Description:</b><br><br>Zone 2 depth to sub soil. | | |

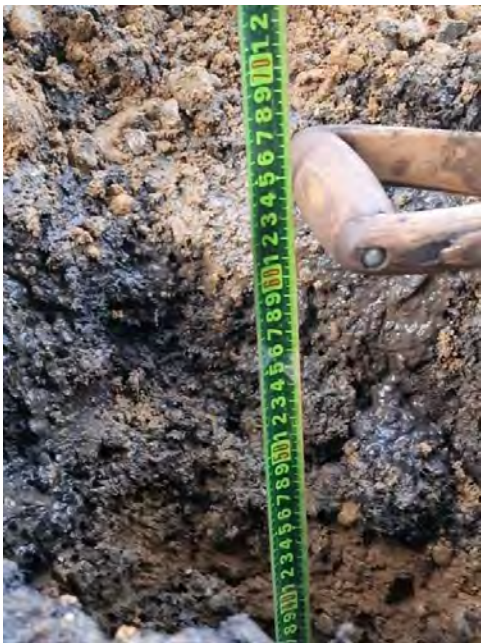
| Photo No.<br>8 | Date:<br>12/12/23 | |

| <b>Description:</b><br><br>Zone 2 depth to subsoil. | | |

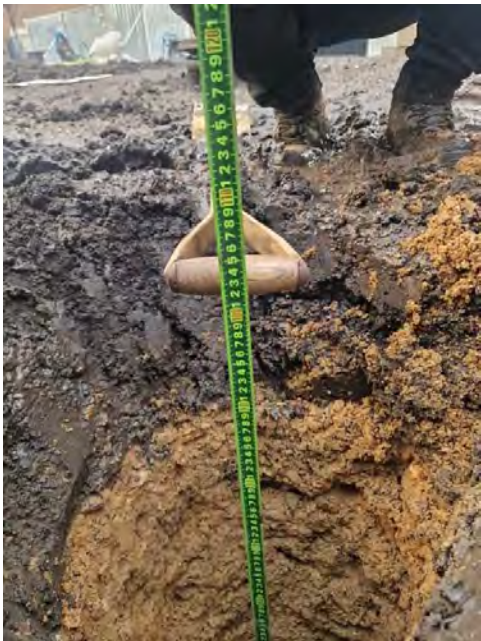
| <b>Photo No.</b><br>9 | <b>Date:</b><br>12/12/23 |

| <b>Description:</b><br><br>Zone 2 membrane proven under sub soil. | |

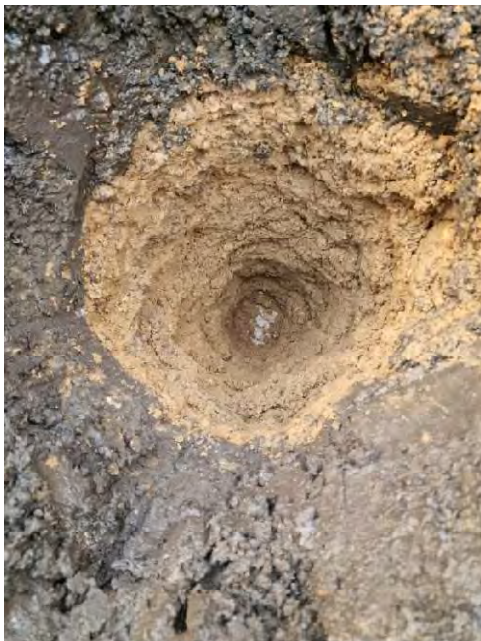
| <b>Photo No.</b><br>10 | <b>Date:</b><br>12/12/23 | |

| <b>Description:</b><br><br>Zone 2 membrane proven under sub soil. | | |

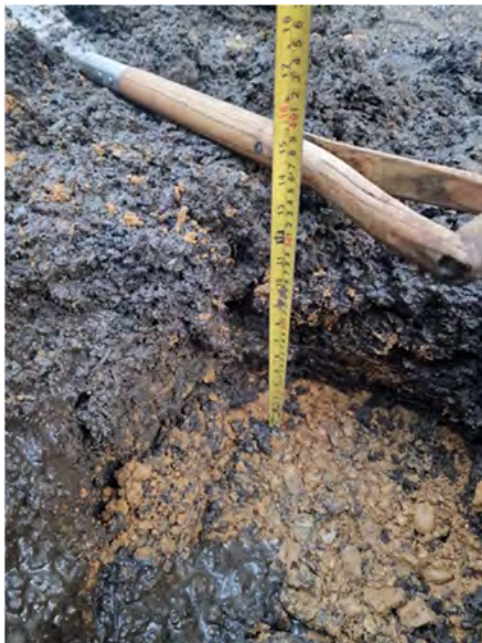
| Photo No.<br>12 | Date:<br>12/12/23 | |

| <b>Description:</b><br><br>Zone 3 depth to sub soil. | | |

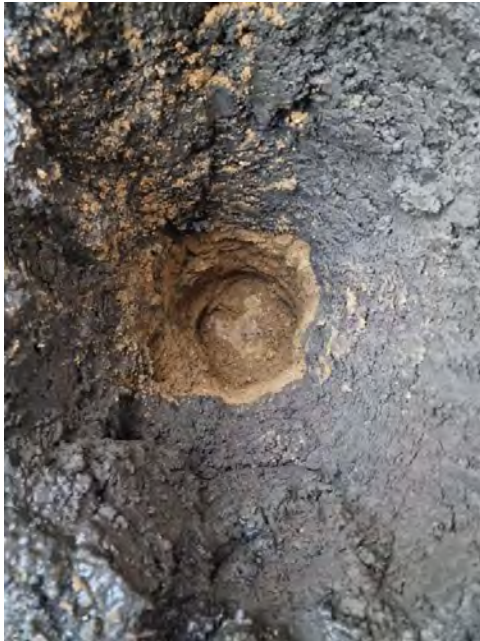
| <b>Photo No.</b><br>13 | <b>Date:</b><br>12/12/23 |

| <b>Description:</b><br><br>Zone 3 membrane<br>proven under sub soil. | |

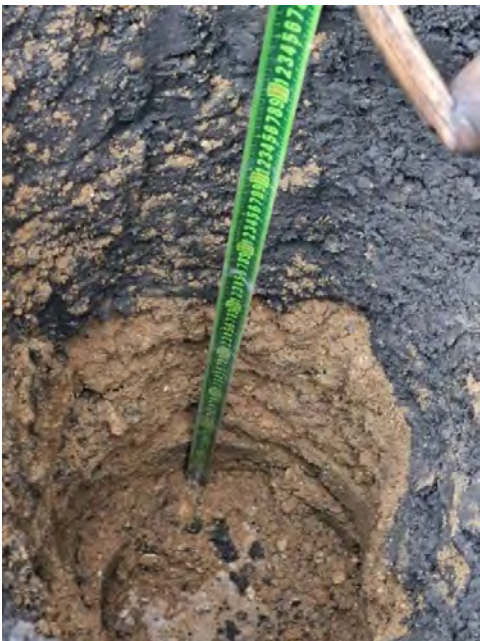
| <b>Photo No.</b><br>14 | <b>Date:</b><br>12/12/23 |

| <b>Description:</b><br><br>Zone 3 membrane<br>proven under sub soil. | |

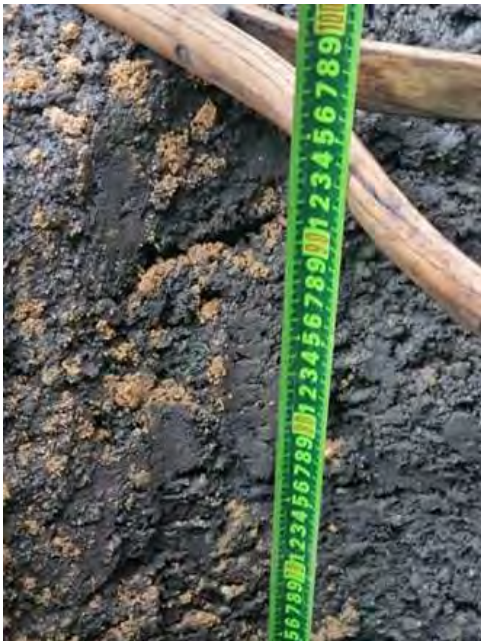
| <b>Photo No.</b><br>15 | <b>Date:</b><br>12/12/23 | |

| <b>Description:</b><br><br>Zone 3 membrane<br>proven under sub soil. | | |
