## **GEO-ENVIRONMENTAL & GEOTECHNICAL ASSESSMENT (GROUND INVESTIGATION) REPORT**

313-315 THE ROUNDWAY AND 8-12 CHURCH LANE,  
LONDON  
N17 7AB

**Job No:** P5141J2799/CLP

**Date:** 04 July 2023

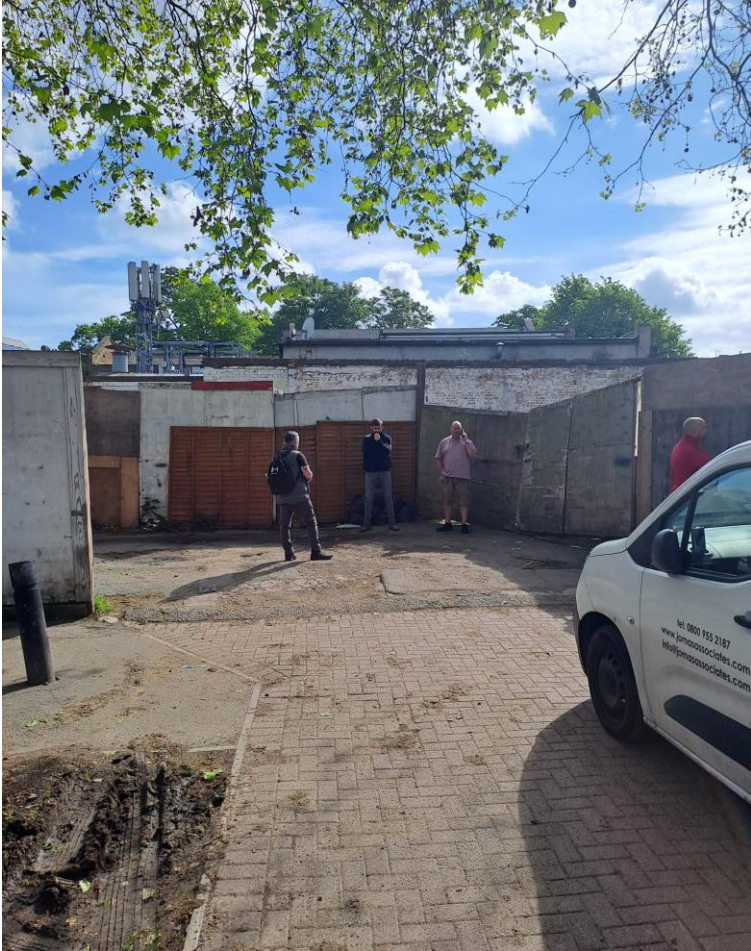
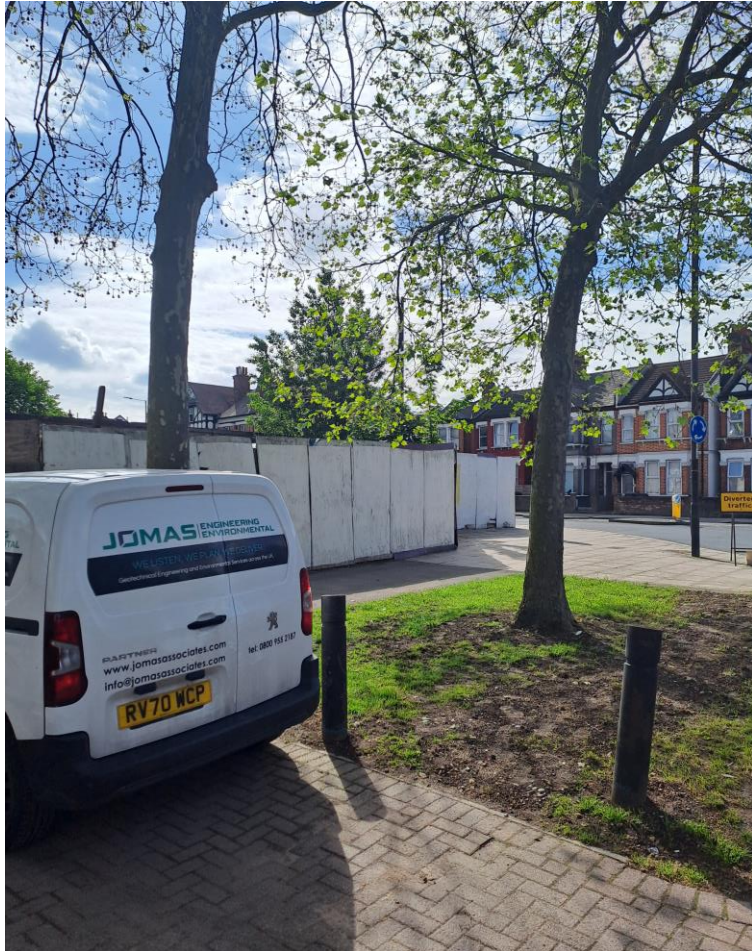
| <b>Photo 1:</b> Entrance to site from The Roundway. | | <b>Photo 2:</b> Low density housing on the right hand side of entrance. | |

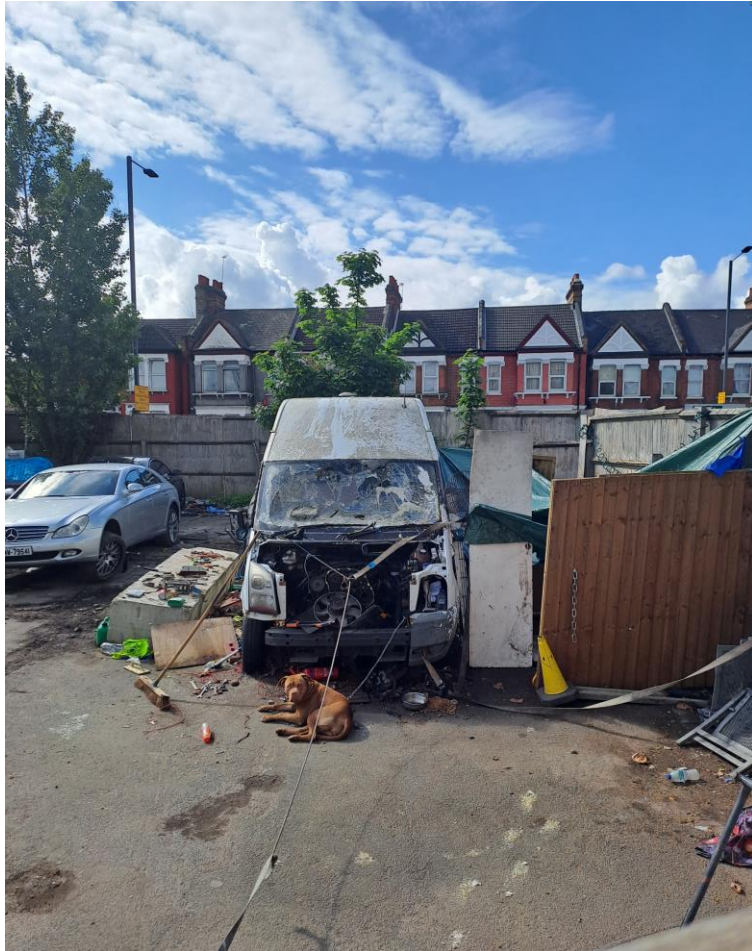
| <b>Photo 3:</b> Service station on the left hand side of entrance. | | <b>Photo 4:</b> Disused cars inside the entrance to site. | |

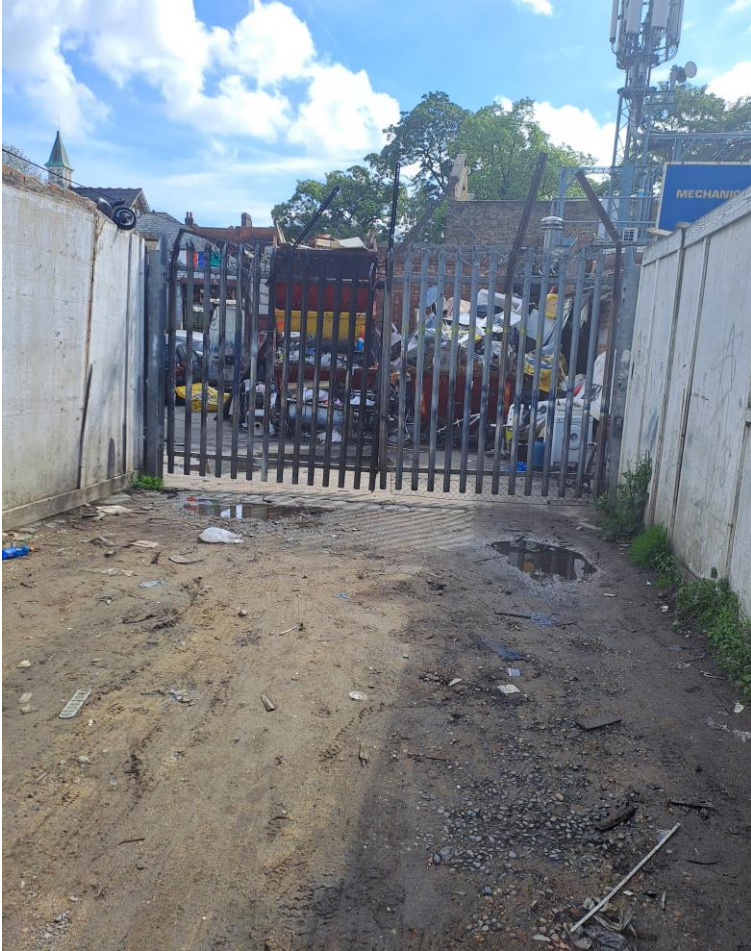
| <b>Photo 7:</b> Large metal gate leading further into site. | | <b>Photo 8:</b> Beyond metal gate, 4 skips piled as well as disused cars. | |

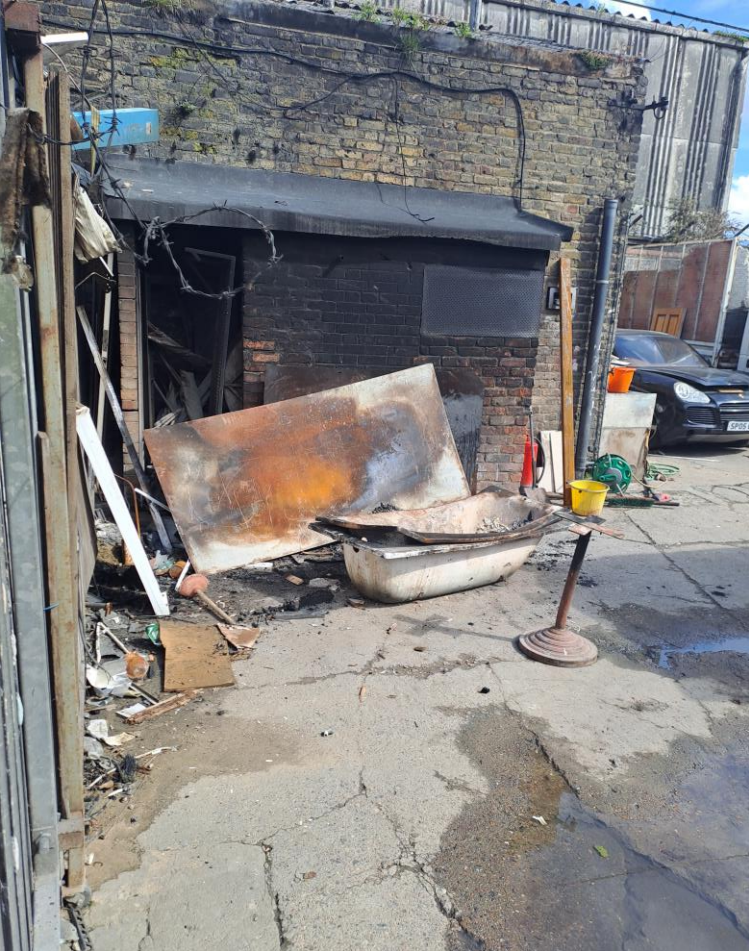
| <b>Photo 9:</b> Partially burnt down building on site. | | <b>Photo 10:</b> Active MOT centre on accessible from Church Lane. | |

| Area | Item | Details |
|---|---|---|
| | <b>Evidence of contamination:</b> | Cooking oil was evidently spilled onto the ground surface within the site, as well as evidence of burned materials within the disused MOT garage in the middle of the site.<br><br>A stockpile was noted in the south of the site which showed varying materials. |

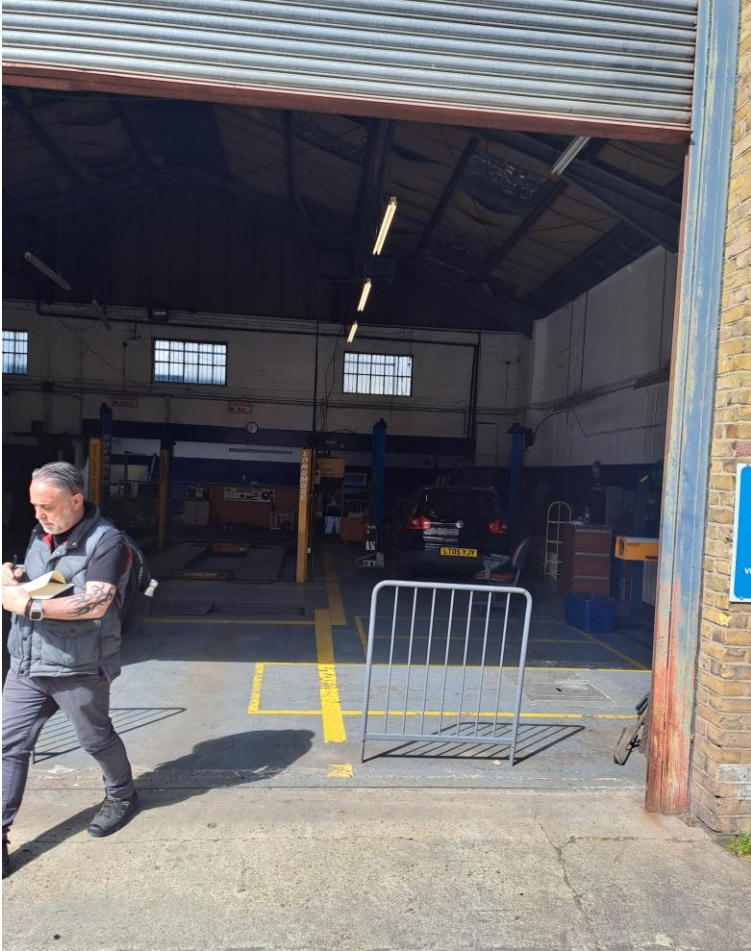
| <b>Photo 11:</b> Entrance and inside MOT centre. | | <b>Photo 12:</b> Disused and rusted barrels in front of MOT centre. | |

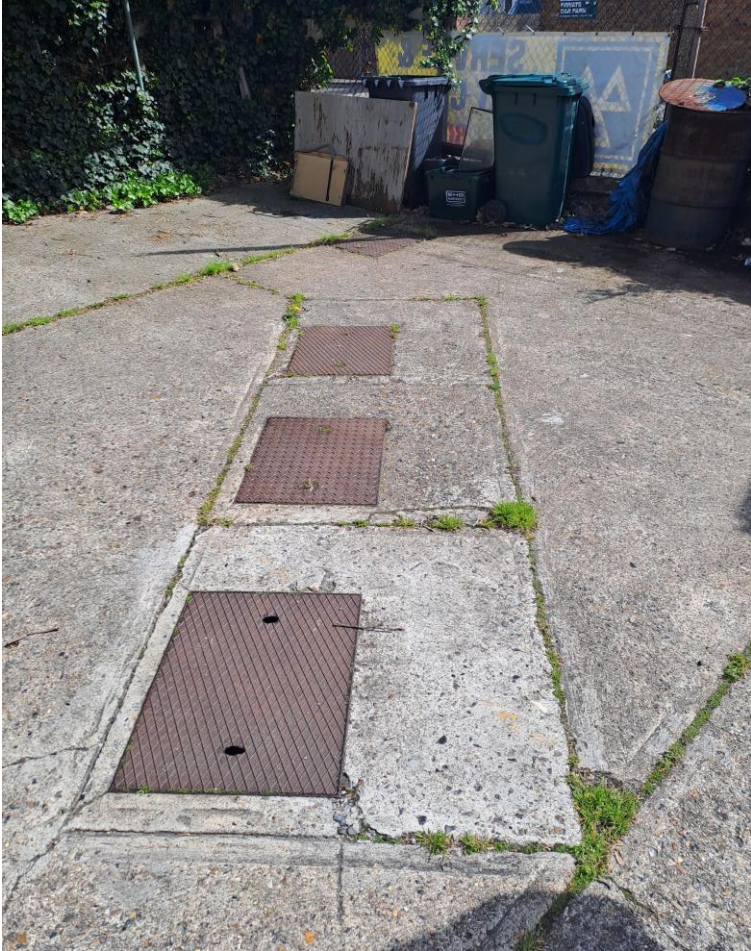
| <b>Photo 13:</b> Suspected interceptor. | | <b>Photo 14:</b> Cooking oil barrels. | |

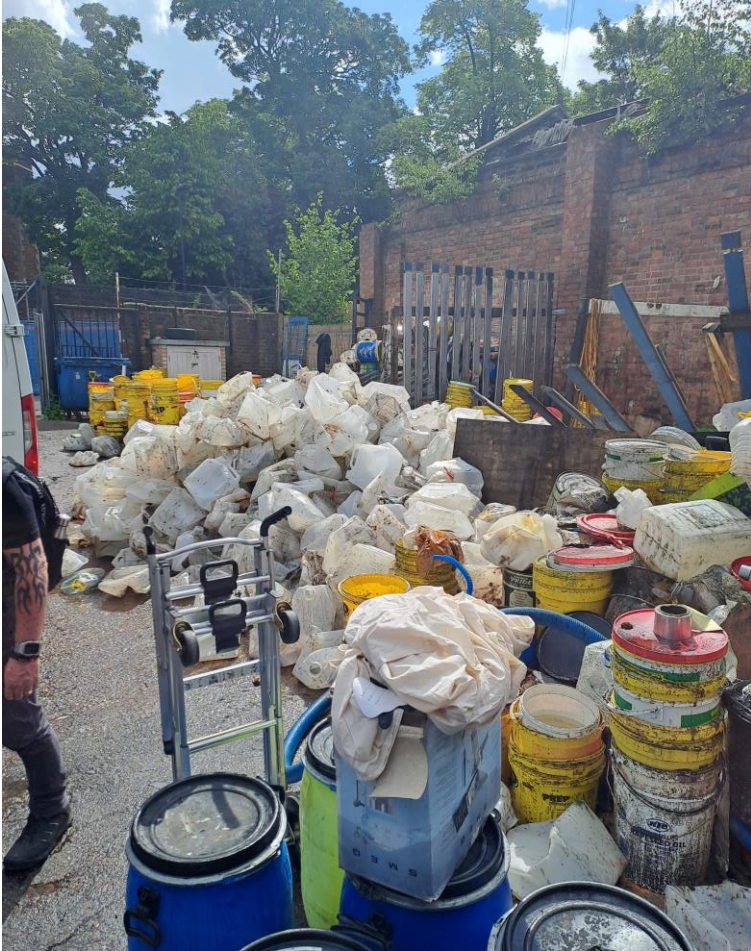
| <b>Photo 15:</b> Empty cooking oil buckets. | | <b>Photo 16:</b> Wide angle view of another entrance to site from Church Lane. | |

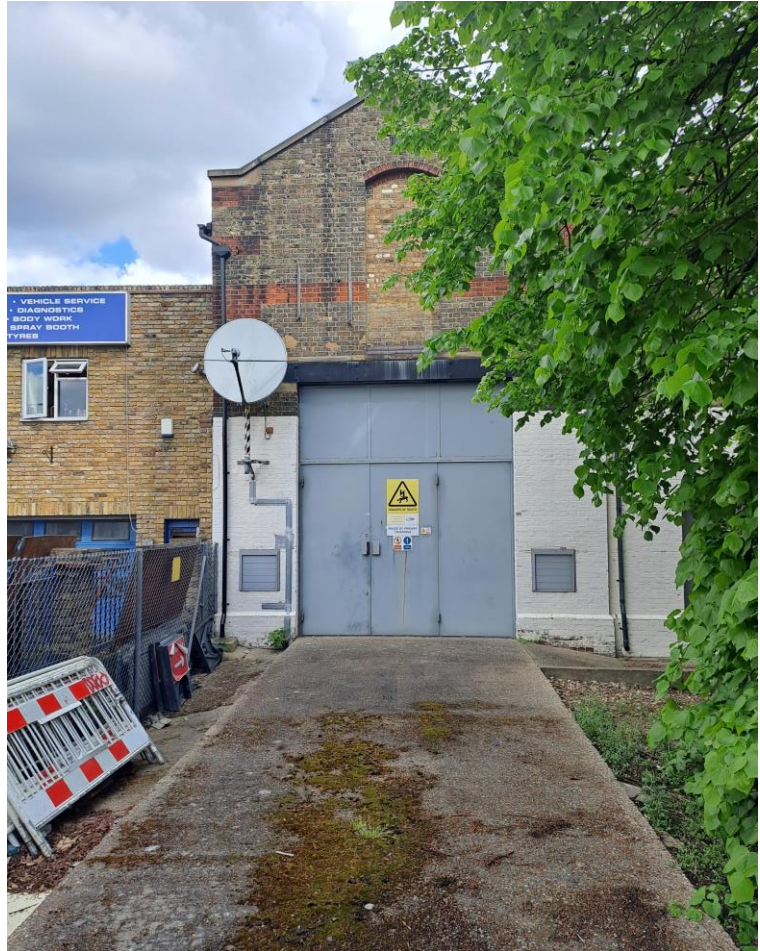
| <b>Photo 19:</b> Entrance to suspected cannabis farm. | | <b>Photo 20:</b> Substation found offsite. | |

| Sources | Pathways (P) | Receptors | Consequence of Impact | Probability of Impact | Risk Estimation | Hazard Assessment |
|---|---|---|---|---|---|---|
| <ul style="list-style-type: none"> <li>Potential for Polychlorinated Biphenyls from substation adjacent to SE (1935) (S5)</li> <li>Potential ground gas generation from possible degradable material within made ground on site and infilled pond off site 20m N (S6)</li> <li>Potential asbestos containing materials at the site, particularly in roofing materials (S7)</li> </ul> | <ul style="list-style-type: none"> <li>Horizontal and vertical migration of contaminants within groundwater (P4)</li> </ul> | | | | | |
