**PHASE I & PHASE II GEO-ENVIRONMENTAL  
SITE INVESTIGATION**

**10 & 12 St James' Lane  
Muswell Hill  
London  
N10 3DB**

**REC Report: 20436/Report 1.1  
Issued: July 2013**

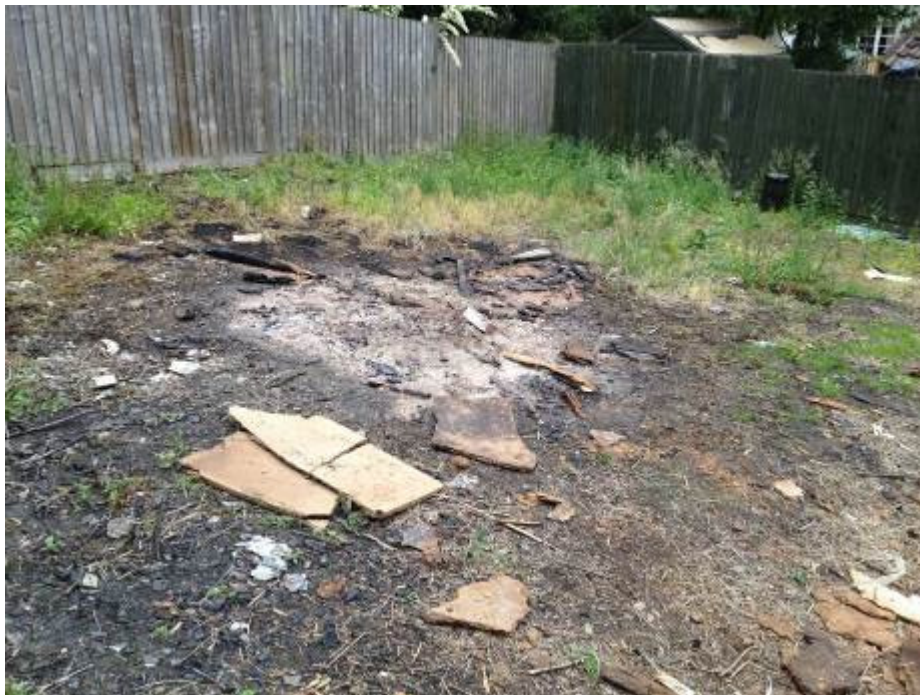
**Figure 1**, Bonfire on the raised soft landscaping

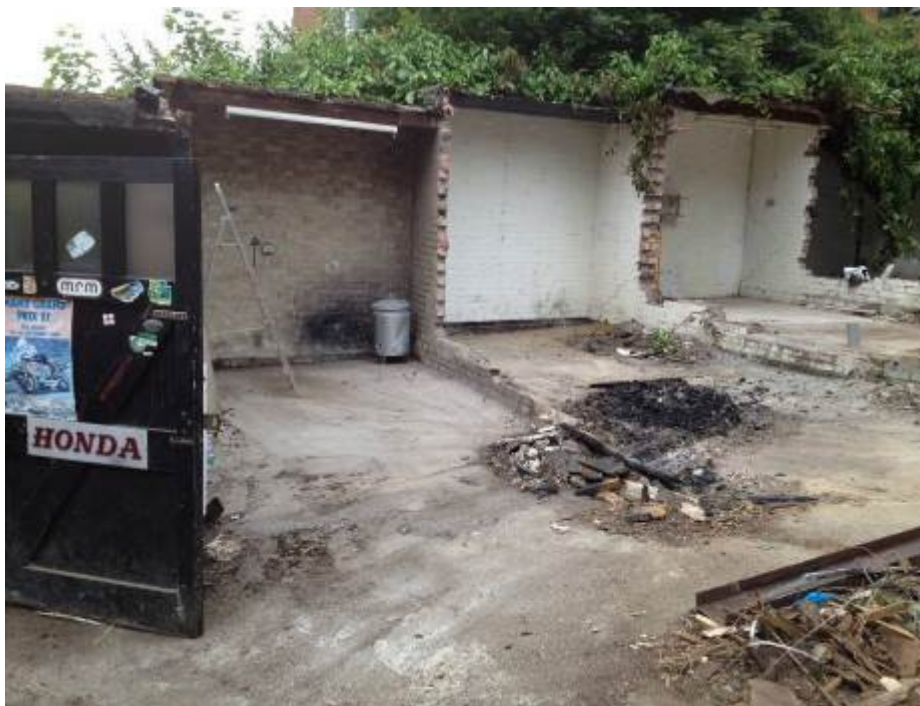
**Figure 2**, Looking East towards the demolished garages.

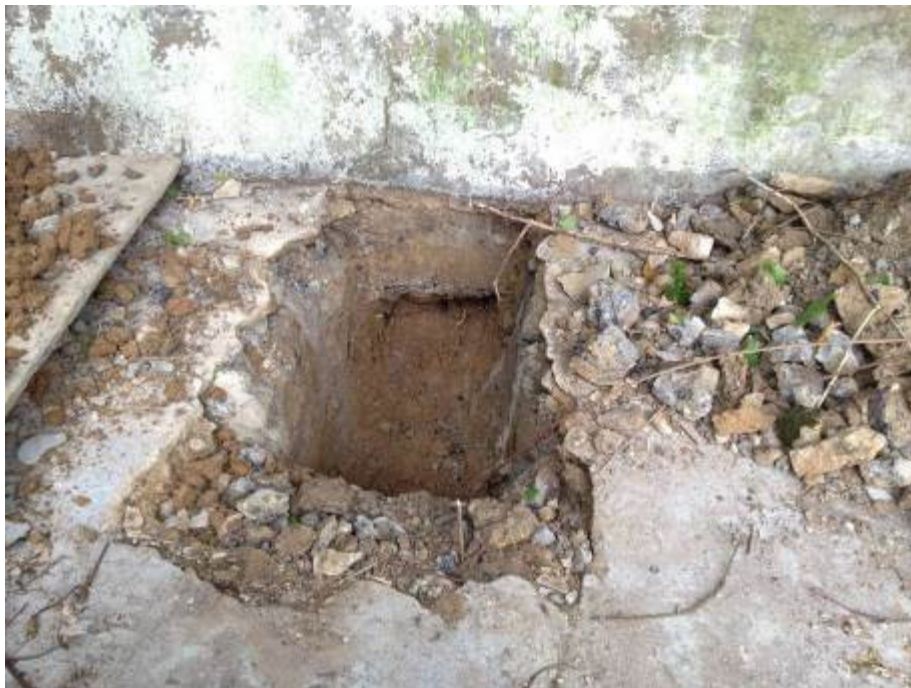
The window sample probeholes were designed to provide geotechnical information and confirm the findings of the Initial Conceptual Site Model (ICSM). 2 no. Hand pits (HP01 + HP02) were advanced to gain information on the foundations of the Southern retaining boundary wall.

**Figure 3**, hand pit dug at the Southern boundary wall.

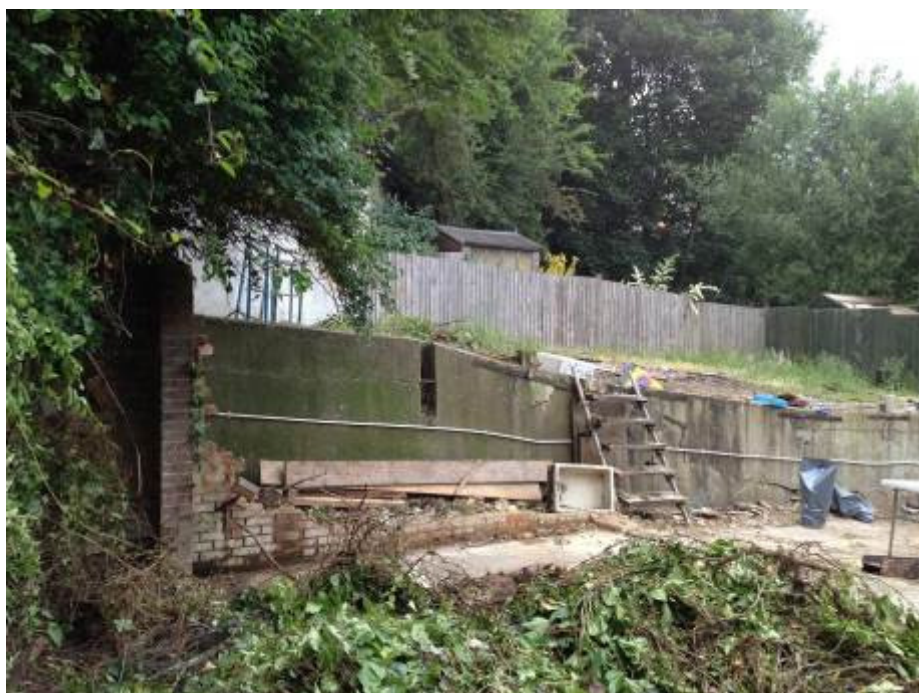
**Figure 4**, Looking West towards the raised soft landscaping
