**313 The Roundway and 8-12 Church Lane**

**Mixed Use Development**

**Planning Condition 40 - Discharge Report**

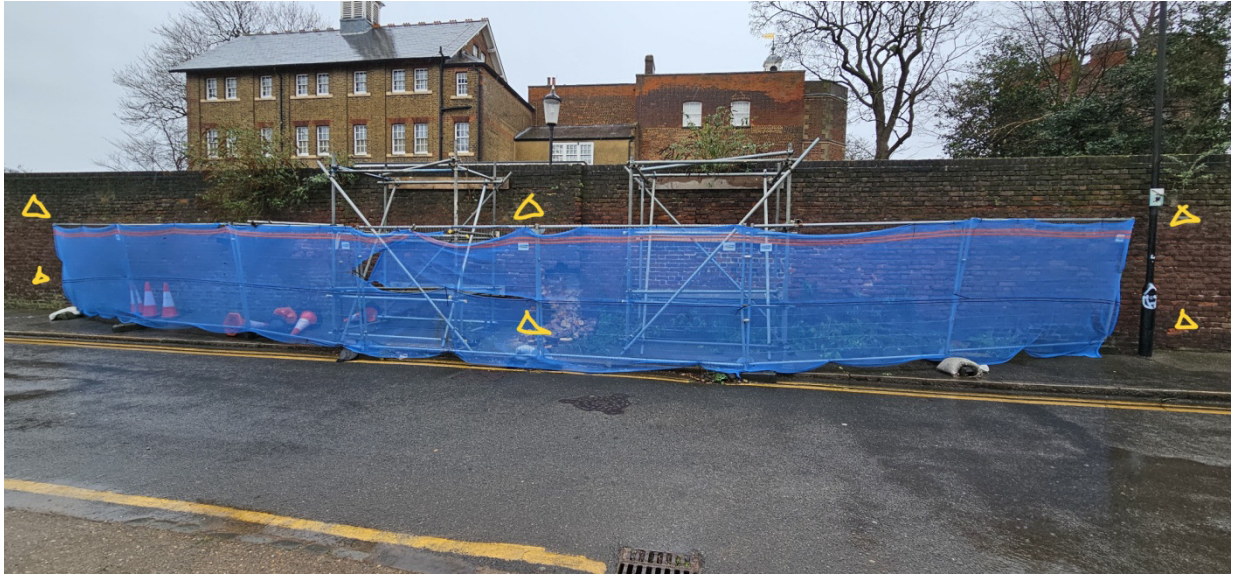
- 3.5. At the time of preparation of this report the wall is in a poor condition and has been temporarily propped by scaffolding to some section where a vehicle impact may have occurred. See Photographs in Appendix A

View Showing Scaffold Erected (by others) and Proposed Movement monitoring targets

- 9.1. Based on the form of construction observed, method of foundations proposed and physical distance between the foundations and the listed Boundary Wall we would conclude there is little to no risk of damage being caused by the proposed construction works.
- 9.2. CFA piling techniques are particularly suited to urban environments as they exhibit no ground movement and no vibrations during installation.
- 9.3. However as a precaution movement monitoring is recommended in the form of fixed laser targets which should be monitored on a weekly basis during the 6 week anticipated piling programme.

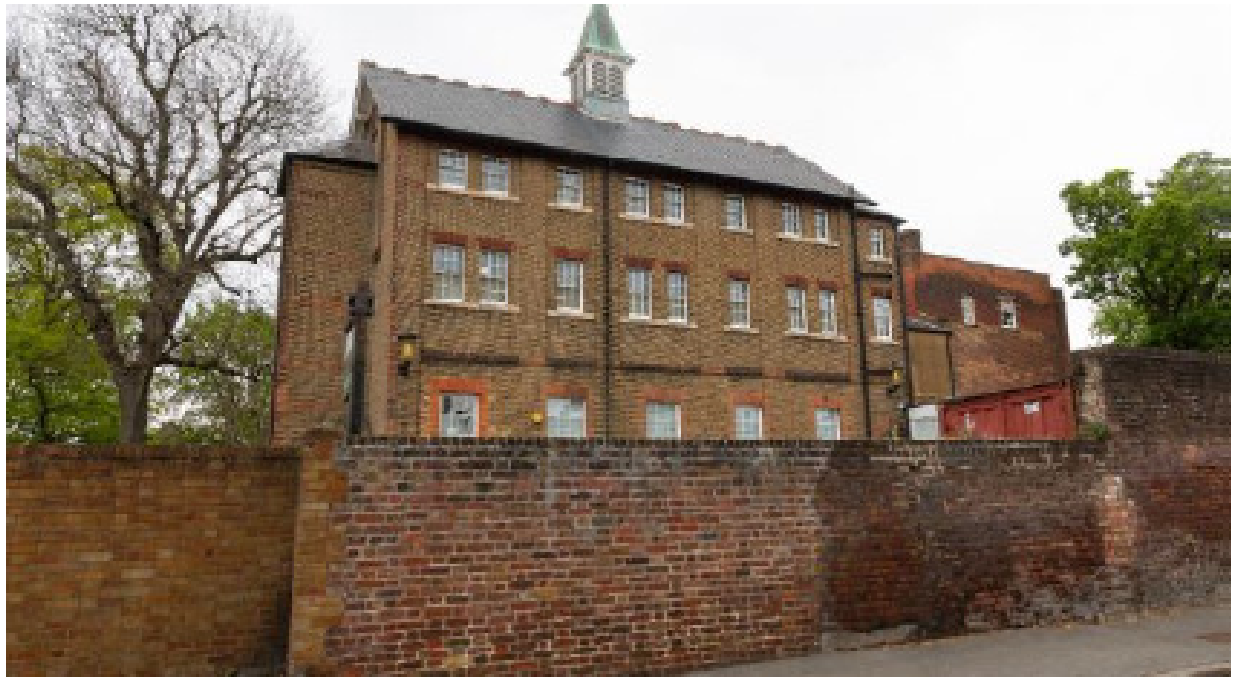
View Showing Newly Constructed Section of Wall (by other) in Yellow Brick
