## **Part 2: BS: 5837 Arboricultural Implications Assessment & 'Draft' Tree Protection Plan Report**

Sproughton  
22 Courtenay Avenue  
London  
N6 4LP

GD/210557/R2

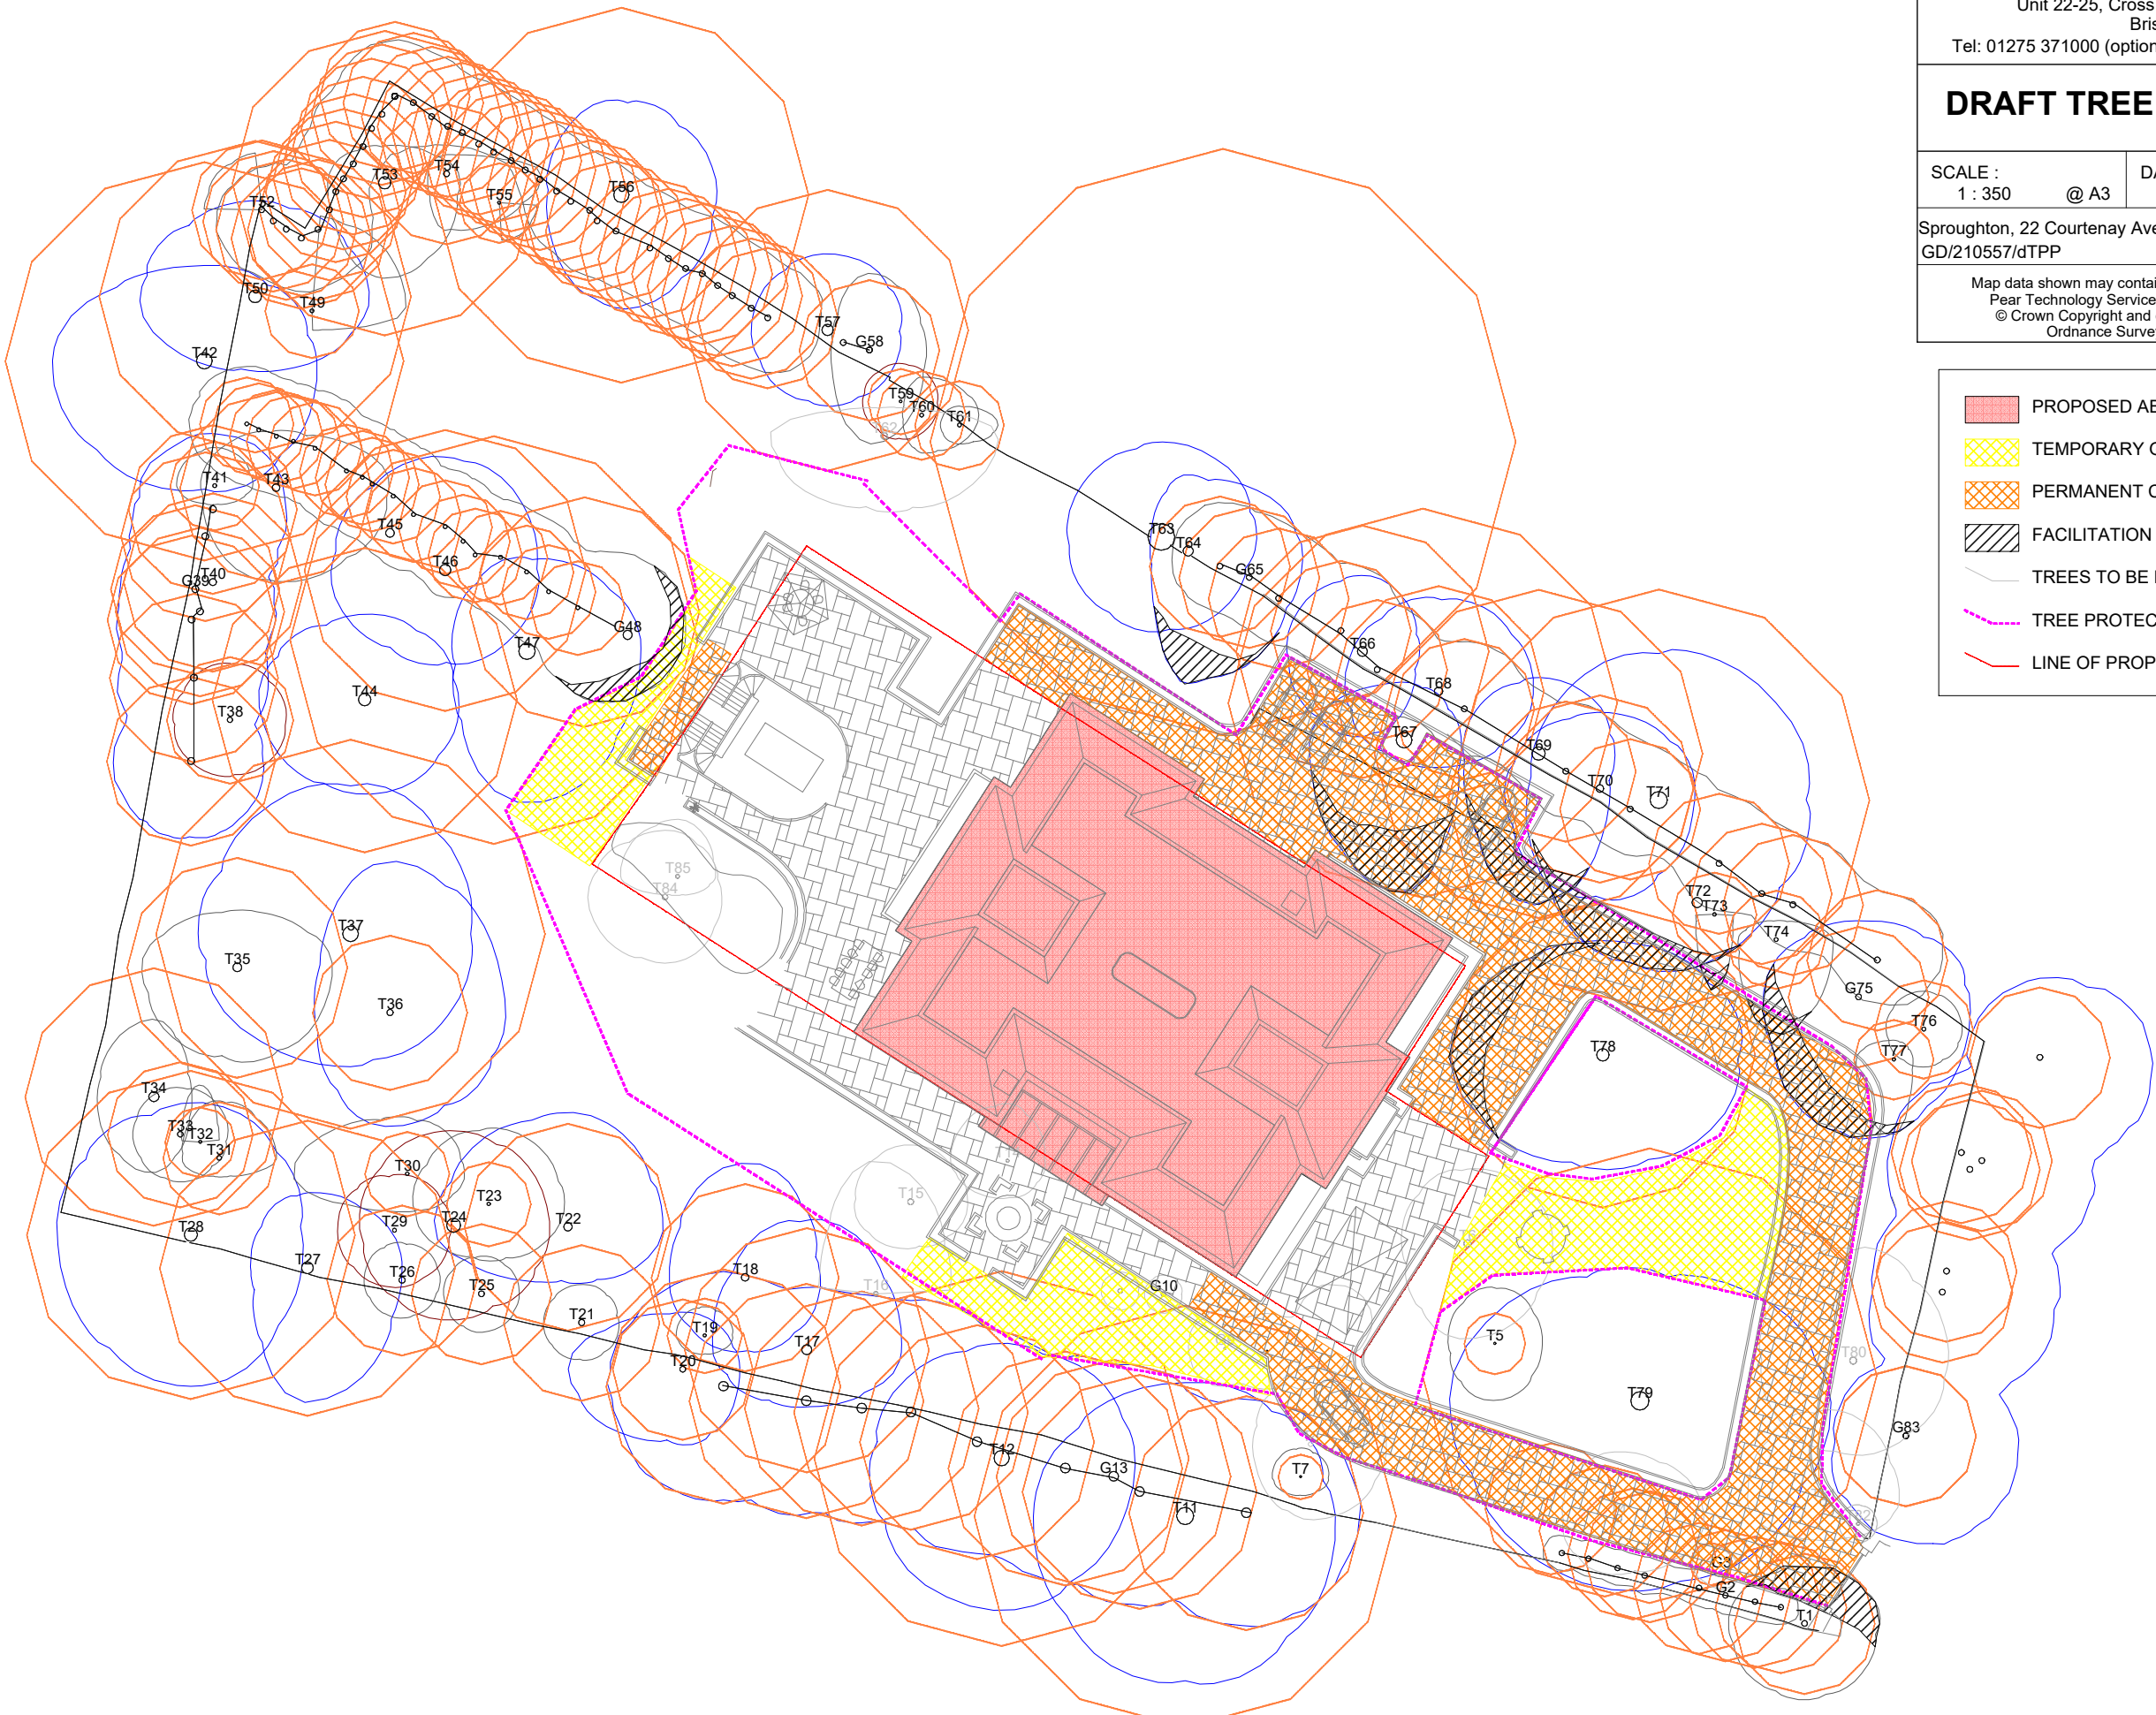
LINE OF PROPOSED BASEMENT

The draft Tree Protection Plan (dTPP) referenced GD/210557/dTPP can be found as an appendix at the end of this report. The TPP has been prepared in accordance with Section 7.1 of British Standard 5837:2012.
