## EXISTING WALL PROFILES 02

**Bruce Castle Wall**  
Title: Existing Wall Profiles 02  
Drawing No: 0722422-Su14 Scale: 1:25 @ A3

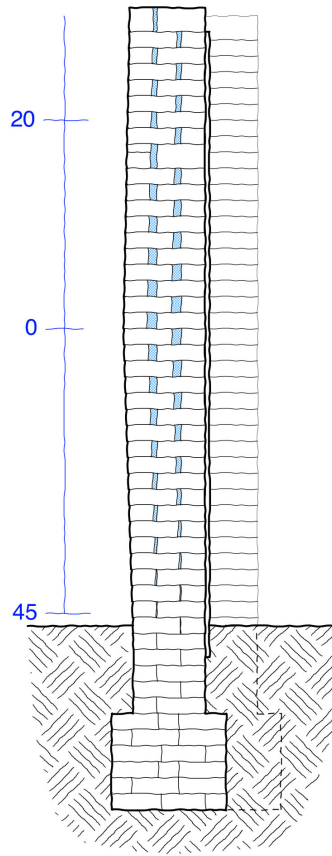
SECTION J

EXISTING CONDITION  
OF WALL :

1 1/2 BRICK ON EDGE  
FORMING COPING TO WALL  
IN CEMENT POINTING.

RED STOCK BRICKS LAID IN  
LIME MORTAR WITH A  
VARIETY OF POINTING IN  
PATCHES, SOME CEMENT  
POINTING LOOSE AND  
DECAYED IN PLACES.

OPEN JOINTED BRICKWORK  
WHICH REQUIRES  
REPOINTING.

CEMENT RENDER ON  
INTERNAL FACE OF WALL  
WITH SOME CRACKING.
