## EXISTING WALL PROFILES 01

**Bruce Castle Wall**  
Title: Existing Wall Profiles 01  
Drawing No: 0722422-Su13 Scale: 1:25 @ A3

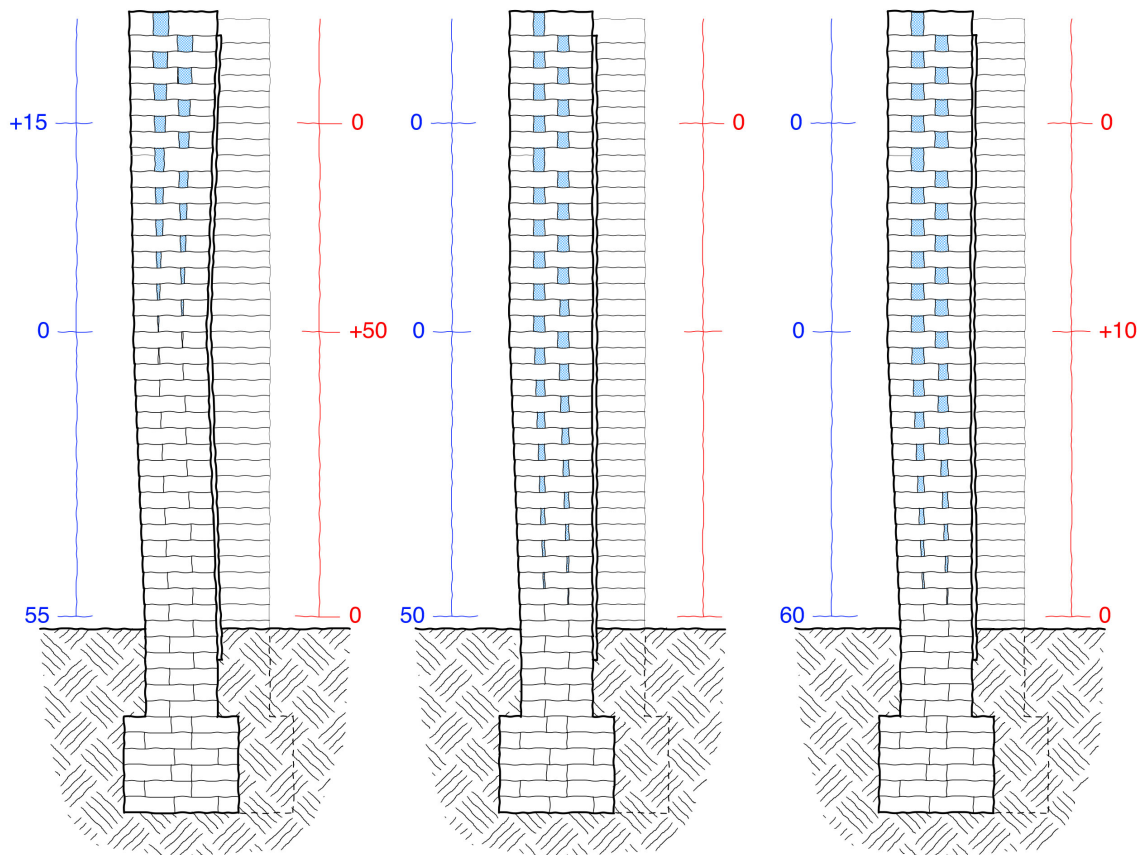
EXISTING CONDITION  
OF WALL :

1 1/2 BRICK ON EDGE  
FORMING COPING TO WALL  
IN CEMENT POINTING.

RED STOCK BRICKS LAID IN  
LIME MORTAR WITH A  
VARIETY OF POINTING IN  
PATCHES, SOME CEMENT  
POINTING LOOSE AND  
DECAYED IN PLACES.

OPEN JOINTED BRICKWORK  
WHICH REQUIRES  
REPOINTING.

CEMENT RENDER ON  
INTERNAL FACE OF WALL  
WITH SOME CRACKING.
