# **Bruce Castle West Boundary Wall Repairs**

## **Design & Access Statement**

BUTLER  
HEGARTY  
ARCHITECTS

Design and Access Statement: Repairs to Bruce Castle West Boundary Wall

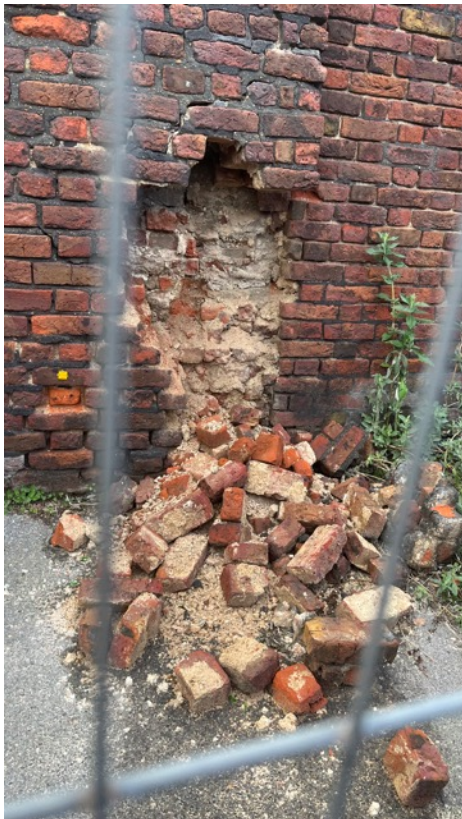
- 2.1 The West Boundary Wall, which runs along Church Lane, is damaged and currently in a state of collapse. The wall has been monitored since August 2022, and a number of inspections and surveys have been conducted since August 2023 to assess the extent of the bulge in the centre of the wall. This has been combined with some agreed initial physical investigations that have partially removed the area of render to the rear face of the wall and included a trial pit investigation. These investigations have revealed a multitude of factors contributing to the decay of the wall. The wall had been propped to help combat the risk of falling but recently a part of it has collapsed due to ongoing poor weather conditions and the driving of foundation piles on an adjoining site (see Fig 1). Thus, the wall requires immediate attention and is an ongoing safety hazard.

Fig 1: Photo of the wall collapsing

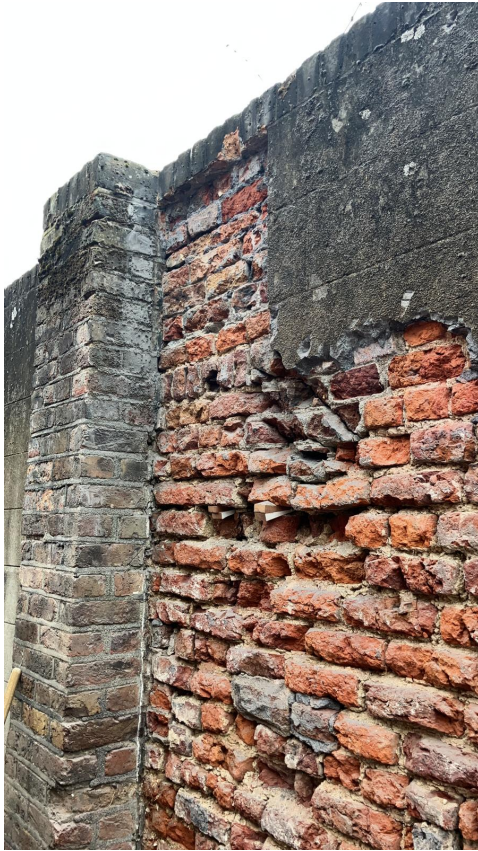
Fig 2: Photo of the internal face of the wall with render removed

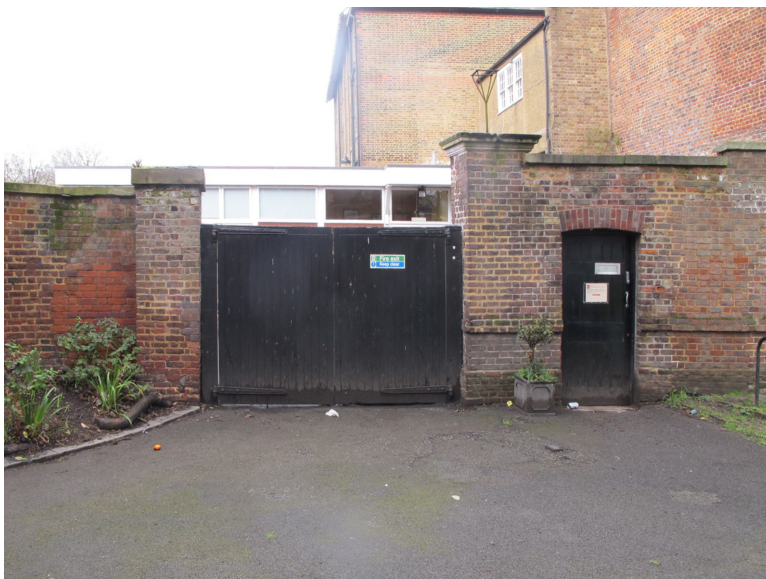
The gates along the south elevation of the west boundary wall are a late 20<sup>th</sup> century addition and a replacement of a previous arrangement. The gates are poorly constructed and have reached the end of their useful life. The top of the gatepost is capped with a cement render which has failed and decayed and needs repairing (see Fig 3).

Fig 3. Image of the gate

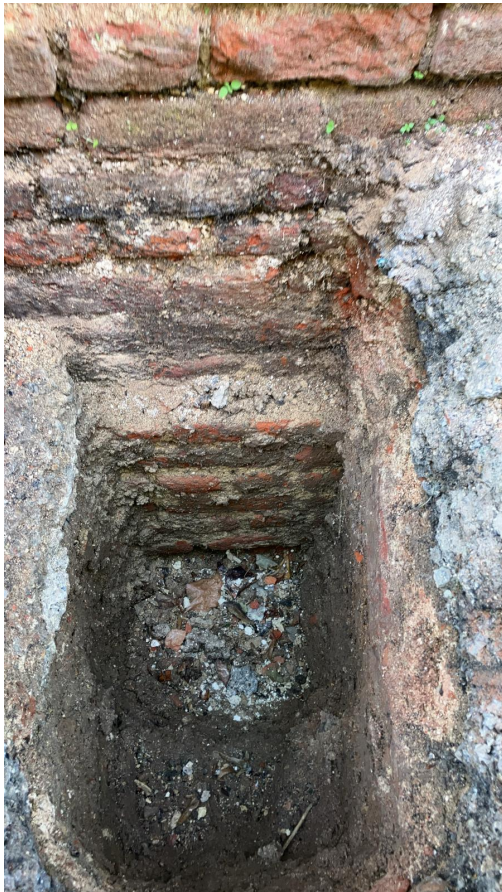
The existing drawings and photographs of the wall record the current degradation of the wall's condition. The wall dates from the 17<sup>th</sup> century, excluding the section at the north end where it becomes lower which has been built in the 20<sup>th</sup> century. The cement render on the internal face of the wall was also a 20<sup>th</sup> century addition. Recent investigations have removed this cement render in small exploratory sections to parts to brickwork (see Fig 2). This was done alongside a trial pit investigation in August 2023, which has revealed the foundations of the wall to be generally in good condition (see Fig 4). The existing elevations (see drawing 0722422/Su05 & Su06) record the results from this investigation. A plumb survey was carried out in order to establish the extent of the bulging of the wall along its length. This study found the bulging along the middle of the wall to be up to 100mm in places. The results of these investigations have led us to the conclusion that the wall is not overturning or suffering from rotation due to ground factors or the like but the result of the wall failing across its thickness, i.e. the front of wall separating from the internal skin of the wall.

Fig 4: Photos of the trial pit investigation, August 2023

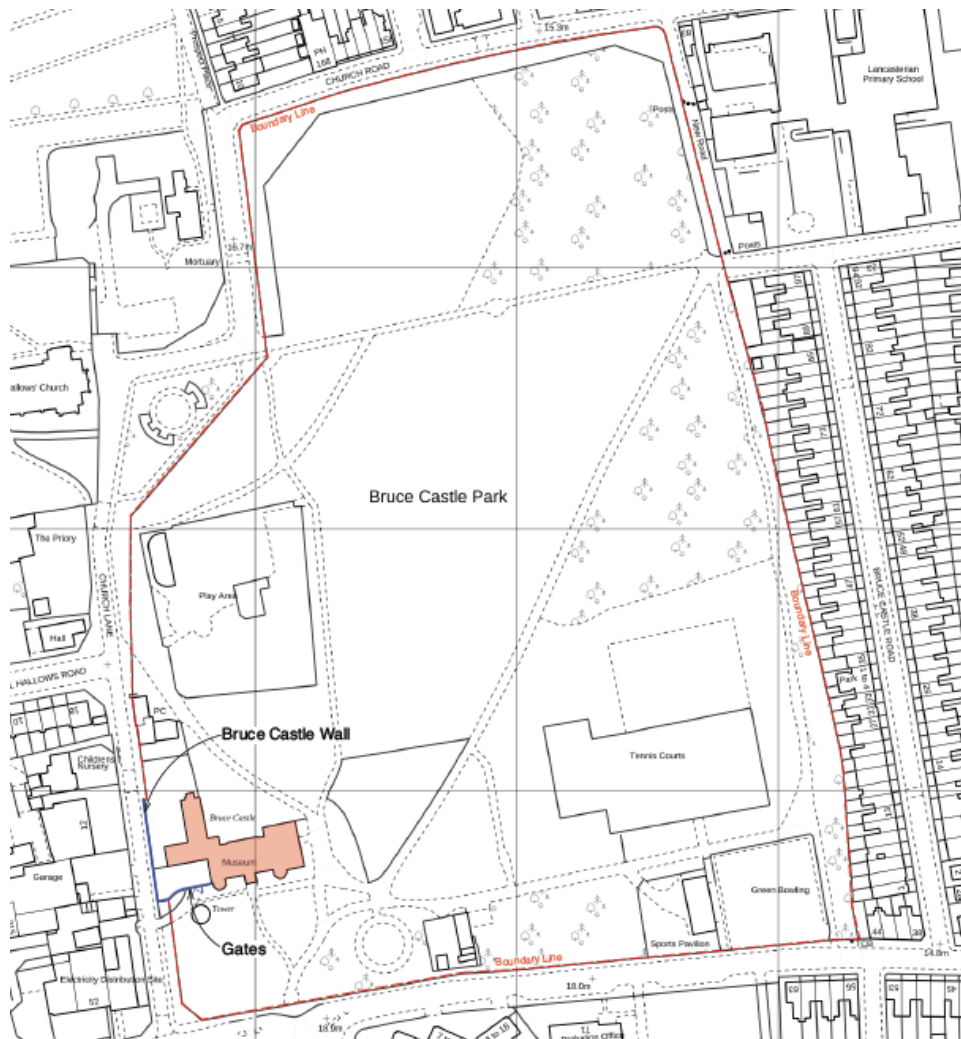
Bruce Castle Park is a historic landscape and the former grounds to Bruce Castle Museum, a Grade I listed building. The west boundary wall borders the car park on Church Lane and runs along Church Lane along a footpath. The gate along the south boundary of the wall provides access between the courtyard and the rest of the park (see Fig 5).

Fig 5. Site Plan showing location of West Boundary Wall and Gates
