# Tottenham Centre

Geo-environmental and Geotechnical Assessment

1922791-01(00)

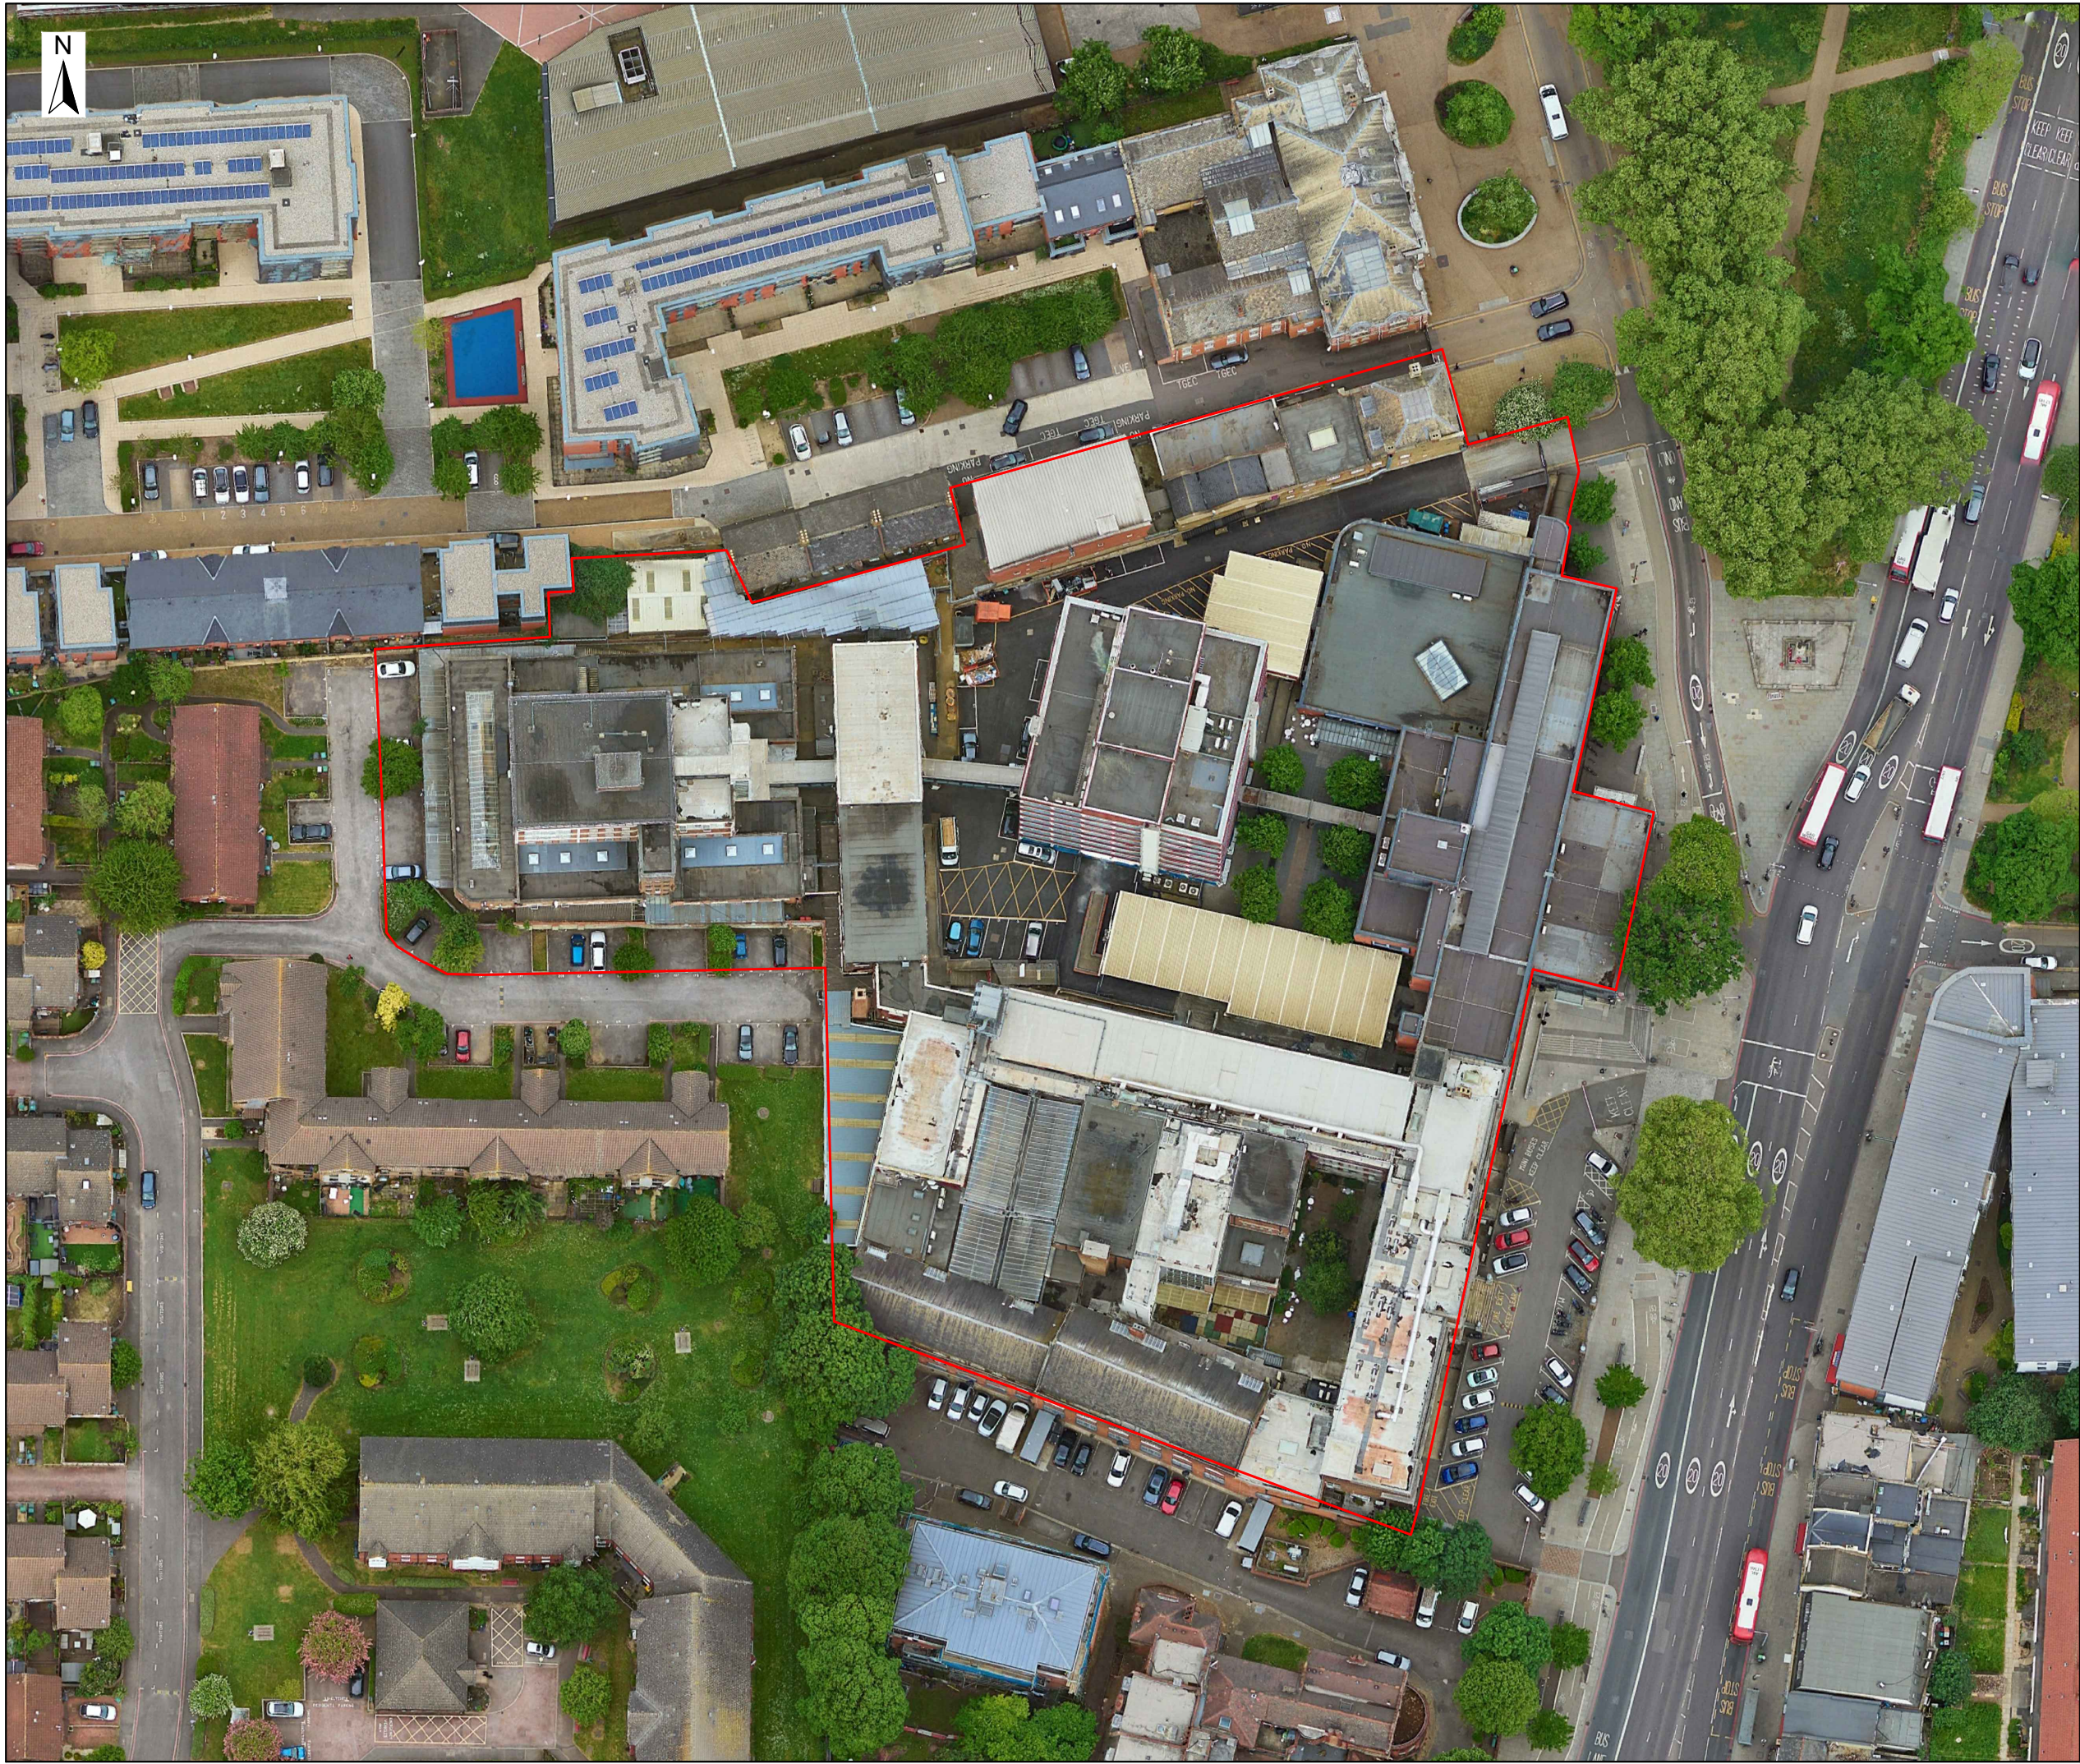
## **FIGURE 2 SITE LAYOUT PLAN**

The Site boundary and current site layout are shown on **Figure 2**. The Site covers an area of c. 1.19 hectares. It is currently occupied by an active educational college facility. The site is an irregular shape and compromises the active college area to the West of the A10 road.

A site plan is provided in **Figure 2** with photographic records included in **Appendix F** detailing the main features identified below.

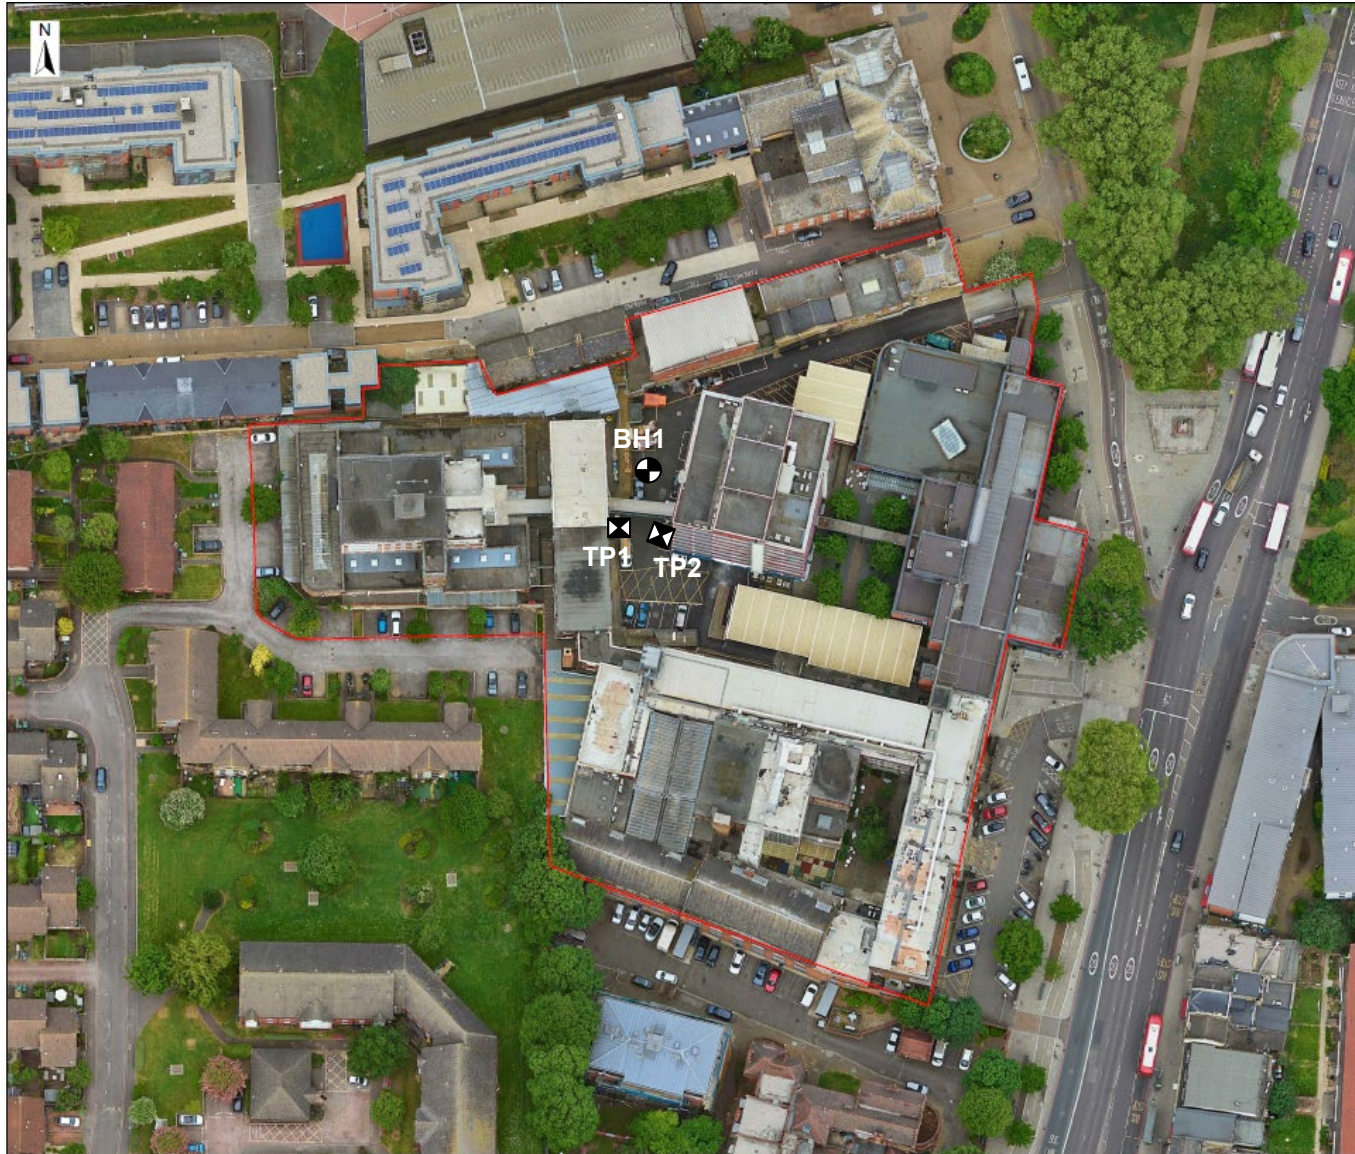
## **FIGURE 3 EXPLORATORY HOLE LOCATION PLAN**

Details of the investigation locations, installations and rationale are presented in Table 14. Two hand excavated trial pits were dug to a maximum depth of 1.20m bgl before being backfilled with arisings. One cable percussive borehole was drilled to a maximum depth of 25.00m bgl and installed with a shallow gas monitoring well. An exploratory hole location plan is shown on **Figure 3**.

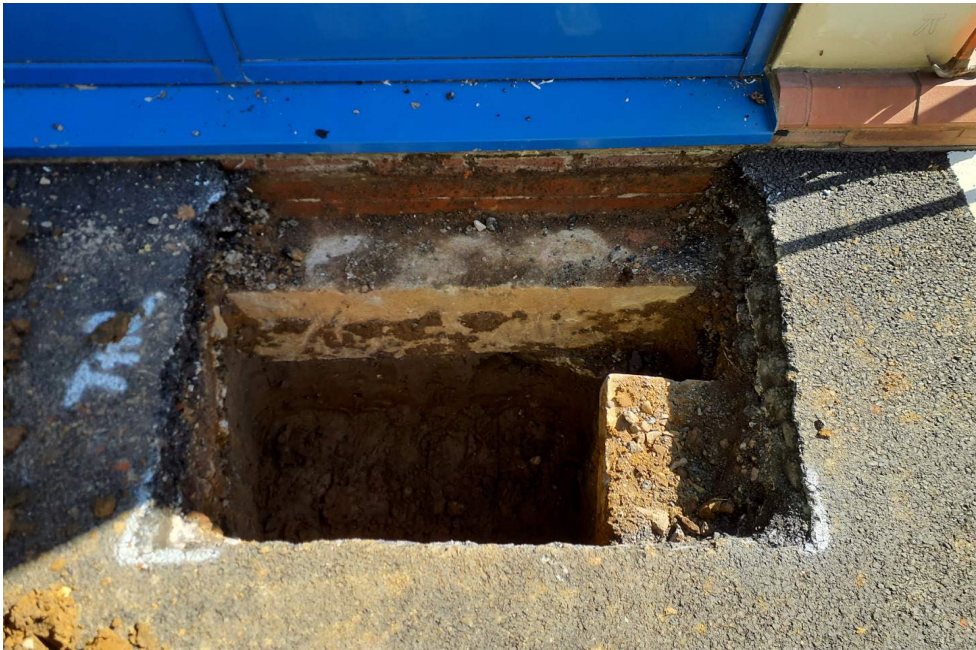
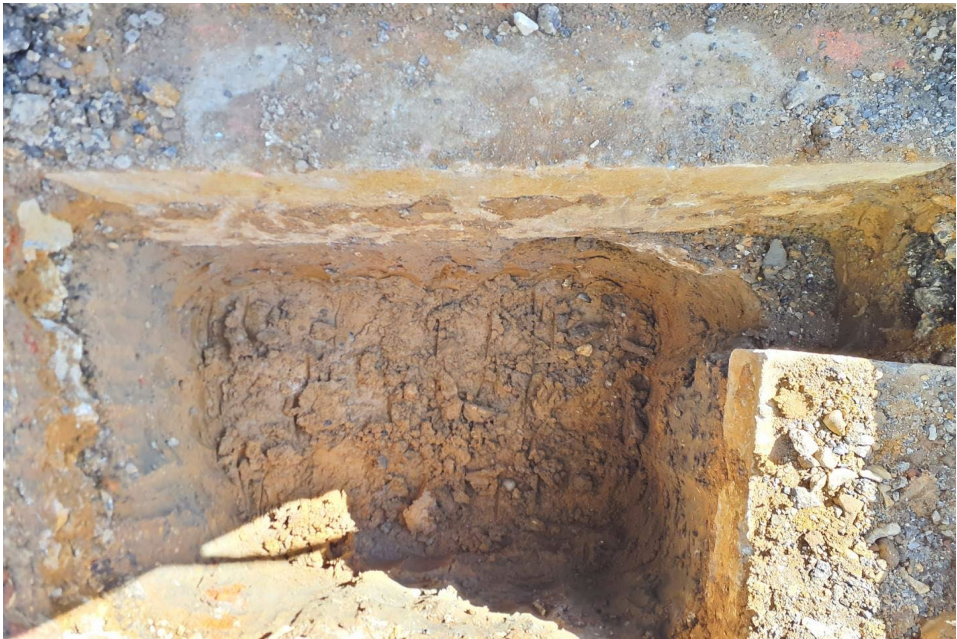
## **FIGURE 4 FOUNDATION INSPECTION PIT DRAWINGS**

0.0 to 0.20m - ASPHALT

0.0 to 0.40m - MADE GROUND (Brown black sandy slightly clayey fine to coarse angular to subangular GRAVEL of brick, asphalt, concrete and flint with brick cobbles. Sand is fine to coarse.

0.75 to 1.20m - MADE GROUND (Brown orange grey mottles slightly sandy slightly gravelly CLAY. Sand is fine to coarse. Gravel is fine to coarse angular to subangular brick, concrete and flint.)

| Foundation protrudes only 0.23m from the wall edge | | | | |

Two foundation inspection pits (TP1 – TP2) were undertaken to establish the foundations of the existing foundations. Details of the foundations and founding stratum are included in the exploratory logs in **Appendix I** and in **Figures 4a & 4b**.
