# 02.07 Thermal Comfort

Overall Findings &  
Recommendations

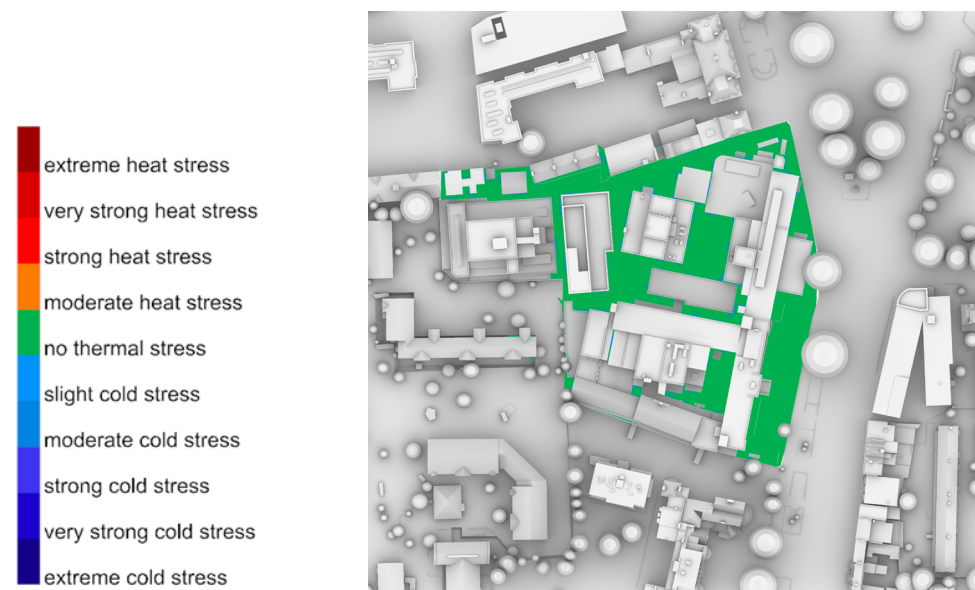
The month of June shows an average UTCI temperature of 22 °C across the site and a slightly lower temperature on the east side of the proposed construction centre. The categorization of this temperature, according to UTCI, is no thermal stress. This is due to the temperate climate and the shading caused by the surrounding buildings, which protect it from direct solar radiation.

U.T.C.I categorisation March 8am to 4pm

U.T.C.I temperature for the month of March 8am to 4pm

As for thermal comfort, the spring period shows mostly no thermal stress, but a limited area has slight cold stress. In the summer, there is no thermal stress throughout the site. Finally, in winter, the wider site shows no thermal stress; however, slight cold stress is seen surrounding the building in addition to moderate cold stress on the southeast side of the building.

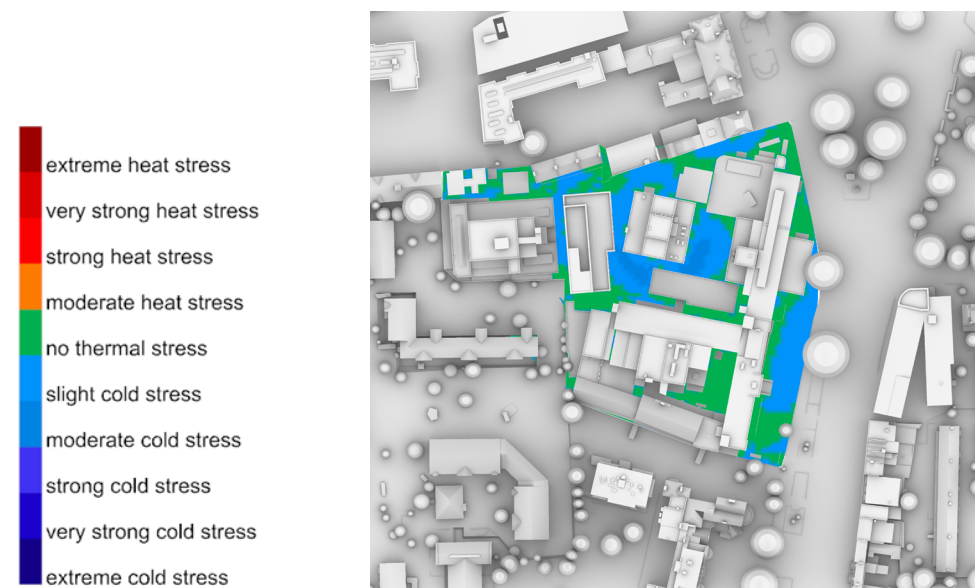
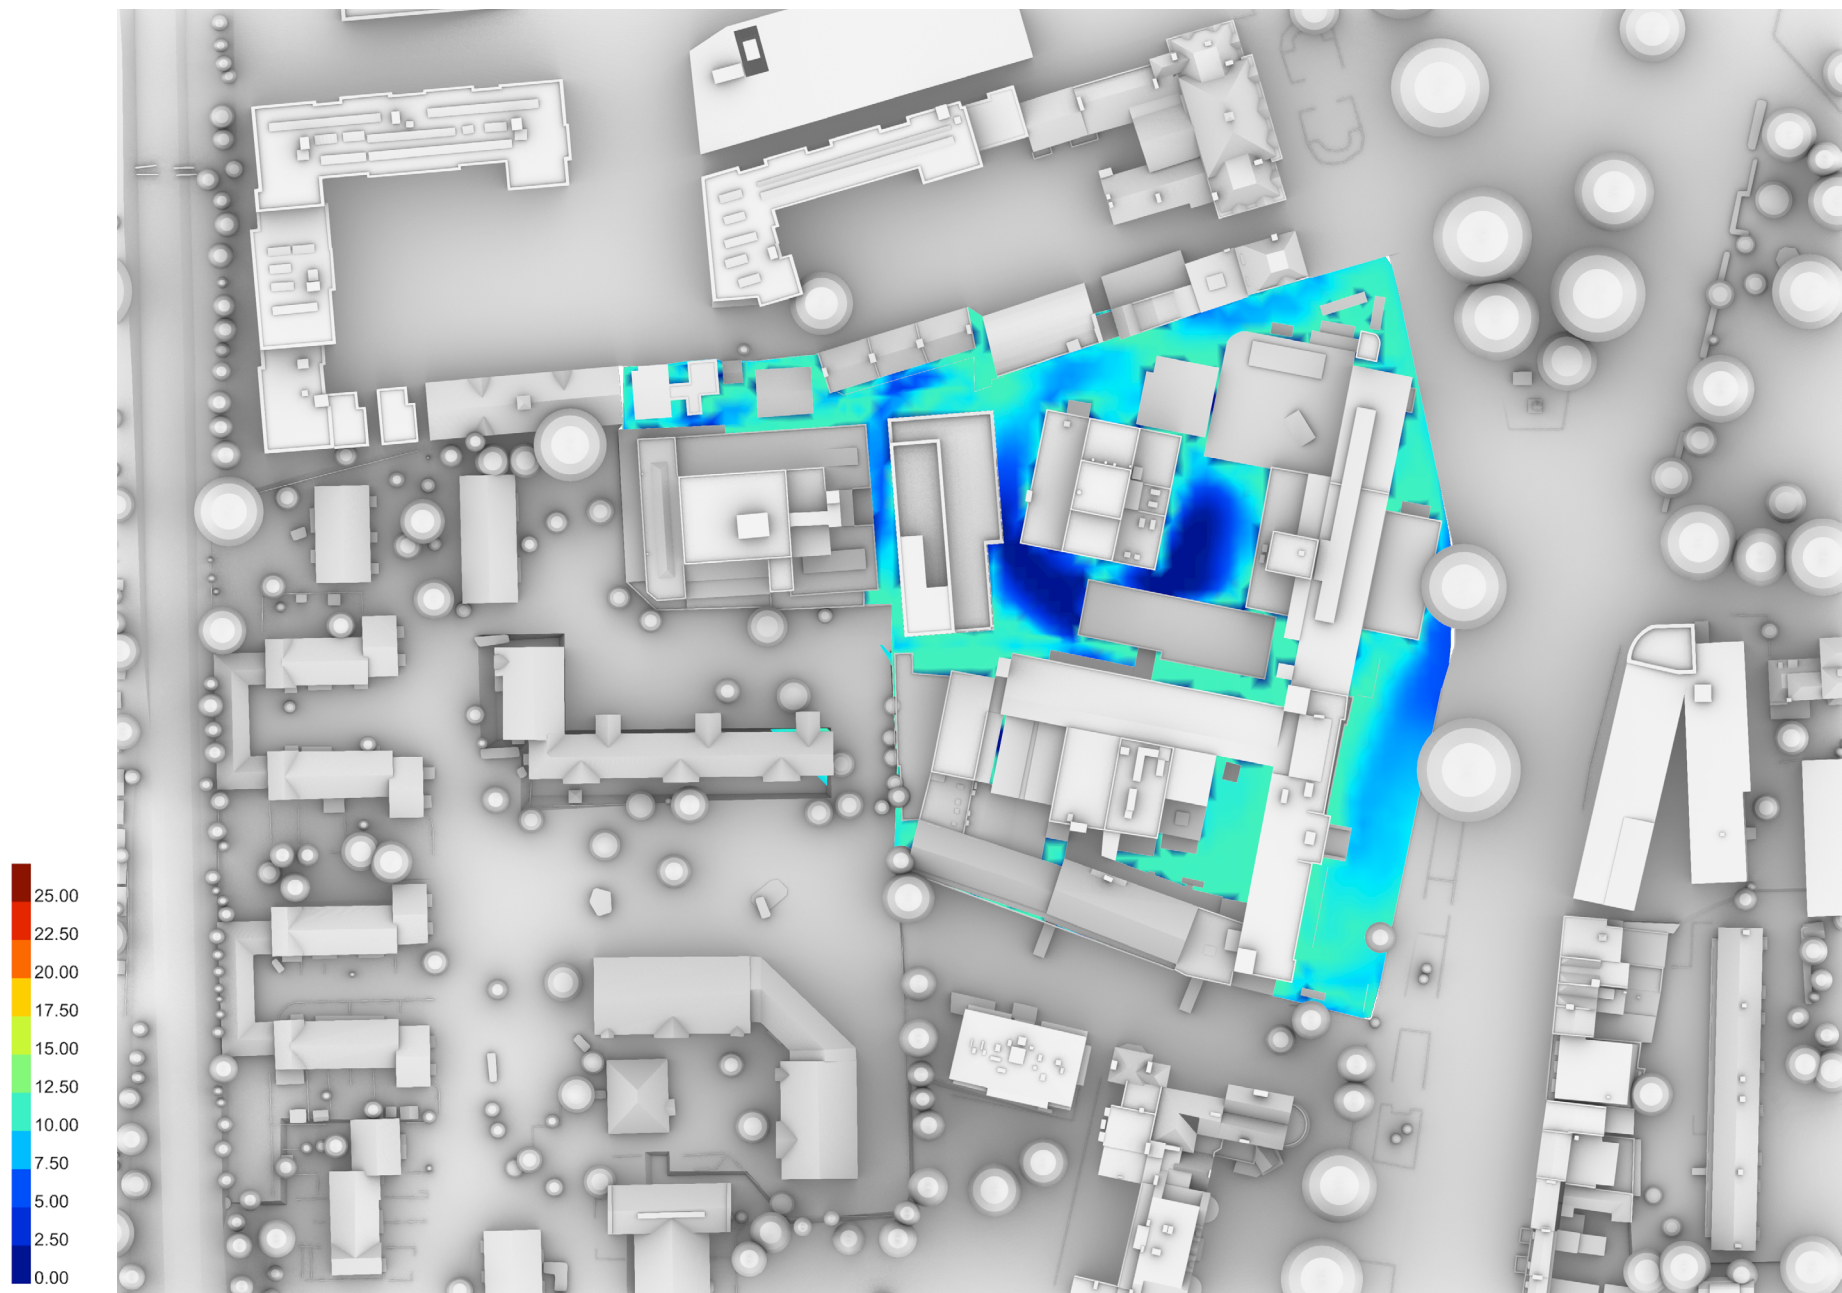
The month of December shows an average UTCI temperature of 10 °C across the site and a particularly low temperature on the east side of the proposed construction centre due to a downdraft effect caused by the difference in height compared to the surrounding buildings. The categorization of this temperature according to UTCI places a large part of the site in slight cold stress, and moderate cold stress can be seen on the west side of the building.

U.T.C.I categorisation March 8am to 4pm

U.T.C.I temperature for the month of March 8am to 4pm

The moderate cold stress experienced in winter on the southeast side of the building is most likely due to the higher wind speeds observed in this area. To mitigate this and allow for outdoor activities, implementation of obstructions is recommended, such as trees to decrease wind speeds without compromising on solar access. This would improve the conditions experienced on site, including activities such as outdoor dining.
