## Preliminary Risk Assessment

807 High Road, Tottenham

February 2024

**Client Name:** F3 Architects LLP on behalf of High Road West  
(Tottenham) Limited  
**Document Reference:** WIE20262-102-R-1-2-1-PRA  
**Project Number:** WIE20265-102

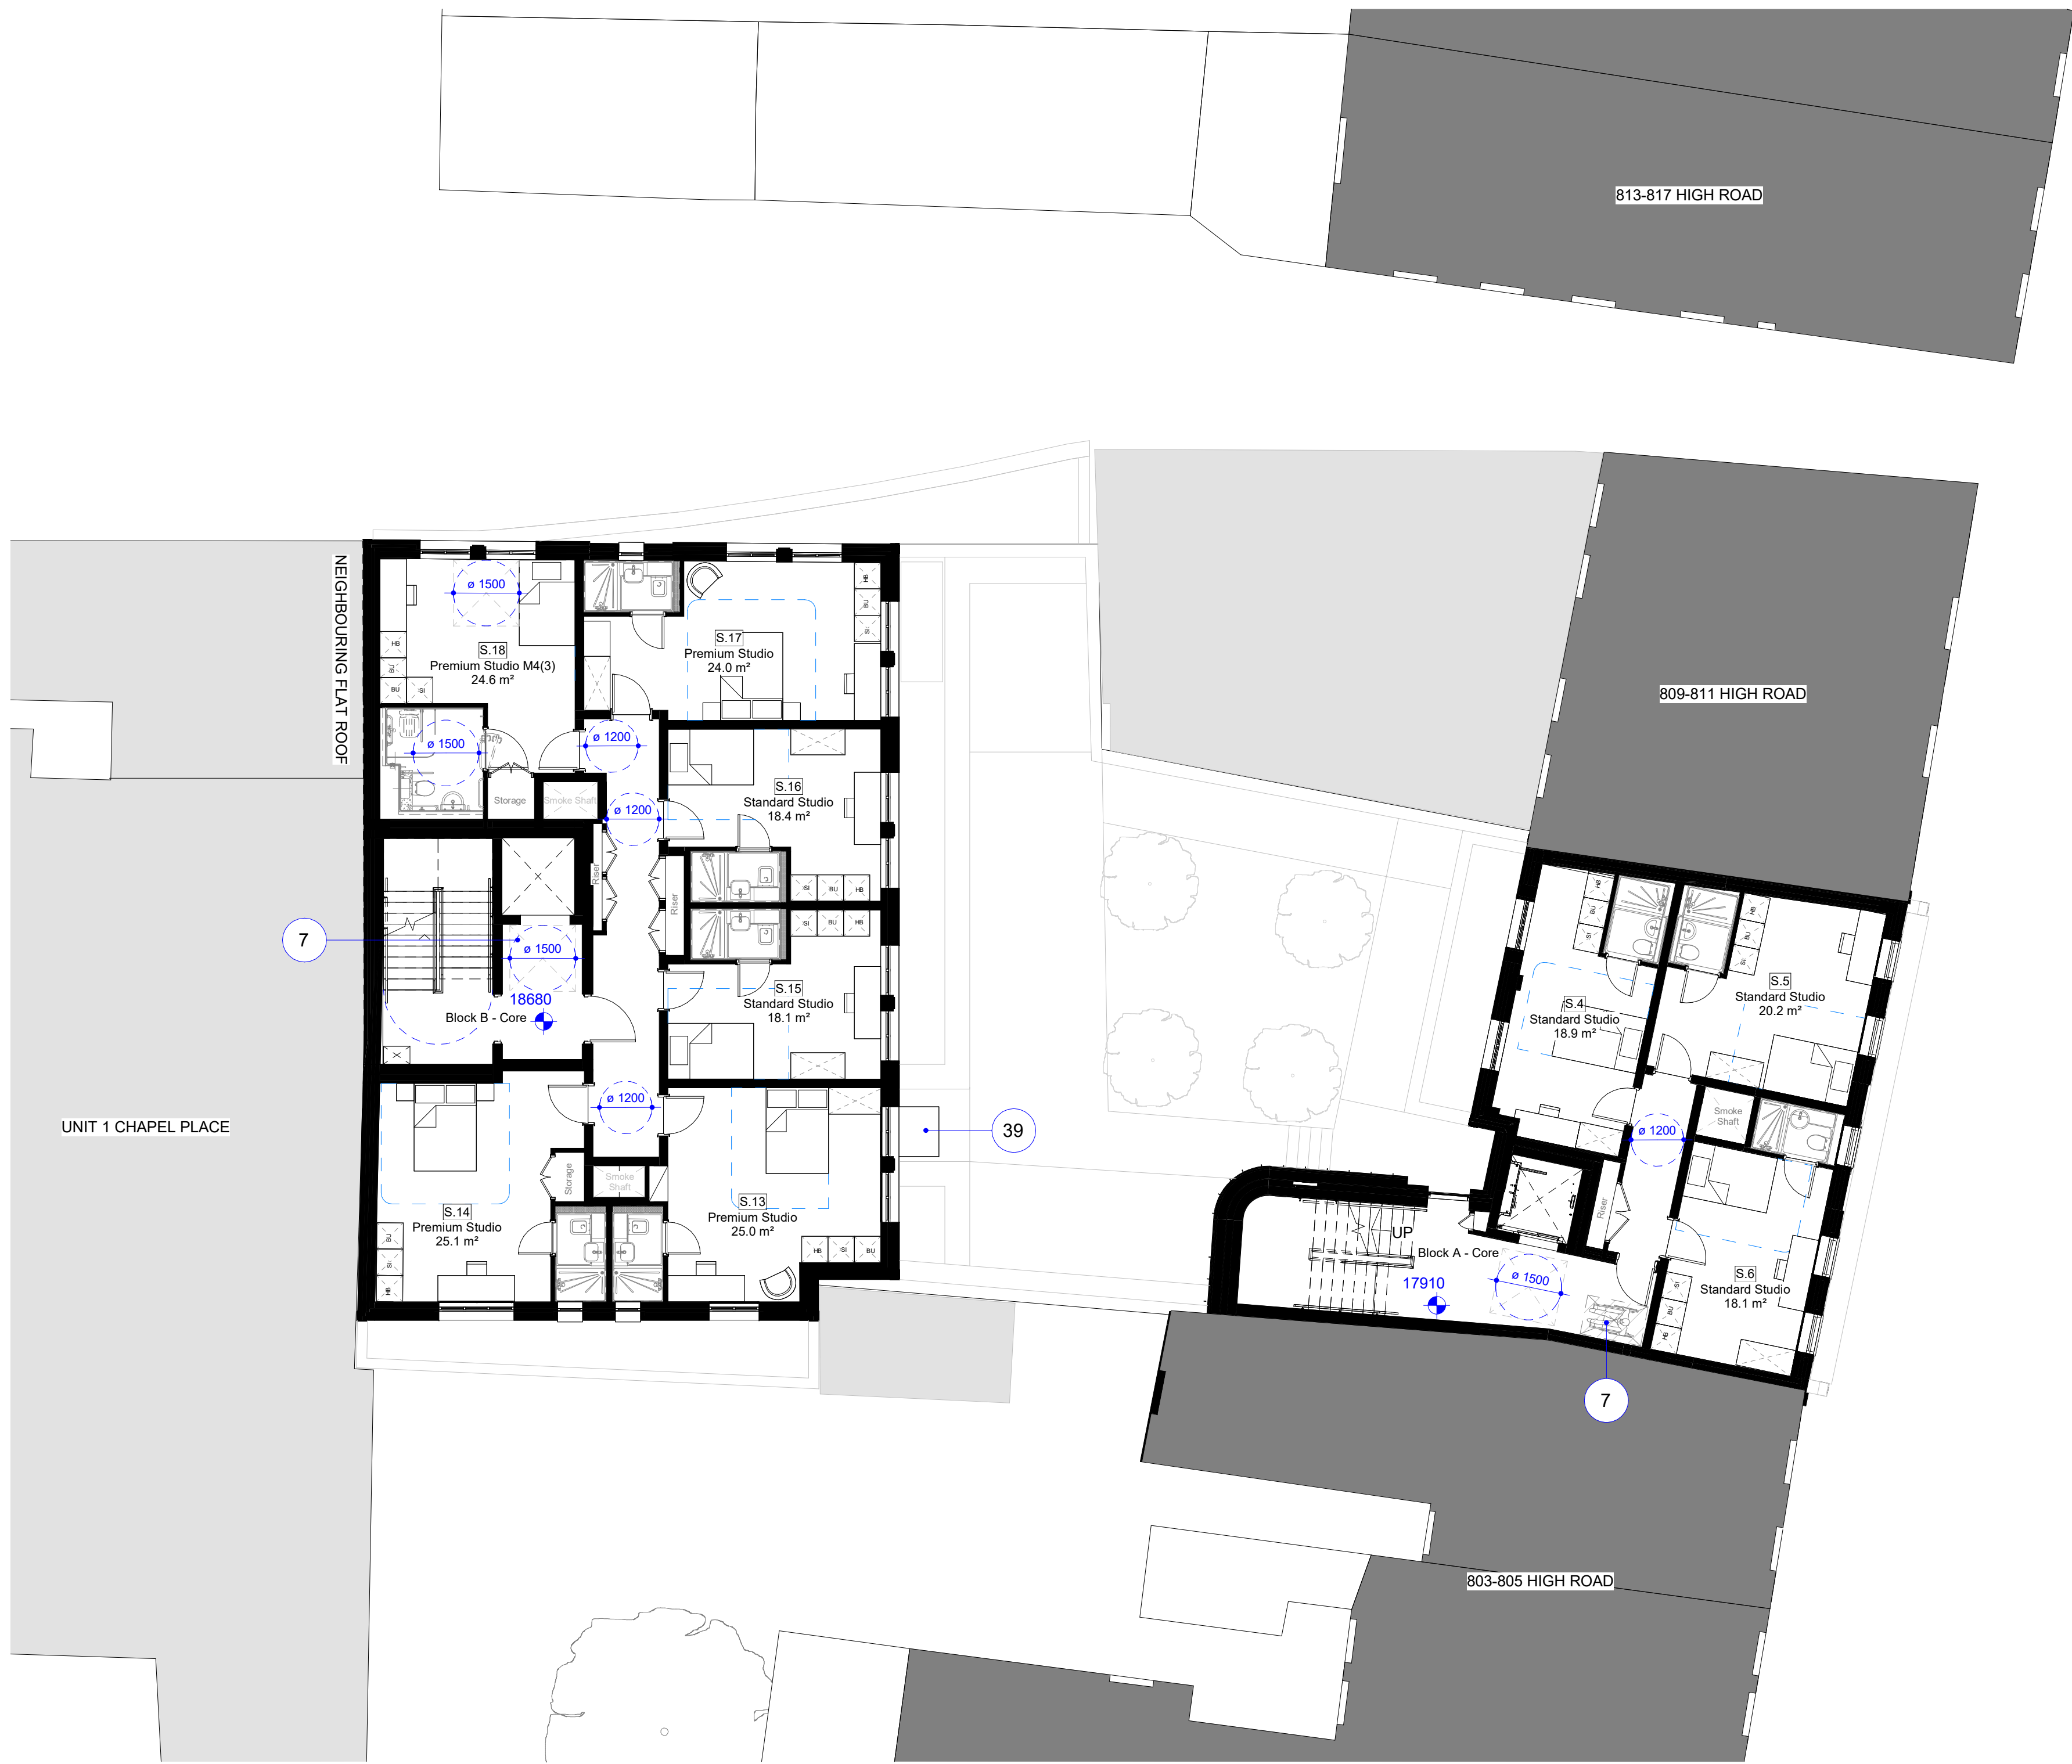
drawing no  
807HR-F3A-XX-01-GA-A-0821

**MATERIAL KEY**

- 1) Painted timber door
- 2) Painted timber framed glass shopfront
- 3) Painted timber stall riser
- 4) Painted pilaster
- 5) Brick - similar to 801 High Road

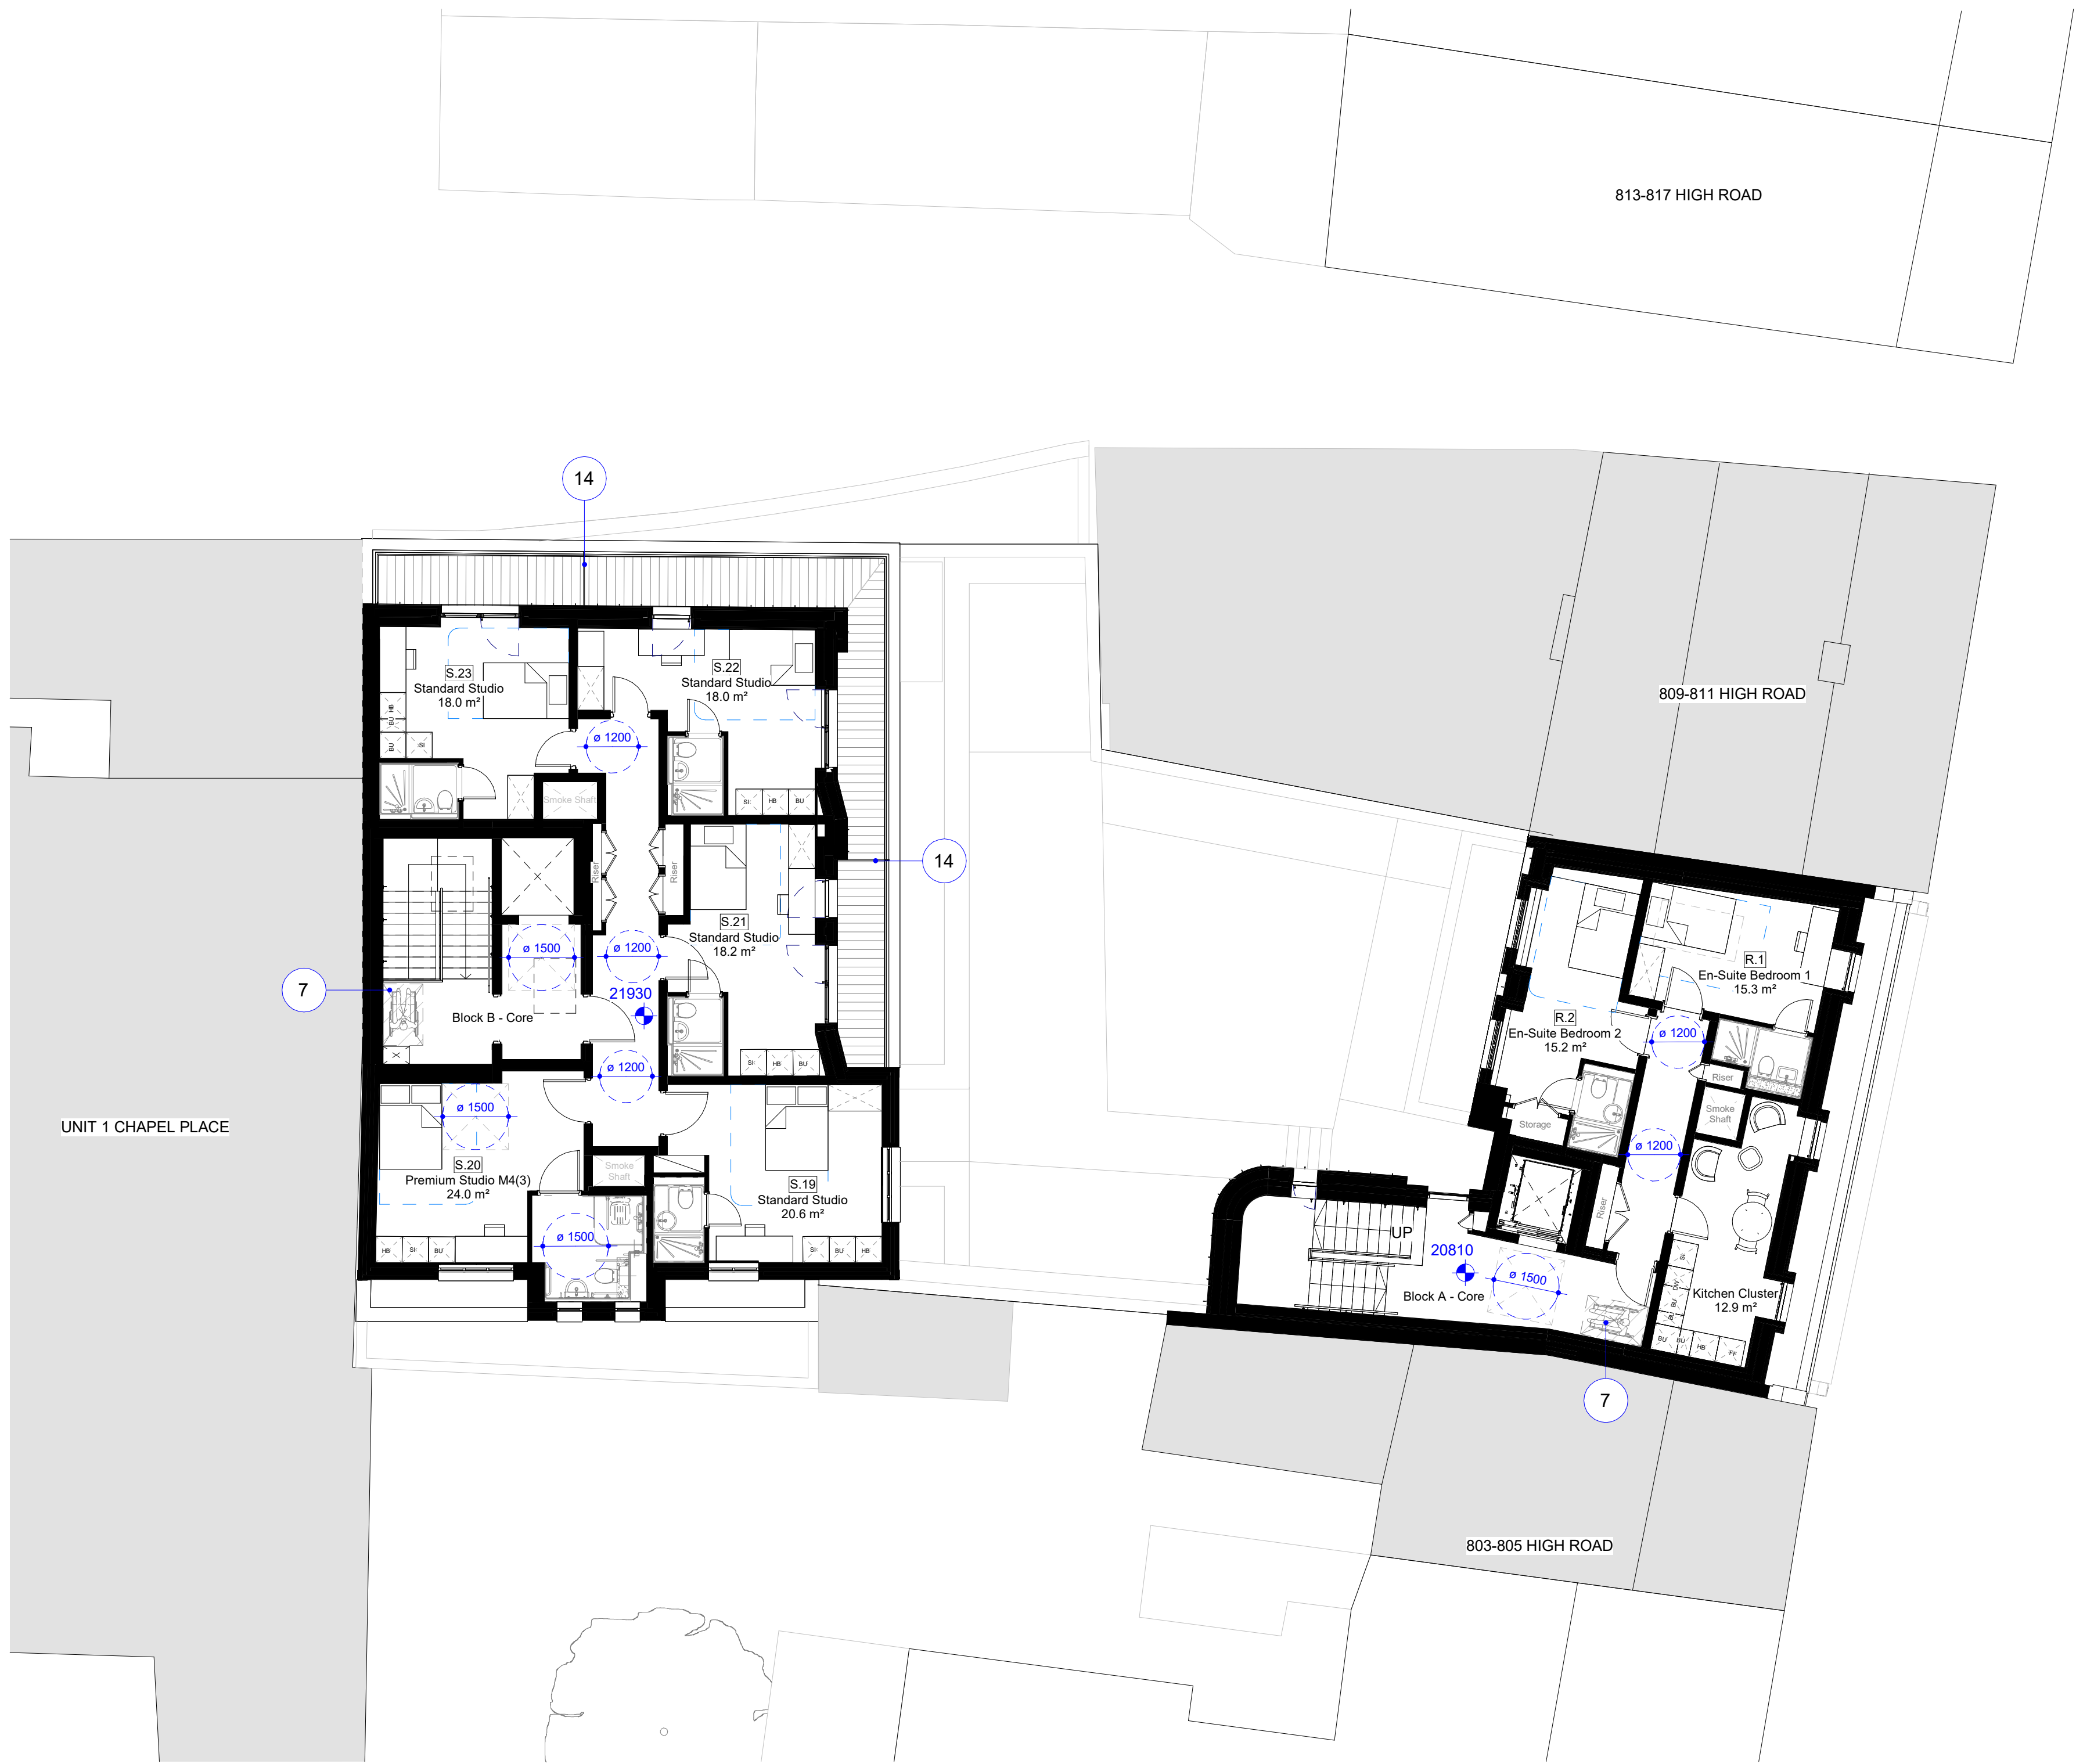
| 807HR-F3A-XX-02-GA-A-0822 |

#### MATERIAL KEY

- 1) Painted timber door
- 2) Painted timber framed glass shopfront
- 3) Painted timber stall riser
- 4) Painted pilaster
- 5) Brick - similar to 801 High Road
