## Large-Scale National Grid Data

Order Number: 308348863\_1\_1  
Customer Ref: 1922791  
National Grid Reference: 533620, 189280  
Slice: A  
Site Area (Ha): 1.19  
Search Buffer (m): 100

The College of Haringey Enfield & North East L ..., Tottenham Centre, High Road, LONDON, N15 4RU

## **APPENDIX E      OTHER SUPPORTING DESK STUDY INFORMATION**

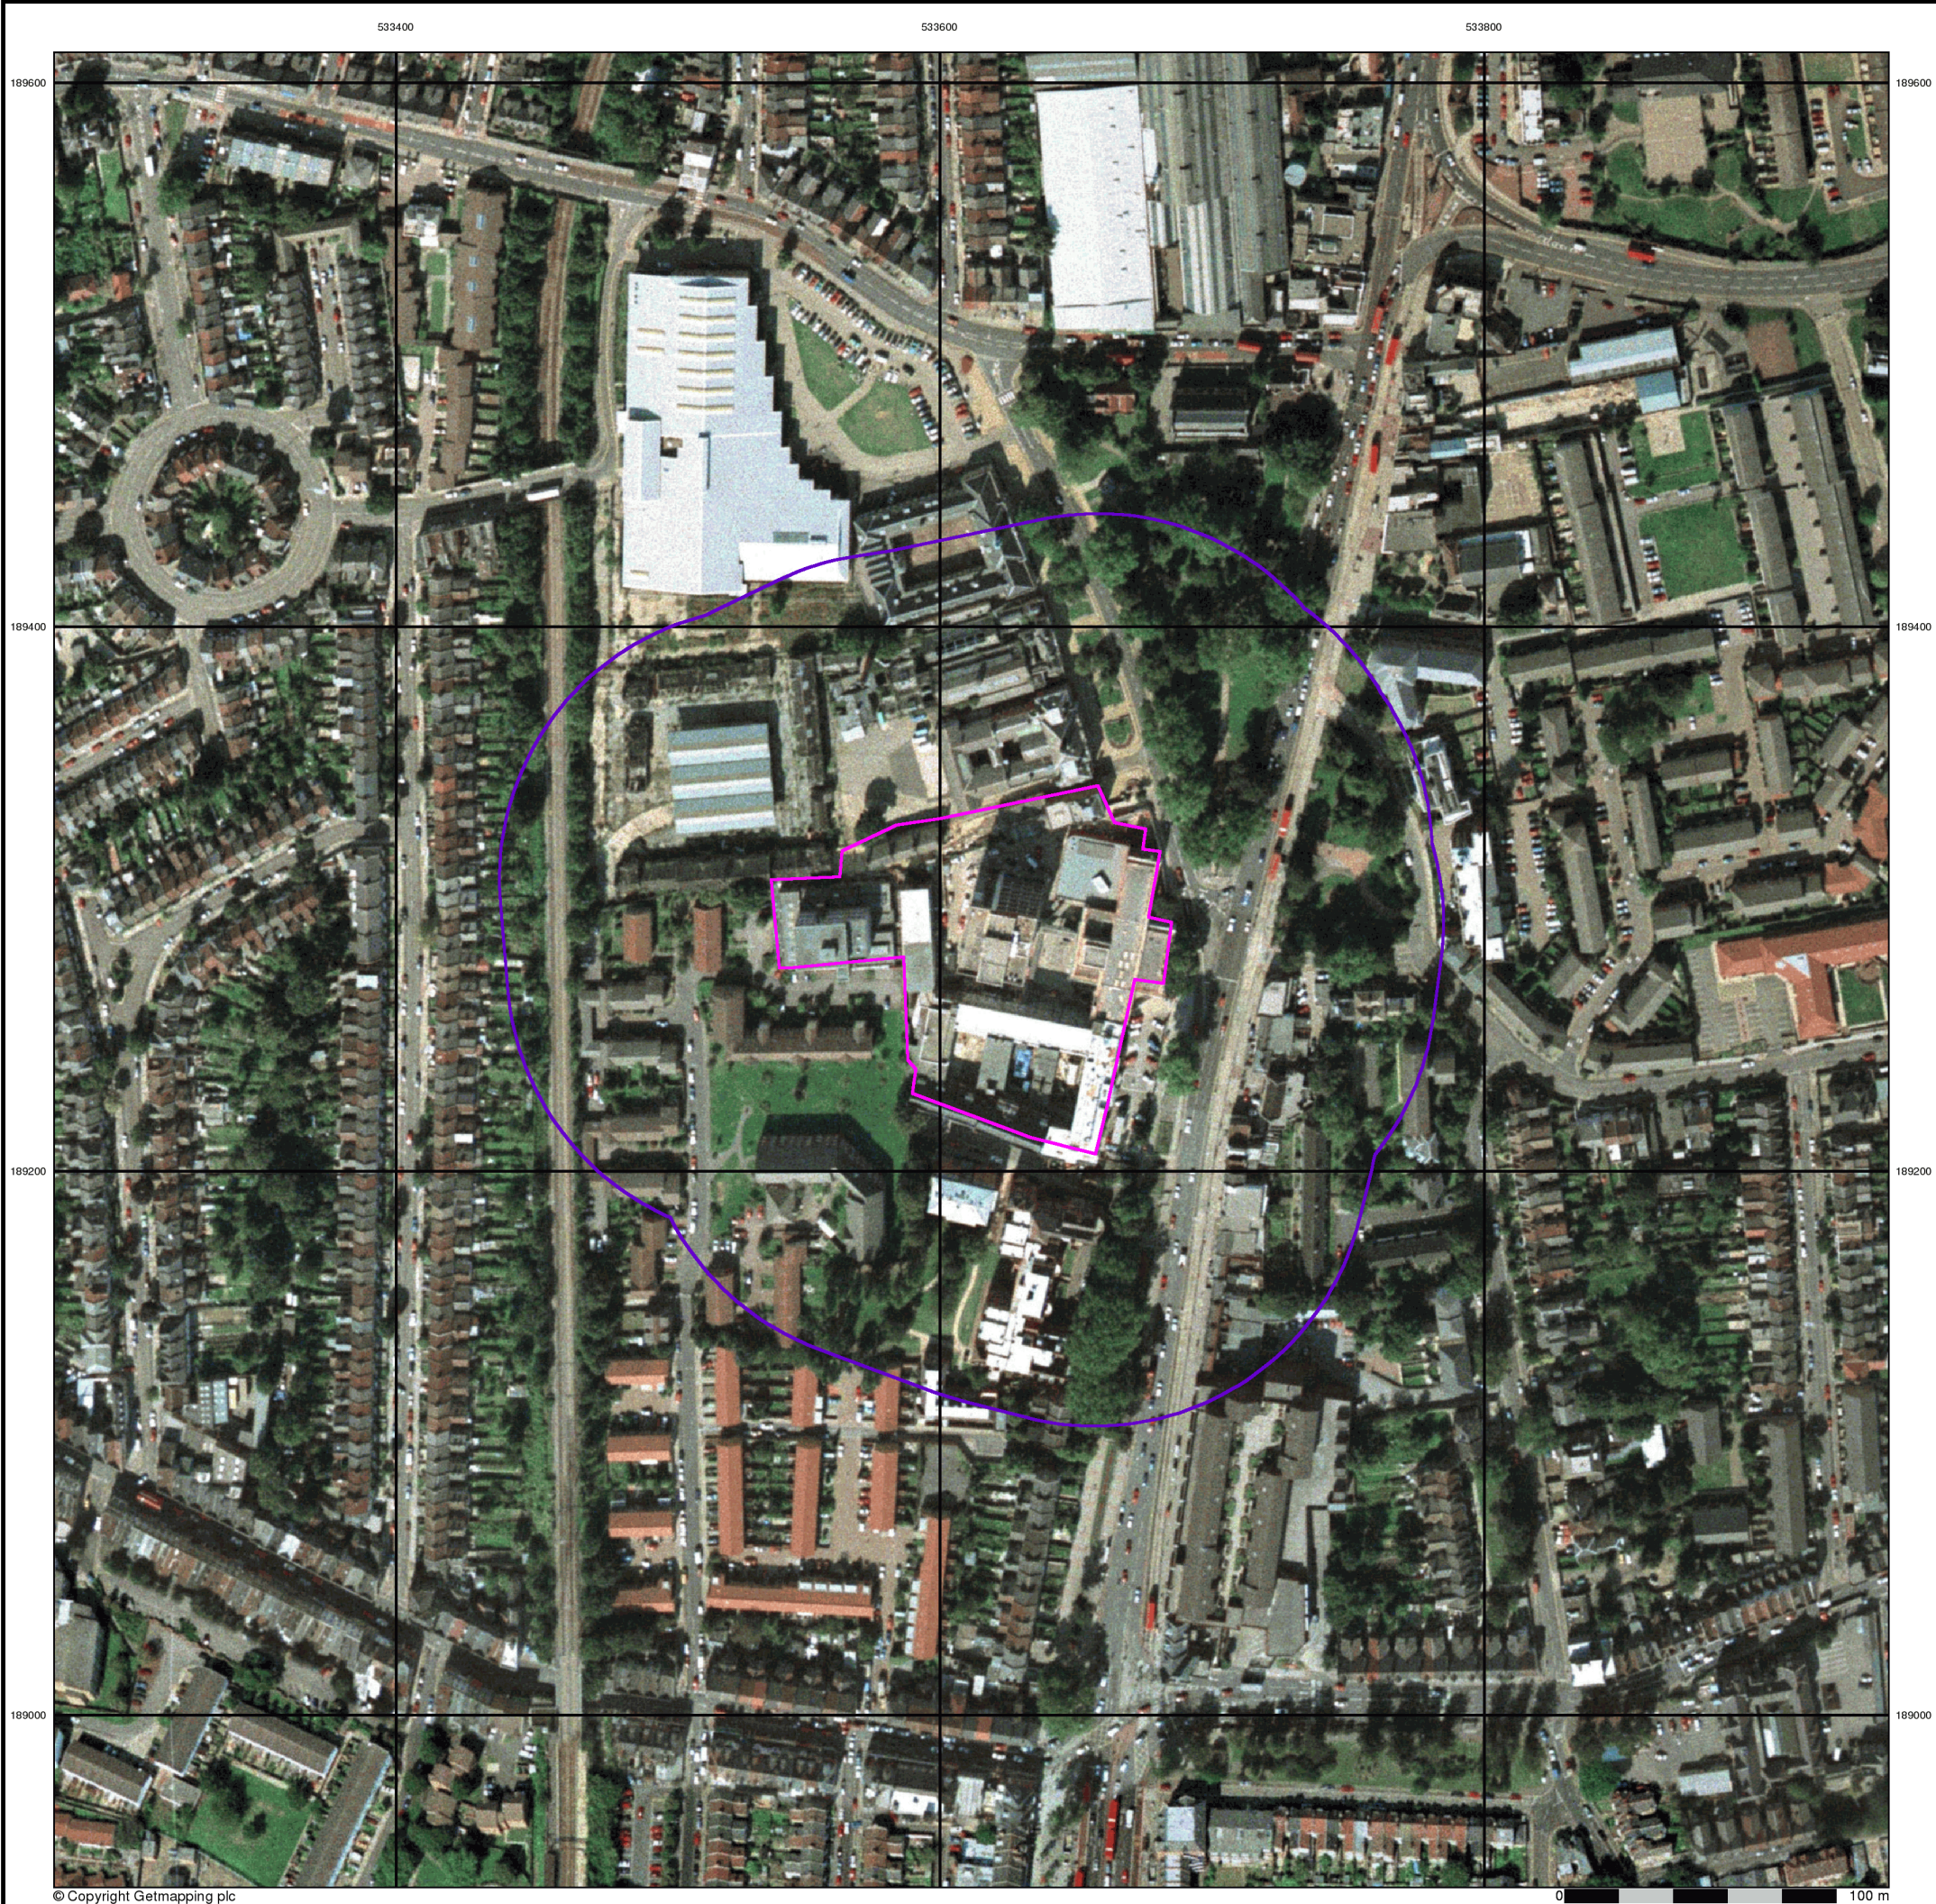
### Historical Aerial Photography - Segment A13

## Historical Aerial Photography

Published 1999

This aerial photography was produced by Getmapping, these vertical aerial photographs provide a seamless, full colour survey of the whole of Great Britain

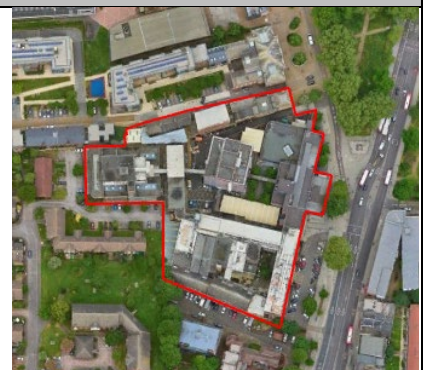
The Site (approximately centred on the National Grid Ref: TQ 33628 89278) is situated in the London Borough of Haringey, approximately 895m south-west of Tottenham Hale railway station.

The Site comprises the Tottenham Centre (the College of Haringey, Enfield and North-East London), consisting of structures of varying storeys (generally two to three) and hard surfaced accessways, car parking facilities and courtyard areas. It is bound to the north by Isobel Place, to the east by Town Hall Approach Road and High Road, to the south by an unnamed accessway and residential properties on Portland Road and to the west by residential properties on Portland Road and associated garden areas.
